Ref : CS/III18001471/Urd3

1. Policy Particulars :- THIRD PARTY CLAIM

4. Description of Damages

VEHICLE DAMAGE INSPECTION REPORT**Our File No:** CS/III18001471/URD3E2
Date: 21/02/2018**REFERENCE**

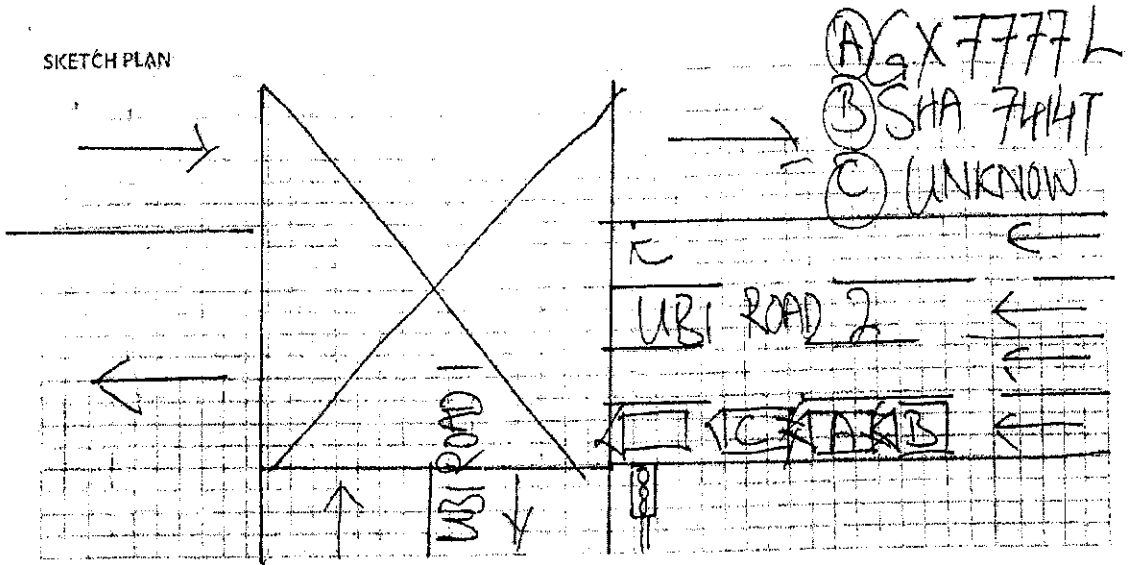
SKETCH PLAN

On 23-01-2018 @ 11:15 AM I was travelling on UBI ROAD 2 TOWARD UBI ROAD 1 in extreme left lane front lorry stop so I follow to stop in stationary position suddenly taxi SHA 7444T behind me could not stop in time and collect onto my vehicle GX7777L Rear portion and the impact was so great that throw my vehicle hit onto front lorry. After accident we 3 person come down to inspect and the front lorry drive away in hurry so I forget to take down his detail.
