### 1. Policy Particulars :- THIRD PARTY CLAIM

### 4. Description of Damages

THE VEHICLE SUSTAINED DAMAGES AT THE REAR PORTION. DAMAGES SEE DETAILS.
--

## ADJUSTMENT ON REPAIR COST FOR VEHICLE NO. SLF 4442H

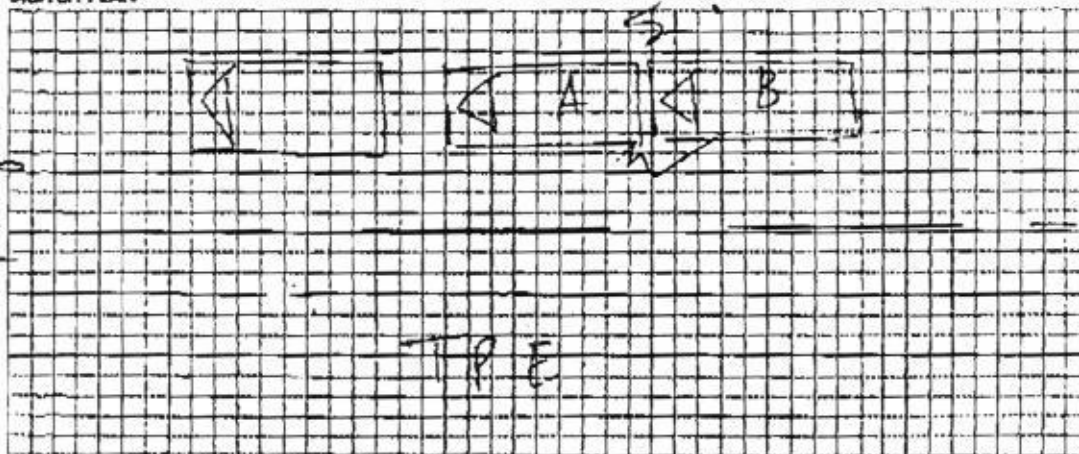
## SKETCH PLAN

On 24/1/18 at about 836 am, my car was stationary on the right lane of TPE waiting to left loyang ave. Suddenly vehicle B behind me hit the rear of my vehicle (A). The driver of vehicle B came down and asked me why I didn't drive my car seeing that the car in front drove off.
