**ACCIDENT INVOLVING SGY 1820D & SGE 1969P ON 09.09.2017**

**Re: Vehicle Registration Number SGE 1969 P (Suzuki APV)**

### ACCIDENT DAMAGED VEHICLE INSPECTION REPORT (WITHOUT PREJUDICE)

**REPAIR DETAILS (SGE 1969 P)**

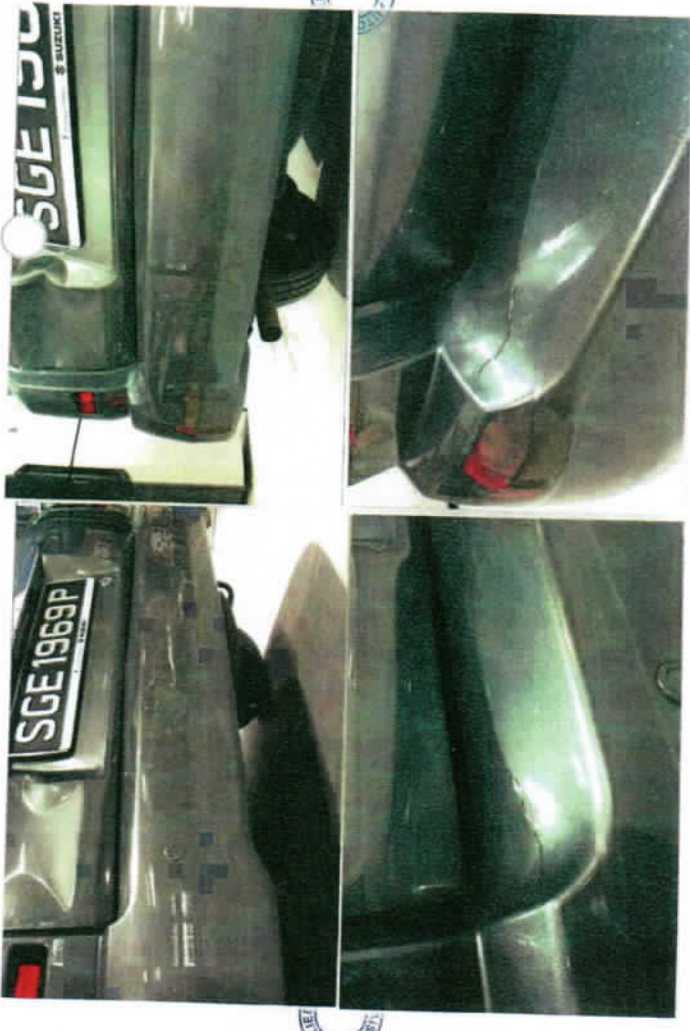
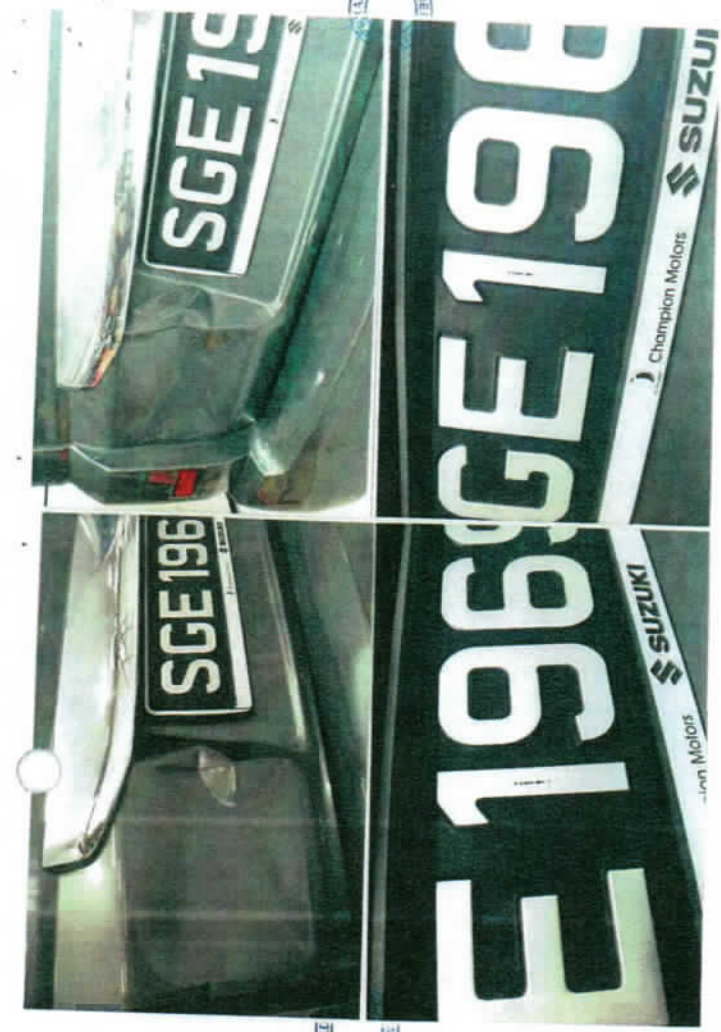
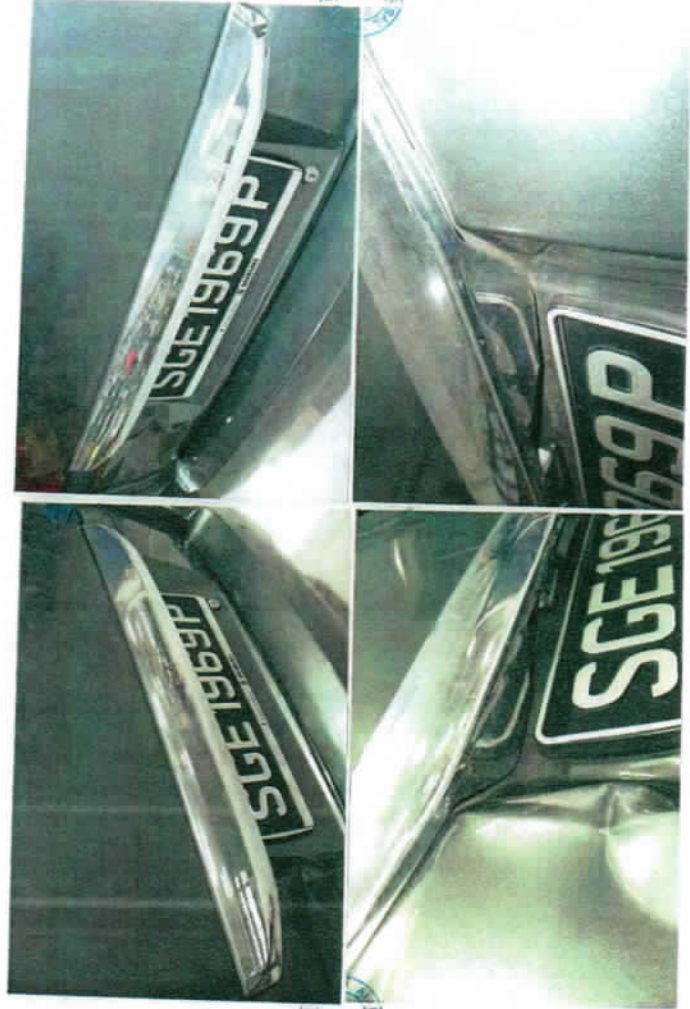
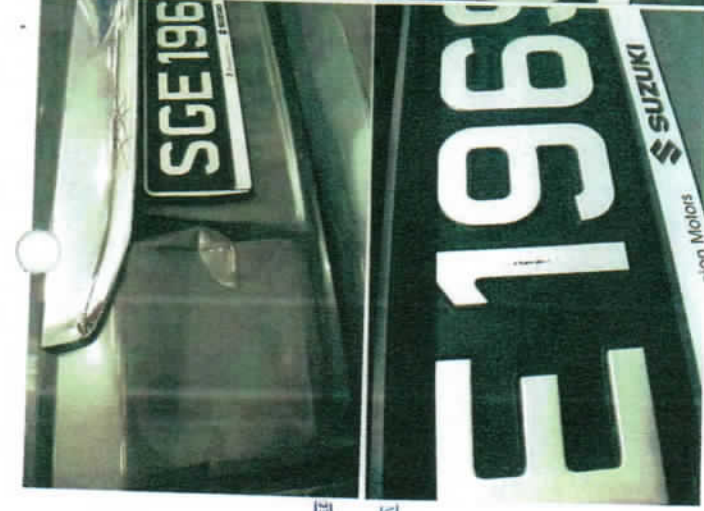
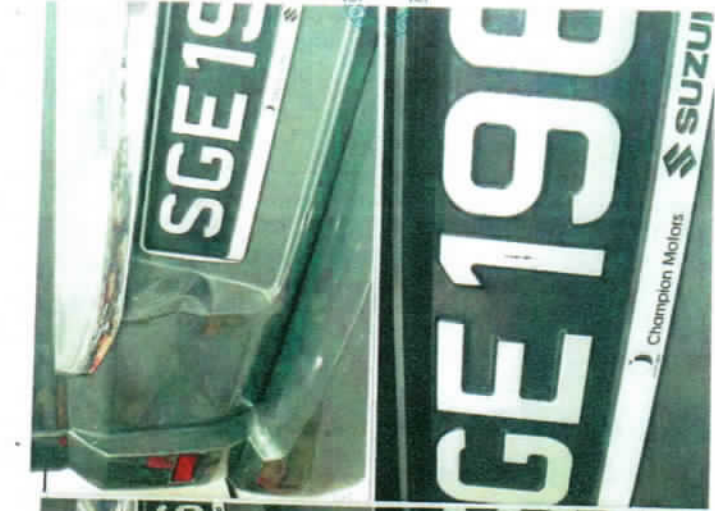
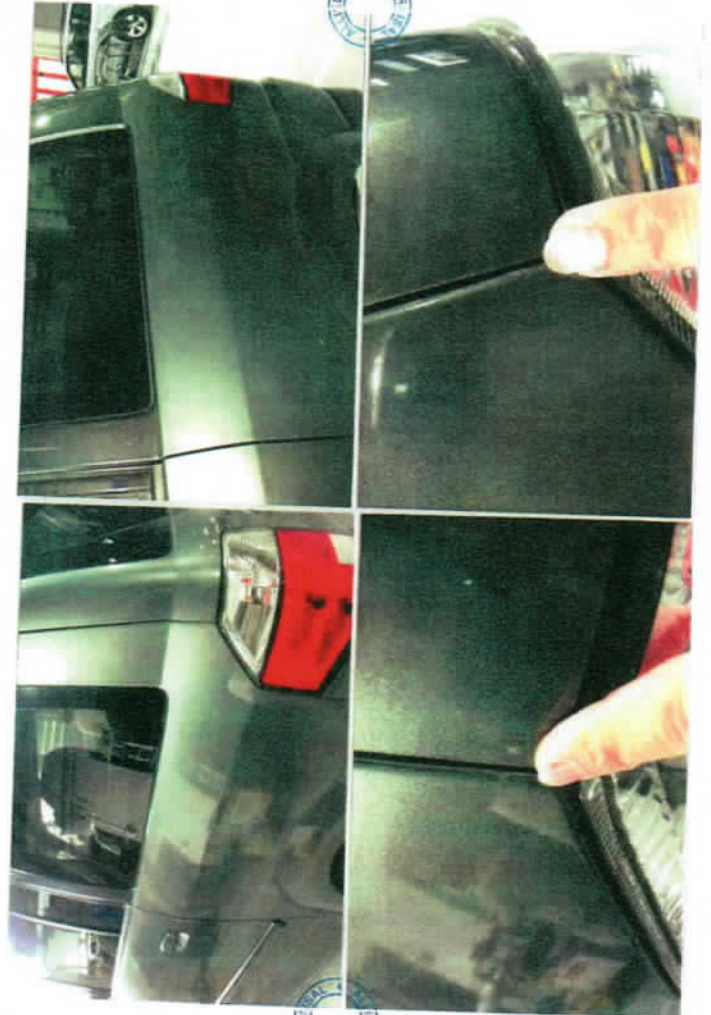
SGE 1969P

The impact of the collision has damaged/affected back door, left rear combination lamp, left rear body panel, rear end panel, rear bumper face, spare wheel carrier lock and etc. Please refer to the Annex for a detailed account of the damages and photographs taken.

We have inspected thoroughly the actual damages found on the vehicle before we conclude as to whether the parts needed replacement or repairs. The estimated cost of repair submitted by the repairer is **\$6,582.60**. We have adjusted the cost to **\$5,489.50** and recommend that the repairs to be taken on a lump sum basis of **\$4,400.00**. In our opinion, the damaged parts are consistent with that caused by the accident.

We have not authorised the repairs. However, for information, under normal circumstances, the period of repair should not exceed 8 working days.

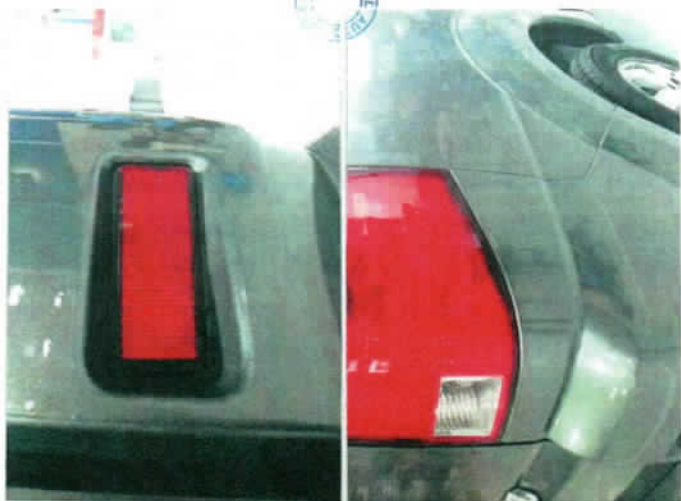
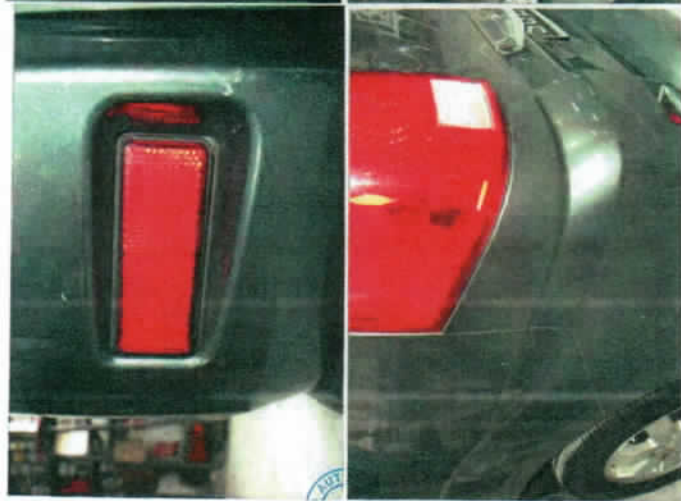
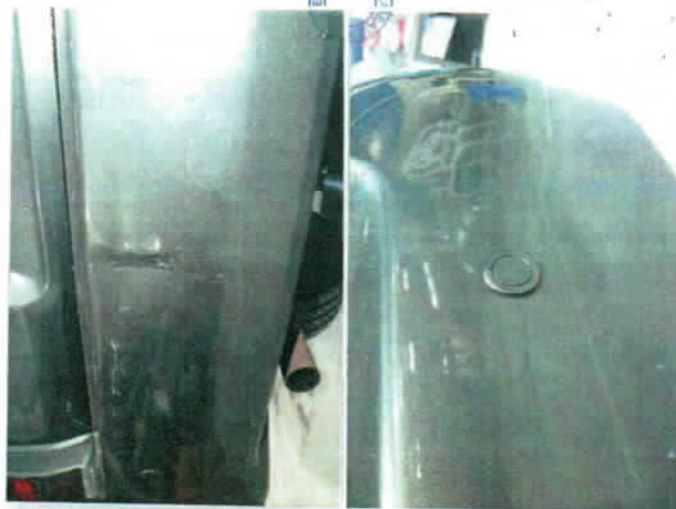
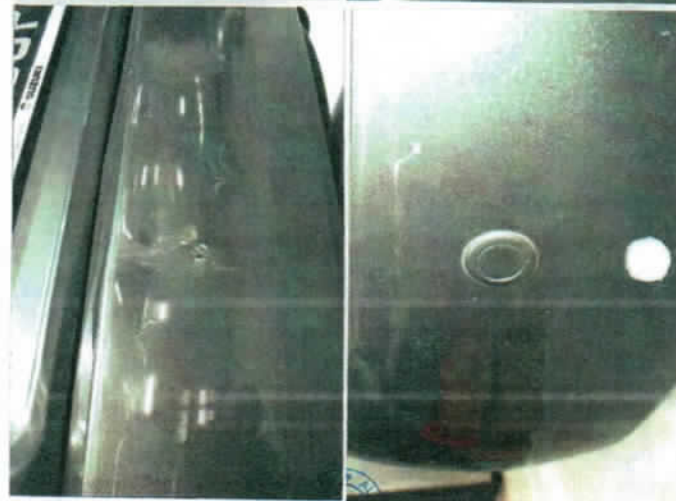
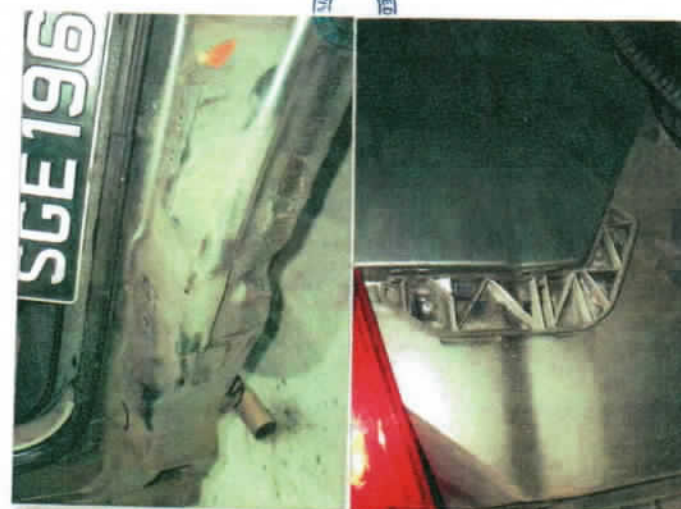
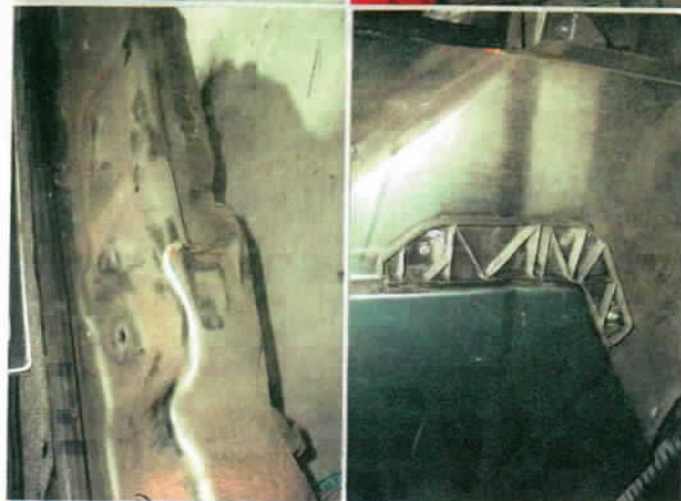
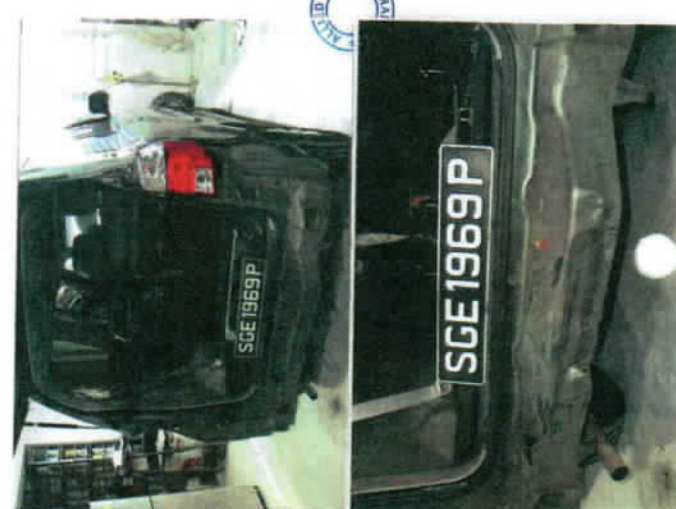
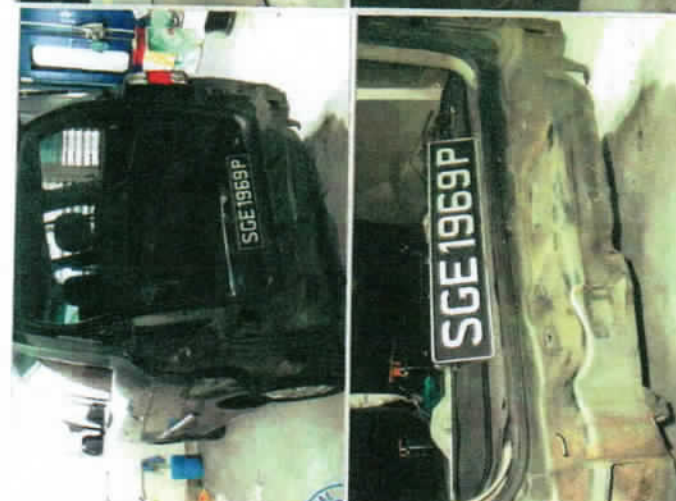
<p>Mainly on the rear near-side portion.</p>

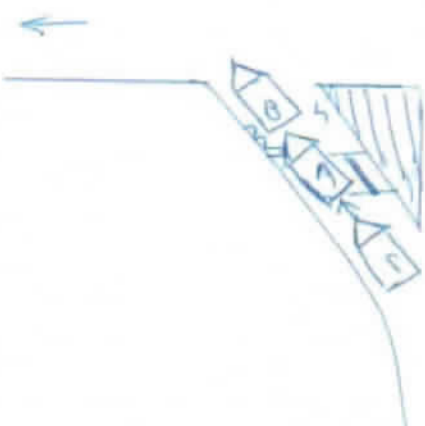
Witnessed by Reporting Centre Personnel
<b>Sketch Plan</b>		
<p>St Batuk Ave 1</p>

<p>Batuk Batuk East Ave 6</p> <p>A) SG4 18200 B) SGE 1969P C) unknown</p>

I had exited into the slip road of Bt Batok East Ave 6 to Bukit Batok Ave 1.  
 Veh (B) was stationary in front of me waiting for the traffic along Bukit Batok Ave 1 to clear. I stopped behind Veh (B).  
 When the traffic was clear, Veh (B) accelerated. I turned my head to check the traffic again, ~~not~~ Veh (B) suddenly brake. I was unable to stop in time & collided onto Veh (B). The vehicle behind me subsequently hit onto the rear of my car, we then drove our vehicles to the roadside & check the damages & exchange particulars.  
 As there was no damage to my vehicle's rear & Veh (C), we agreed no compensation & thus did not exchange particulars, & the driver of Veh (C) left. However Veh (B) sustained damages on the rear.
