## VEHICLE DAMAGE INSPECTION REPORT

Our File No: CS/MSG18001718/GTD3E2

Claimant Vehicle No: SKB1680P

Make &amp; Model: HONDA JAZZ, 1.3 L (A)

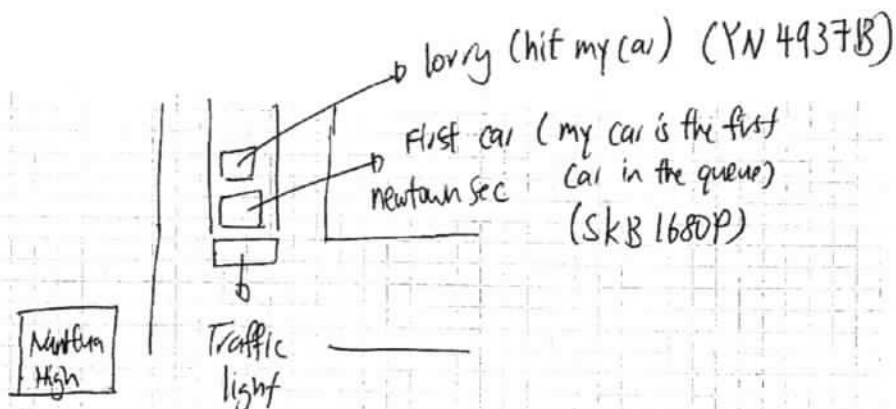
### SKETCH PLAN

DESCRIBE CIRCUMSTANCES OF THE ACCIDENT

It was raining at that time. I was already slowing down when the traffic light turned orange and stopped when it turned red. After I stopped for a while, my car was hit by a lorry from the back. There was a loud 'bang' and my car jerked forward.

I ~~stopped~~ stepped out to examine my car and ~~the~~ back of my car was dented. The front of the lorry was also dented.
