1. Policy Particulars :- THIRD PARTY CLAIM

Insured Veh.	GY 3194P	Veh. Inspected	SHD 4593M
Policy No.	5088208678	Coverage (\$)	0.00
Claim No.		Excess (\$)	0.00
Assign From		Assign Date	01/02/2018

TP Claims against NTUC Income: Follow-Through Survey

ADJUSTMENT ON REPAIR COST FOR VEHICLE NO. SHD 4593M

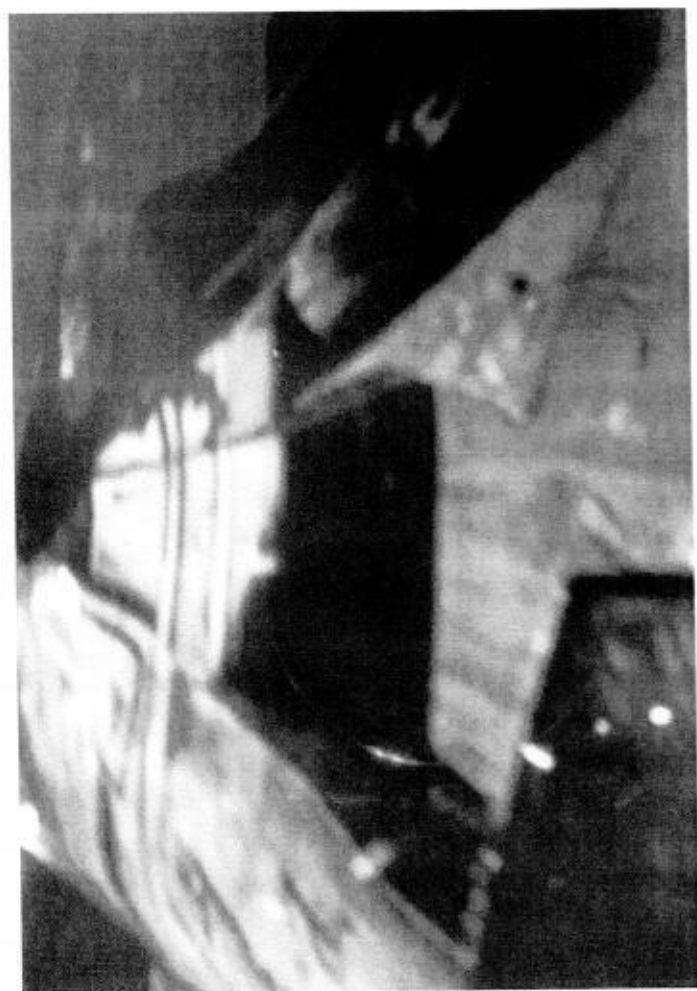
THE VEHICLE SUSTAINED DAMAGES AT THE O/S REAR PORTION. DAMAGES SEE DETAILS.
--

Qty	Description of Parts	Condition	Estimate By Workshop (\$)	Our Adjusted (\$)
REPLACEMENT OF PARTS				
1	REAR BUMPER	DEFORMED	578.40	578.40
10	REAR BUMPER CLIP	NECESSARY	22.00	22.00
1	REAR BUMPER PROTECTOR (RH)	CUT	38.00	38.00
1	TAIL LAMP (RH)	CRACKED	344.00	344.00
1	REAR FENDER (RH)	TO REPAIR	1,935.90	-
1	REAR FENDER INNER LINING (RH)	SERVICEABLE	74.10	-
1	REAR WINDSCREEN MOULDING	NOT NECESSARY	60.00	-
1	REAR WHEEL HUP-CAP (RH)	GRAZED	145.00	145.00
	LESS 20% DISCOUNT		-639.48	-225.48
			2,557.92	901.92
SPECIAL NETT ITEMS				
1	REAR BUMPER ADVERTISEMENT LOGO (SN)	NECESSARY	50.00	50.00
1	REAR FENDER ADVERTISEMENT LOGO (RH)(SN)	NECESSARY	100.00	100.00
1	REAR FENDER COMFORT STICKER (RH)(SN)	NECESSARY	30.00	30.00
1	REAR WINDSCREEN SEALANT (SN)	NOT NECESSARY	46.00	-

226.00	180.00
LABOUR				
	THATCHAM STANDARD REPAIR TIME ON BODY WORKS.		1,410.00	490.00
	THATCHAM TTS STANDARD SPRAY PAINTING COST AND LABOUR.		450.00	360.00
			1,860.00	850.00
GRAND TOTAL			4,643.92	1,931.92
RECOMMENDED COST OF LUMP SUM REPAIRS (TO ITS PRE-ACCIDENT CONDITION) (CONFIRMED)				1,550.00
