Preliminary Advice

Insured Vehicle No	: XD7869J		
TP Vehicle No	: GX5529A	Accident Date	: 29/01/2018
Make	: NISSAN CABSTAR	Assignment Date	: 01/02/2018
Date of Inspection	: 05/02/2018	Est. Duration of Repair	: 5.00
Inspection At	: PH AUTO SERVICES (HQ) 1 KAKI BUKIT AVENUE 6 #01-107 AUTOBAY @ KB SINGAPORE 417883

Estimated repair cost for vehicle no: GX5529A NISSAN

VEHICLE DAMAGE INSPECTION REPORT

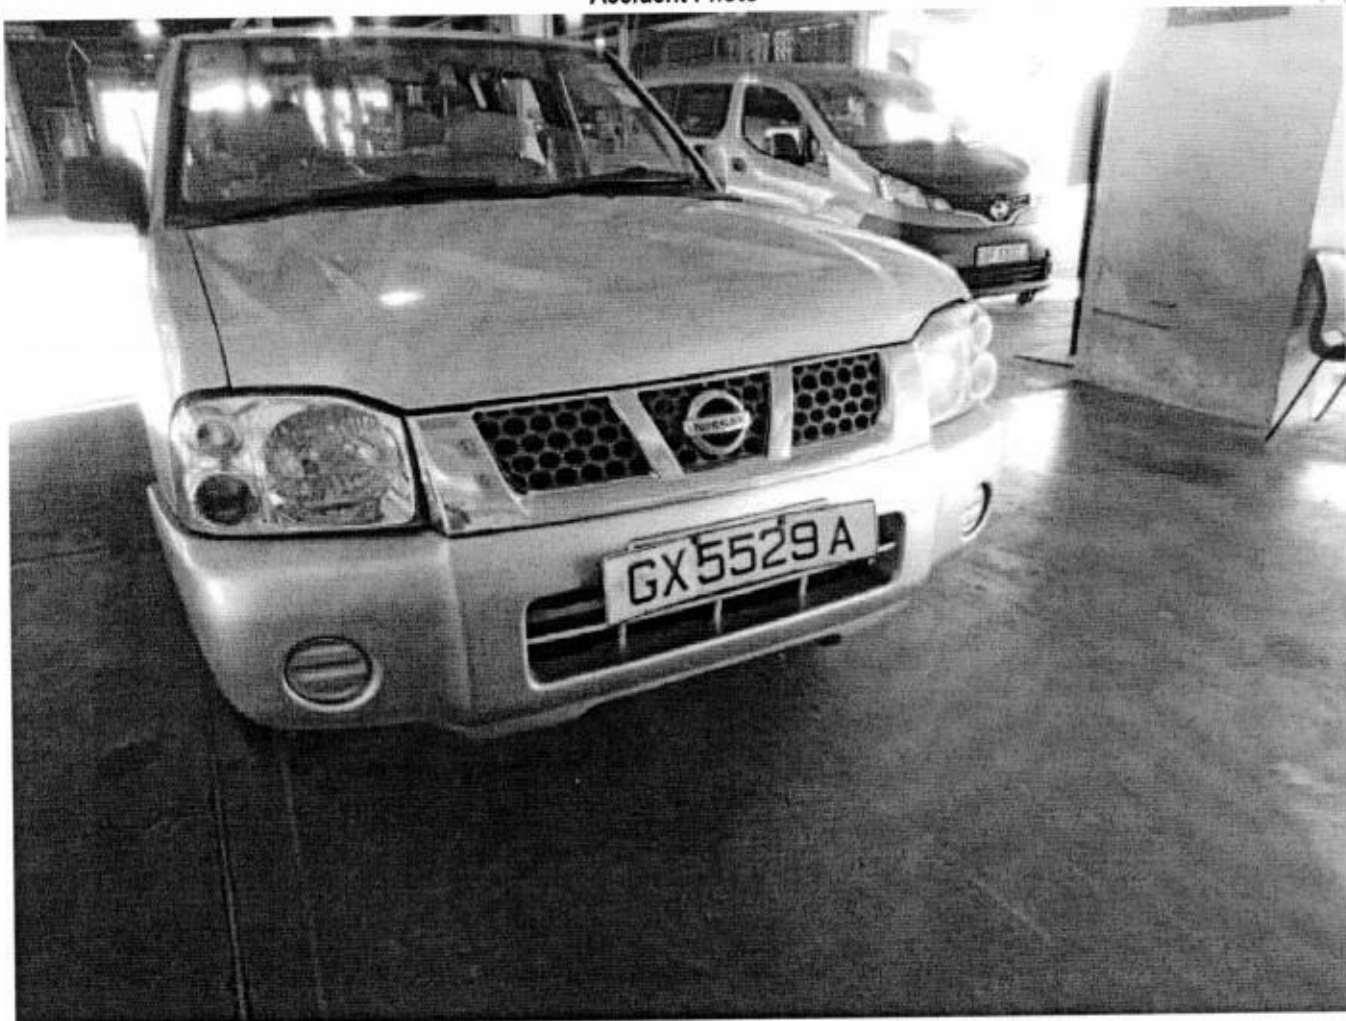
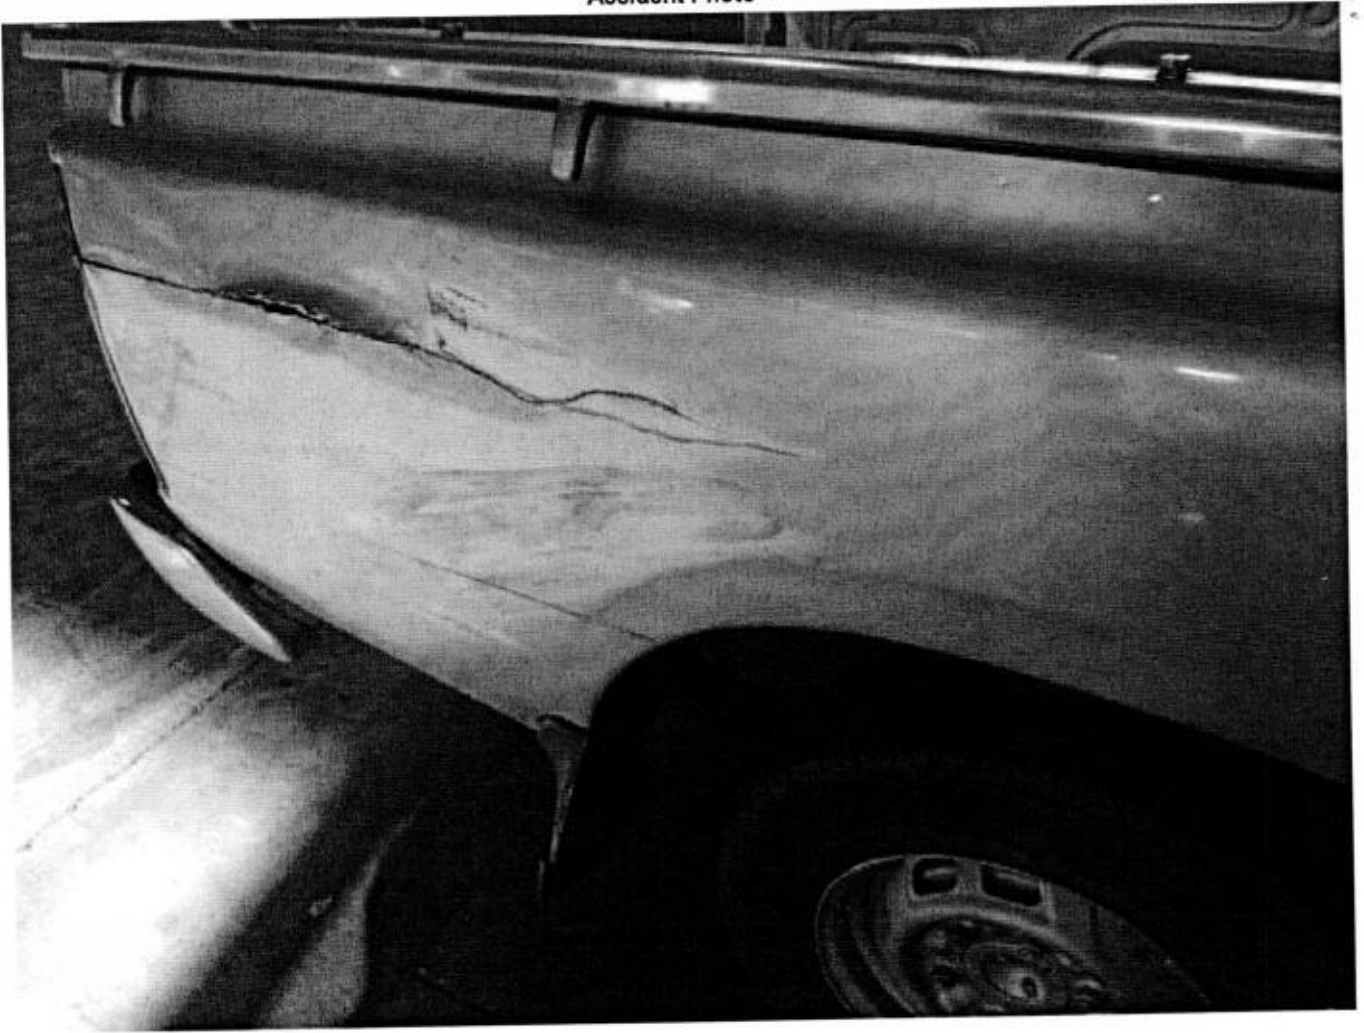
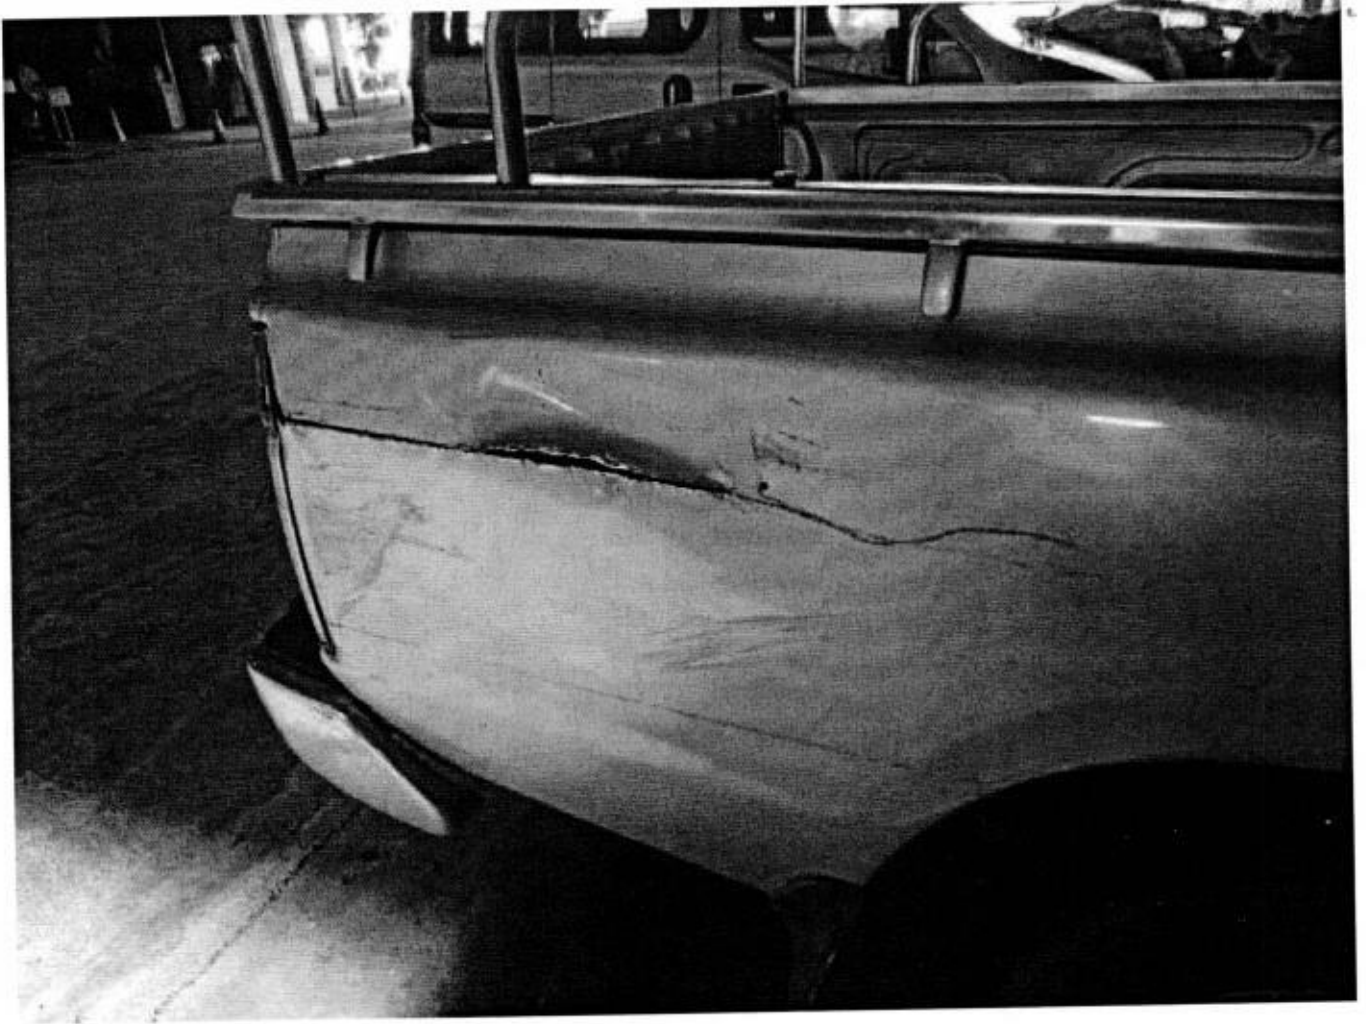
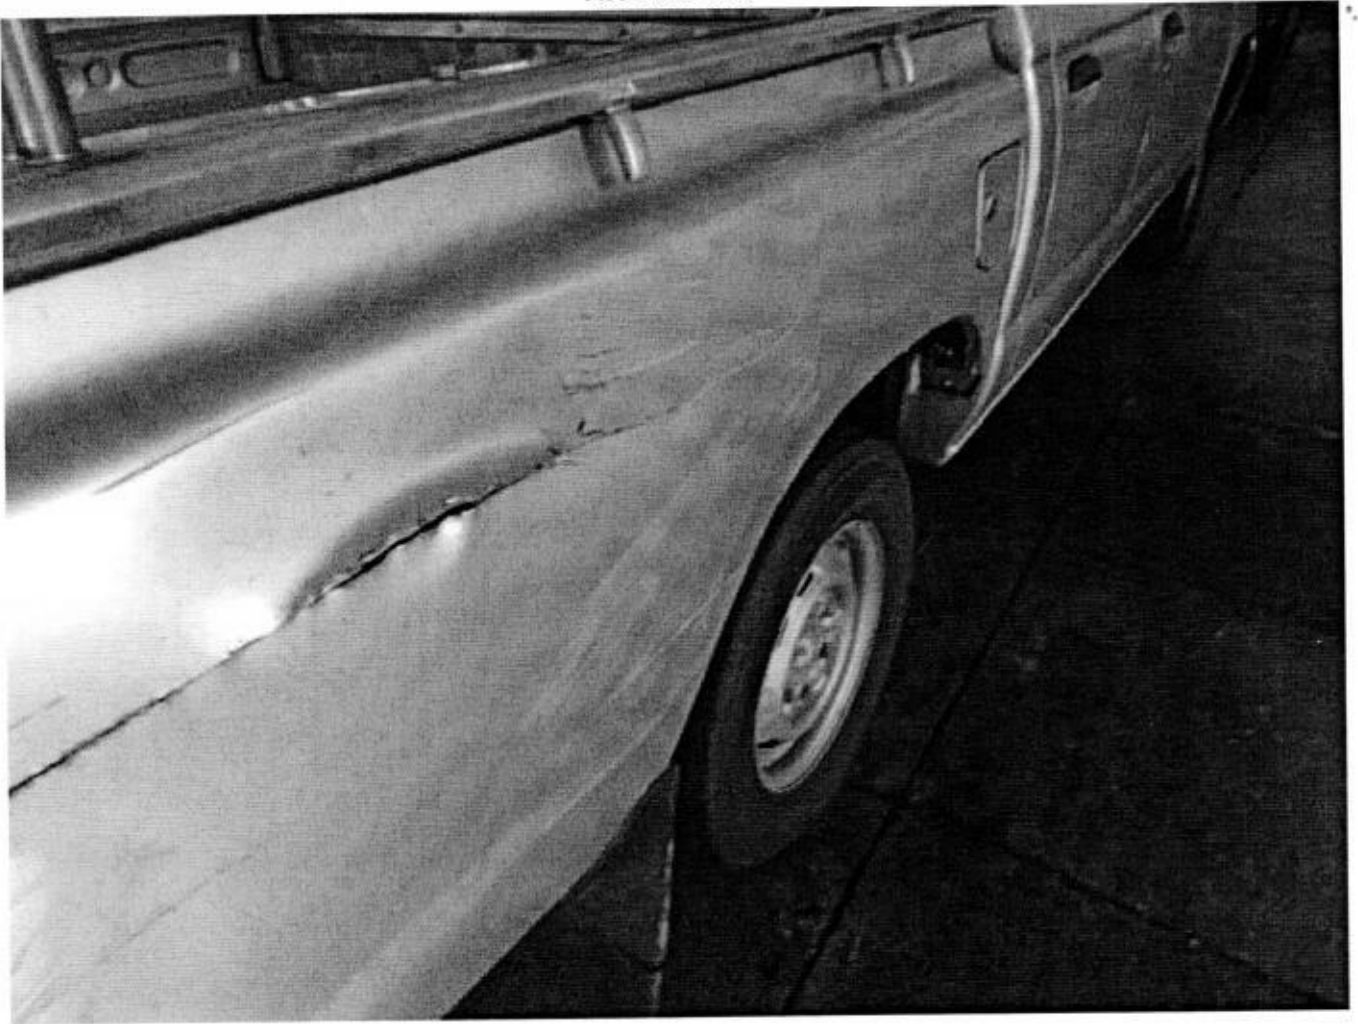
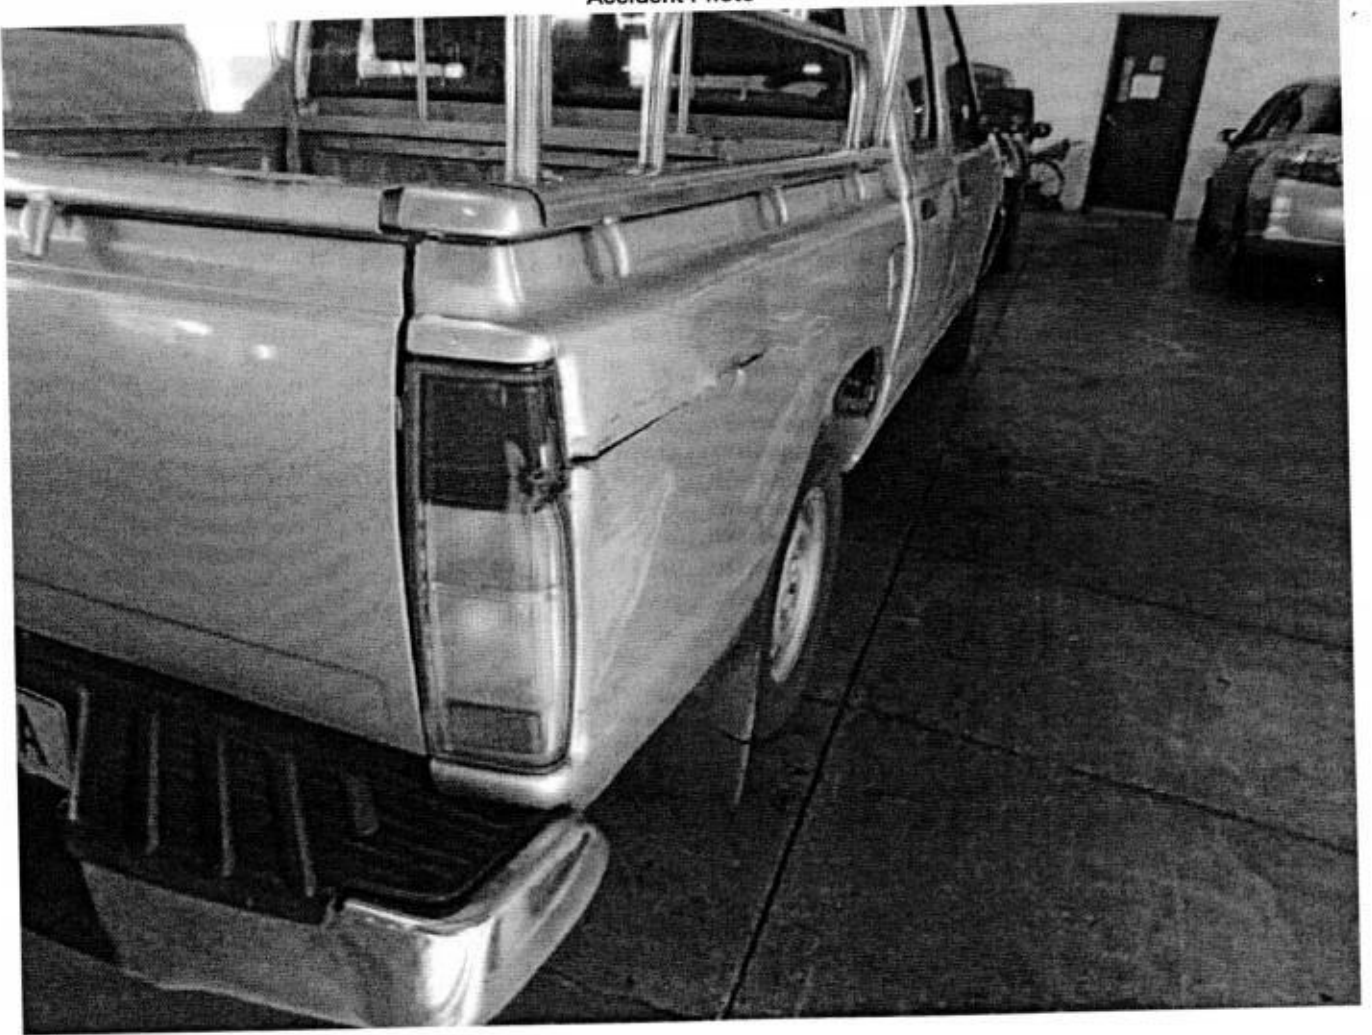
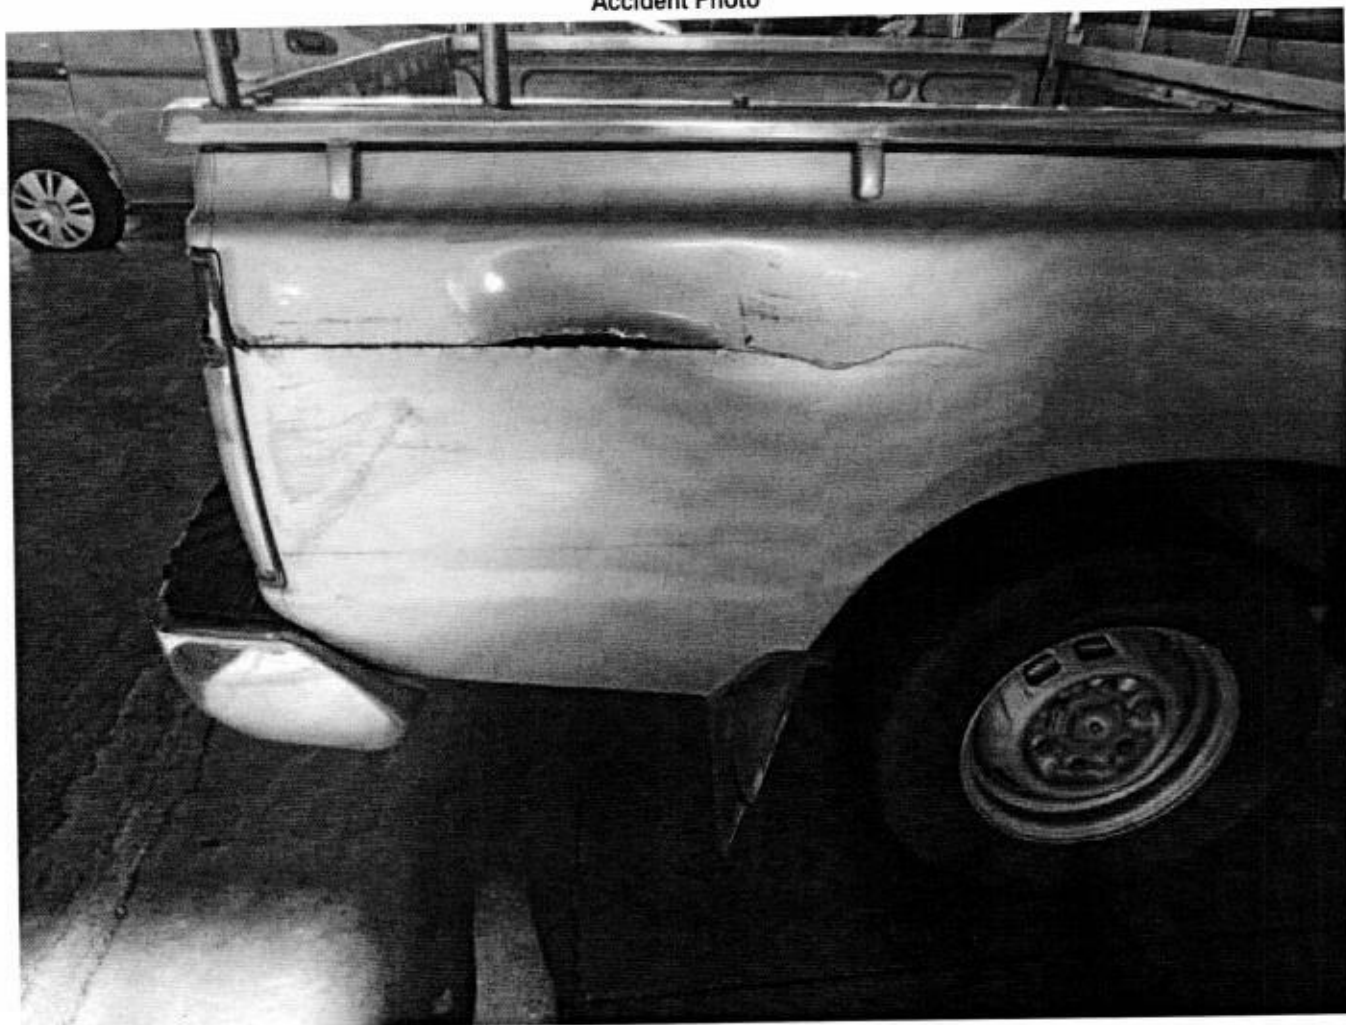
Accident Photo

The vehicle sustained impact / damages o/s portion and parts claimed are consistent to the accident.

While waiting stationary at the traffic light junction on the left lane. Driver of truck (XD7869J) driving on the middle lane got too close and scraped the right back of my vehicle (GK5529A) causing a tear of approximately 1/2 meter and damages on the right light.
