# National Assessment Centre Services

## 1. Policy Particulars :- THIRD PARTY CLAIM

THE VEHICLE SUSTAINED DAMAGES AT THE REAR PORTION. DAMAGES SEE DETAILS.
--

**ADJUSTMENT ON REPAIR COST FOR VEHICLE NO. SHA 4608X**

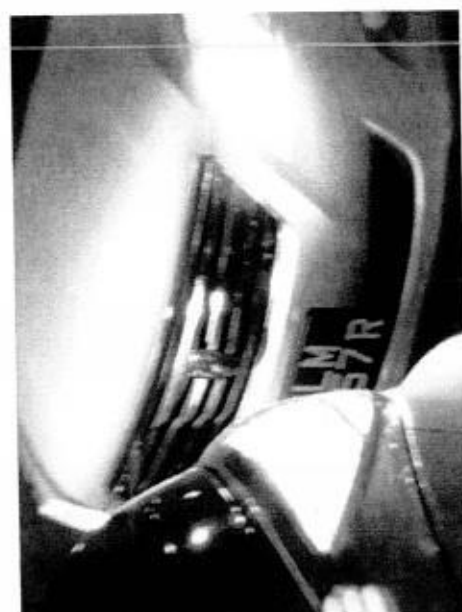
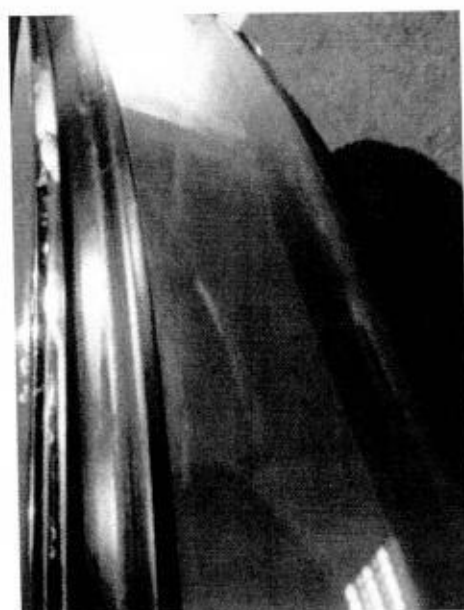
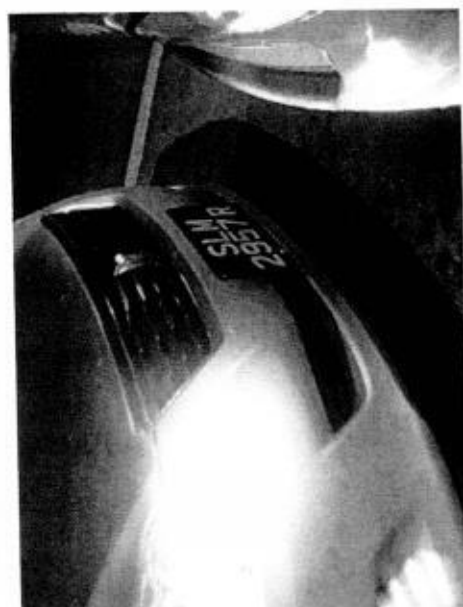
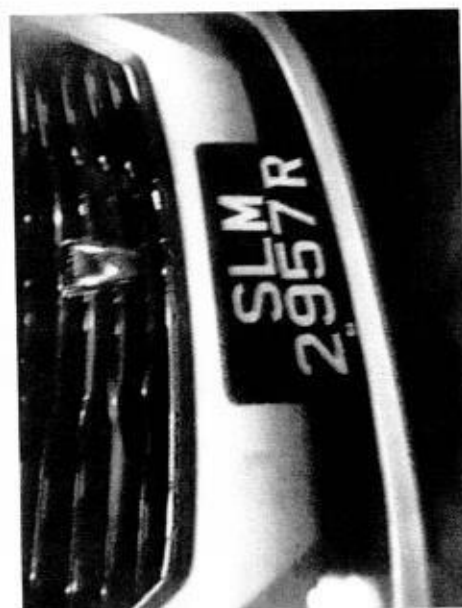
Qty	Description of Parts	Condition	Estimate By Workshop (\$)	Our Adjusted (\$)
<b>REPLACEMENT OF PARTS</b>				
1	REAR BUMPER	DEFORMED	603.60	603.60
1	REAR BUMPER REINFORCEMENT	SERVICEABLE	504.35	-
2	REAR BUMPER REINFORCEMENT BRACKET (LH/RH) @\$180.00	SERVICEABLE	360.00	-
1	REAR BUMPER SIDE BRACKET	SERVICEABLE	49.00	-
10	REAR BUMPER CLIPS	NECESSARY	22.00	22.00
1	REAR BUMPER SPONGE	SERVICEABLE	143.40	-
1	REAR BUMPER UNDER COVER	SERVICEABLE	225.00	-
	LESS 20% DISCOUNT		-381.47	-125.12
			1,525.88	500.48
<b>NETT ITEMS</b>				
1	REAR BUMPER REVERSE SENSOR (N)	SHORTED	135.70	135.70
	LESS 10% DISCOUNT		-	-13.57

135.70	122.13
<b>SPECIAL NETT ITEMS</b>				
1	REAR BUMPER RUBBER MAT (SN)	NECESSARY	50.00	50.00
			50.00	50.00
<b>LABOUR</b>				
	THATCHAM STANDARD REPAIR TIME ON BODY WORKS.		550.00	220.00
	THATCHAM TTS STANDARD SPRAY PAINTING COST AND LABOUR.		200.00	180.00

750.00	400.00
<b>GRAND TOTAL</b>			<b>2,461.58</b>	<b>1,072.61</b>
<b>RECOMMENDED COST OF REPAIRS (CONFIRMED)</b>				<b>1,072.61</b>
