# Survey Department Check List (Case Handler)

# National Assessment Centre Services

## 1. Policy Particulars : THIRD PARTY CLAIM

**ADJUSTMENT ON REPAIR COST FOR VEHICLE NO. SH 7825Z**

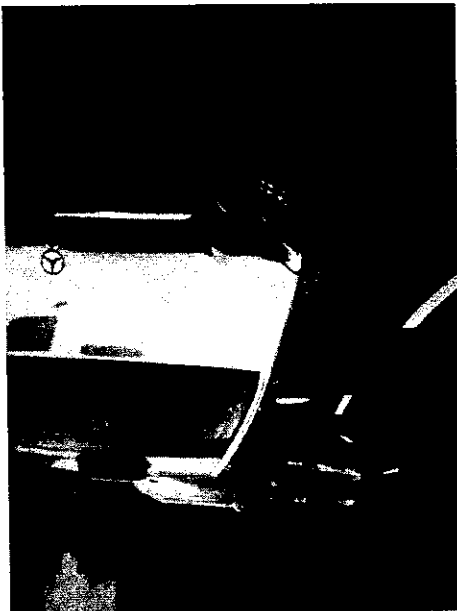
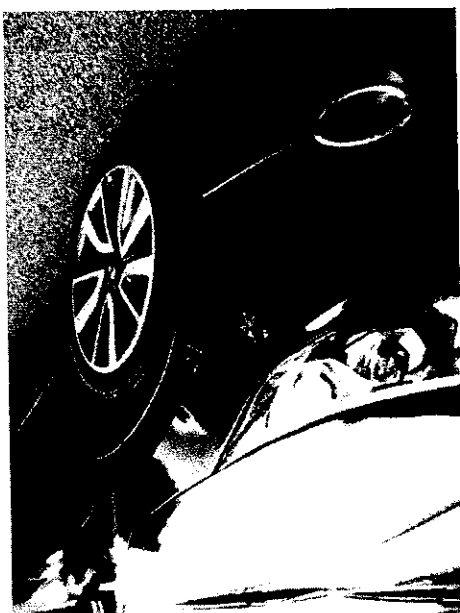
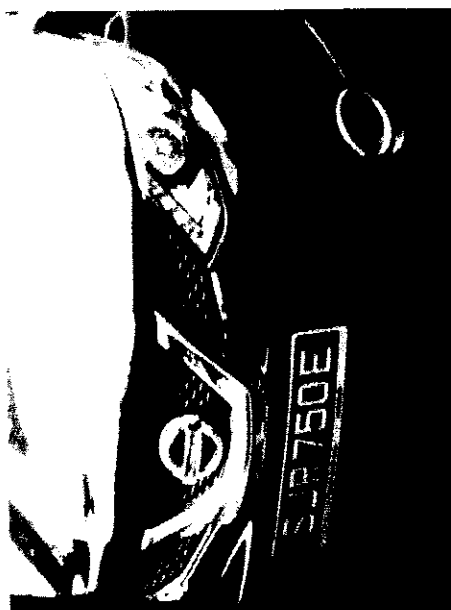
Code: INC4	
<b>1. Policy Particulars - THIRD PARTY CLAIM</b>				
Insured Veh.	SJR 750E	Veh. Inspected	SH 7825Z	
Policy No.	5081230850-01	Coverage (\$)	0.00	
Claim No.	MT/0981207-003	Excess (\$)	0.00	
Assign From		Assign Date	06/02/2018	
<b>2. Vehicle Particulars - Condition</b>				
Make & Model	MERCEDES BENZ E220	c.c	2143	
Engine No.	HIDDEN	Year of Reg.	2015	
Chassis No.	WDD2120012B175085	Colour	WHITE	
Odometer	422707	Steering	IN ORDER	
Brakes	IN ORDER	Modification	SPORTS RIM	
General	GOOD			
<b>3. Conditions of Tyres</b>				
	Size	Make	Balance	
R/H Front Tyre	225/55 R16	WEST LAKE	7 mm	
L/H Front Tyre	225/55 R16	WEST LAKE	7 mm	
R/H Rear Tyre	225/55 R16	WEST LAKE	7 mm	
L/H Rear Tyre	225/55 R16	WEST LAKE	7 mm	
<b>4. Description of Damages</b>				
THE VEHICLE SUSTAINED DAMAGES AT THE O/S REAR PORTION. DAMAGES SEE DETAILS.

Qty	Description of Parts	Condition	Estimate By Workshop (\$)	Out Adjusted (\$)
<b>REPLACEMENT OF PARTS</b>				
1	REAR BUMPER	DEFORMED	1,510.00	1,510.00
2	REAR BUMPER BRACKET TOP (LH/RH) @\$125.00	N/S SERVICEABLE / O/S DISTORTED	250.00	125.00
2	REAR BUMPER RETAINER MOUNTING (LH/RH) @\$115.00	N/S SERVICEABLE / O/S DISTORTED	230.00	115.00
1	TAILLAMP (RH)	CUT	1,280.00	1,280.00
1	REAR FENDER (RH)	TO REPAIR	2,980.50	-
1	REAR FENDER SPLASH SHIELD (RH)	SERVICEABLE	195.00	-
1	REAR WINDSCREEN GLASS C/W MOULDING	SERVICEABLE	1,845.00	-
	LESS 20% DISCOUNT		-1,658.10	-606.00
			6,632.40	2,424.00
<b>SPECIAL NETT ITEMS</b>				
1	REAR BUMPER RUBBER MAT (SN)	NECESSARY	50.00	50.00
1	REAR WINDSCREEN SEALANT (SN)	NOT NECESSARY	180.00	-

<b>RECOMMENDED COST OF LUMP SUM REPAIRS (TO ITS PRE-ACCIDENT CONDITION) (CONFIRMED)</b>			<b>3,900.00</b>
---	--	--	-----------------
