Preliminary Advice

VEHICLE DAMAGE INSPECTION REPORT

Our File No: CS/MSG18002604/K1RD3N2

Handling Insurer:	MSIG Insurance (Singapore) Pte. Ltd.	Policy No:	MSD/VMT/17-373030-CA
Claimant Vehicle No :	SHB8784M	Insured Vehicle No :	FX4086D
Date of Loss:	08/02/2018	Nature of Claim:	TP
		Claim No:	MSCN/18-000220

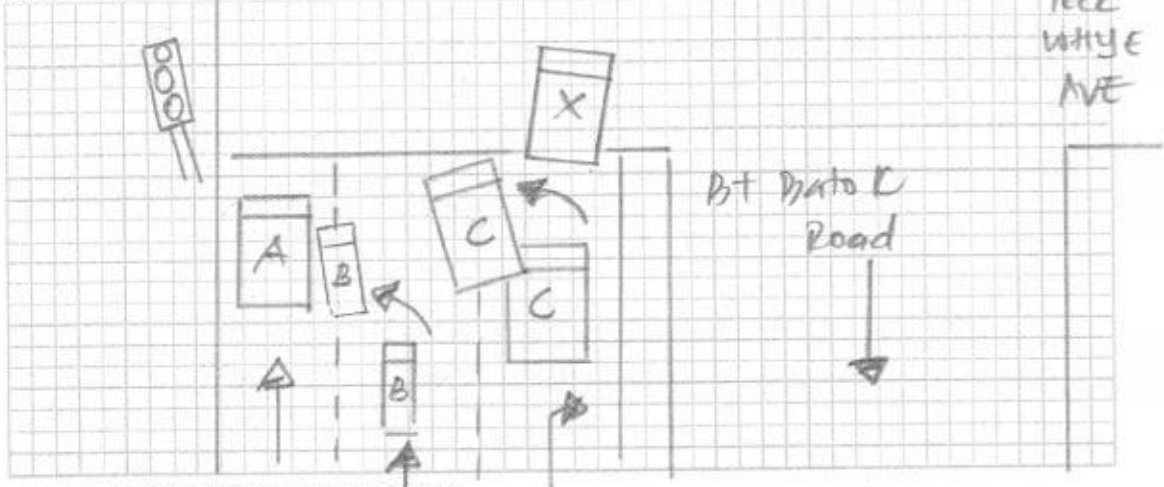
SKETCH PLAN

ON 08/02/2018 AT ABOUT 0610 HRS, I WAS DRIVING MY TAXI (**SHB 8784M**) TRAVELLING ALONG BT BATOK ROAD AT THE TRAFFIC LIGHT JUNCTION OF TECK WHYE AVE, WITH A PASSENGER ONBOARD – IN THE LEFT LANE.

TRAFFIC LIGHT WAS GREEN ON MY ROUTE FAVOUR & I PROCEED AHEAD BUT SUDDENLY I FELT AN IMPACT FROM MY RIGHT.

WHEN INSPECTED, I DISCOVERED THAT VEHICLE B (**FX 4086D – M/CYCLE**) WHICH WAS IN THE MIDDLE LANE – HAD COLLIDED ONTO THE RIGHT PORTION OF MY TAXI AND VEHICLE C (**SKR 9163 D- TOYOTA**) WHICH WAS ON THE RIGHT LANE, WAS INVOLVED IN THE COLLISION AS WELL.

BASED ON THE VIDEO FOOTAGE VIEWED, IT SHOWED VEHICLE C (**SKR 9163 D**) WHICH WAS IN THE RIGHT LANE – FAILED TO KEEP FOR PROPER LOOK OUT, HAD STEERED/FILTERED INTO THE MIDDLE LANE. AS SUCH, VEHICLE B LOST CONTROL THUS COLLIDED ONTO THE RIGHT PORTION OF MY TAXI.

DUE TO THE IMPACT, MY TAXI HAD DAMAGES ON THE RIGHT PORTION AND I WAS NOT AWARE OF DAMAGES TO OTHER VEHICLES.
