## 1. Policy Particulars :- THIRD PARTY CLAIM

NTUC INCOME INSURANCE CO-OPERATIVE LTD Ref: NS/INC18002726/K1qbn2

THE VEHICLE SUSTAINED DAMAGES AT THE REAR O/S PORTION. DAMAGES SEE DETAILS.
--

**ADJUSTMENT ON REPAIR COST FOR VEHICLE NO. SHB 6696Y**

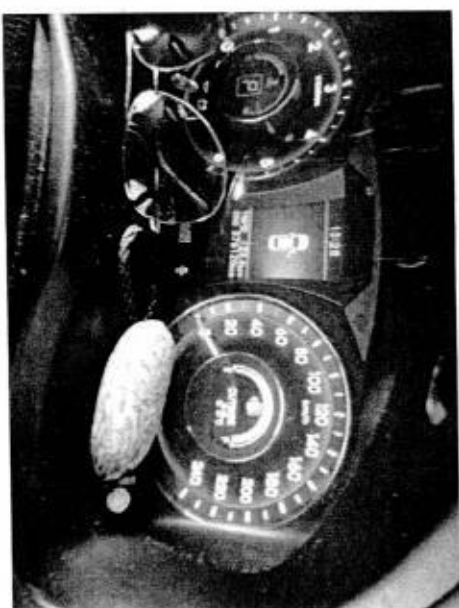
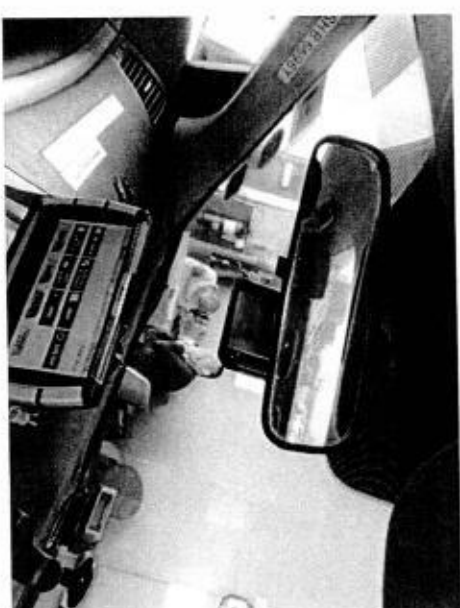
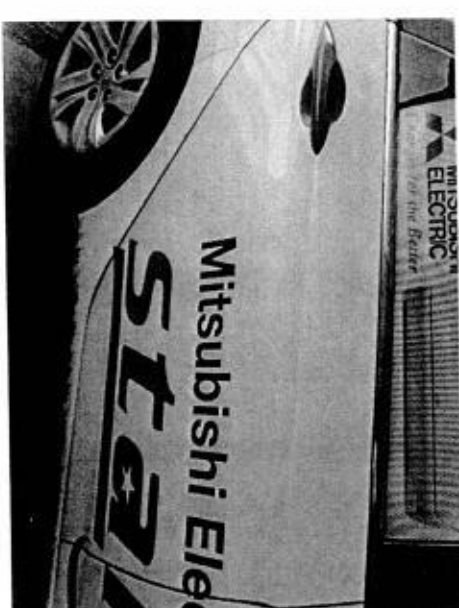
SHB 6696Y - 5 Re 2013  
 Type: M/Cat / M/Cycle / Bus / Van / Lorry - 0 Prime Mover  
 Truck / Trailer or  
 Make: Hyundai Z40 CC: 1685  
 Colour: Blue 4 D: 0 Std: N/A  
 Sp Reading: 376/25 T-Pace: 0 Std: N/A  
 Eng No: \_\_\_\_\_  
 O/C: KM HLD 414MPY 042208  
 Gen Cond: Good / 6 / Poor / Burnt  
 Steering: Inop / 6 / Jammed / Leaked / Burnt or  
 Brake: Inop / 6 / Jammed / Leaked / Burnt or  
 Mod: N/A / SRim / STD 6 / Rim or  
 Tyre Size: FR 205/60 R16  
RR  
 BS / DUN / EXNOVA / GY / FS / LIZA / MIC / HTSU / PIR / SUM /  
 TOYO / YOKO or Wet/Re  
 Front: \_\_\_\_\_ Rear: \_\_\_\_\_  
 R/Bal: 7 mm R/Bal: 7 mm  
 L/Bal: 7 mm L/Bal: 7 mm  
 D/OA: 9/2/18 D/O: 9/2/18  
 Survey held at: CDE (Lm)  
 Des. of Damages: Frt / Rear / O/S / N/S / U/O / Roofed or  
Rear O/S -  
 The U/O / Chassis frame / Body Structure affected due to collision.

1. The repair job shall bill to: NTUC --- SLC4221U
2. The finalized amount shall be:
  - (a) Spare Parts after List discount \$0.00
  - (b) Labour Charges \$0.00
  - Total for Part-By-Part Repair Cost** \$0.00
  - (c.) Lumpsum Repair (if applicable)  
Total for Lumpsum repair cost after Less: 20% \$300.00  
**Final Lumpsum Repair cost**

3. Estimated normal period for repairs: 2 working days.
