To Inspect Vehicle No: FBL 1202R

We refer to your instruction to appraise the vehicle **FBL 1202 R** on 13th February 2018.

VEHICLE INSPECTION REPORT

Registration No	: FBL 1202 R	Mileage	: 35600km
Make/Model	: Honda NC750XA	Engine No	: RC88E5004981
Type Of Body	: Motorcycle	Chassis No	: JH2RC90A4GK003498
Year Of Manu./Regn.	: 2016	Passenger Cap.	: 1 Passenger
Colour	: Blue	Others	: -

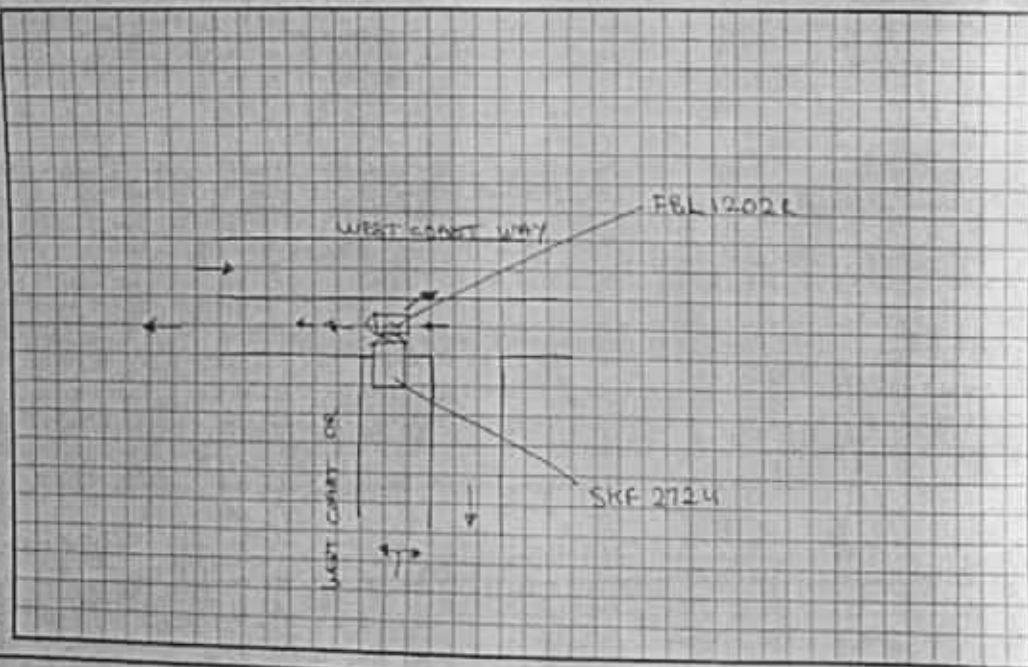
Sketch Plan

On 09/02/2018 at about 0700hrs, I was leaving my house for work
On 09/02/2018 at about 0730hrs, as I was travelling along Junction of West Coast Way and West Coast Drive, towards Pandan Loop, a Black BMW Car (SKF272U) hit onto the left side of my motorcycle. The following part of my motorcycle was damaged:

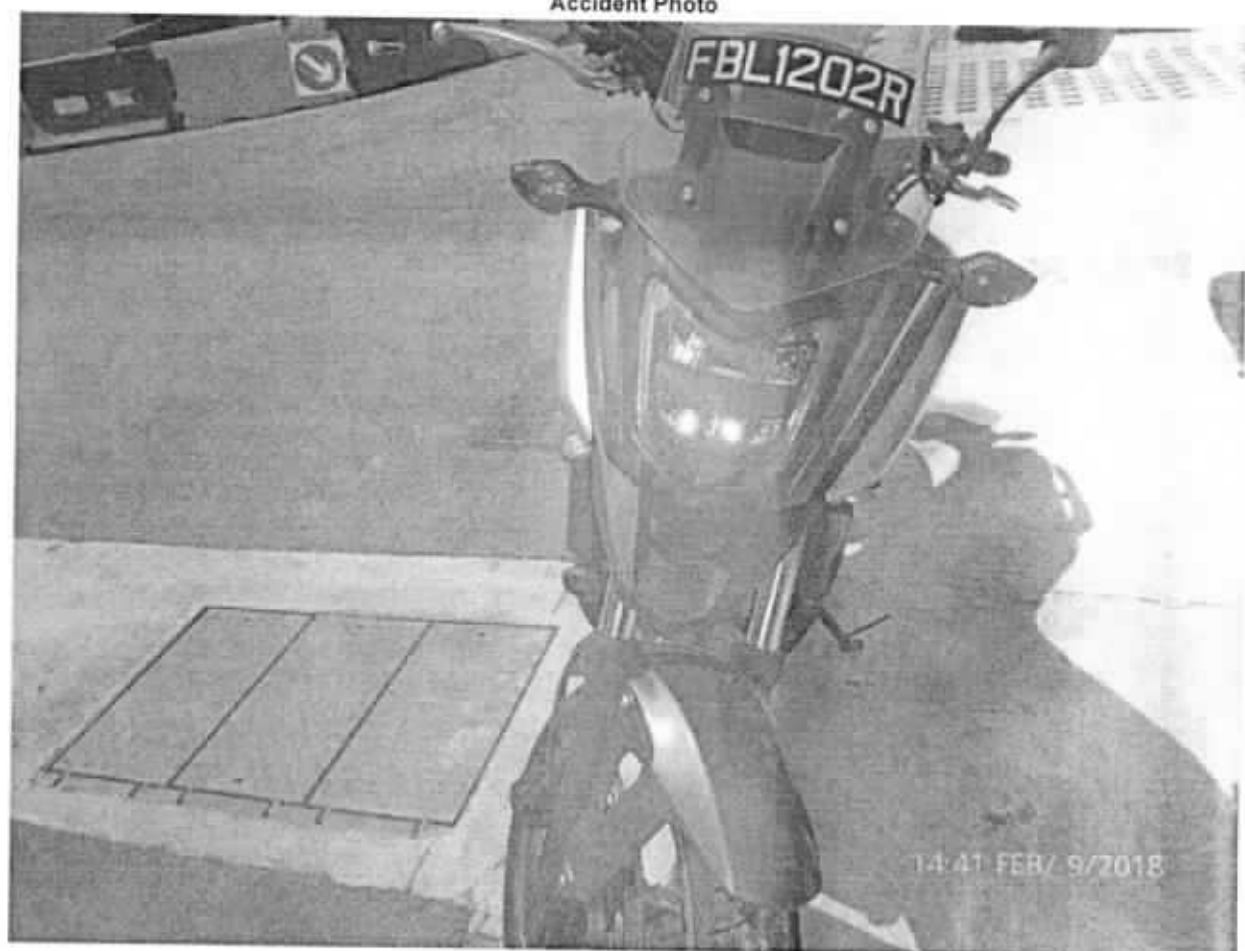
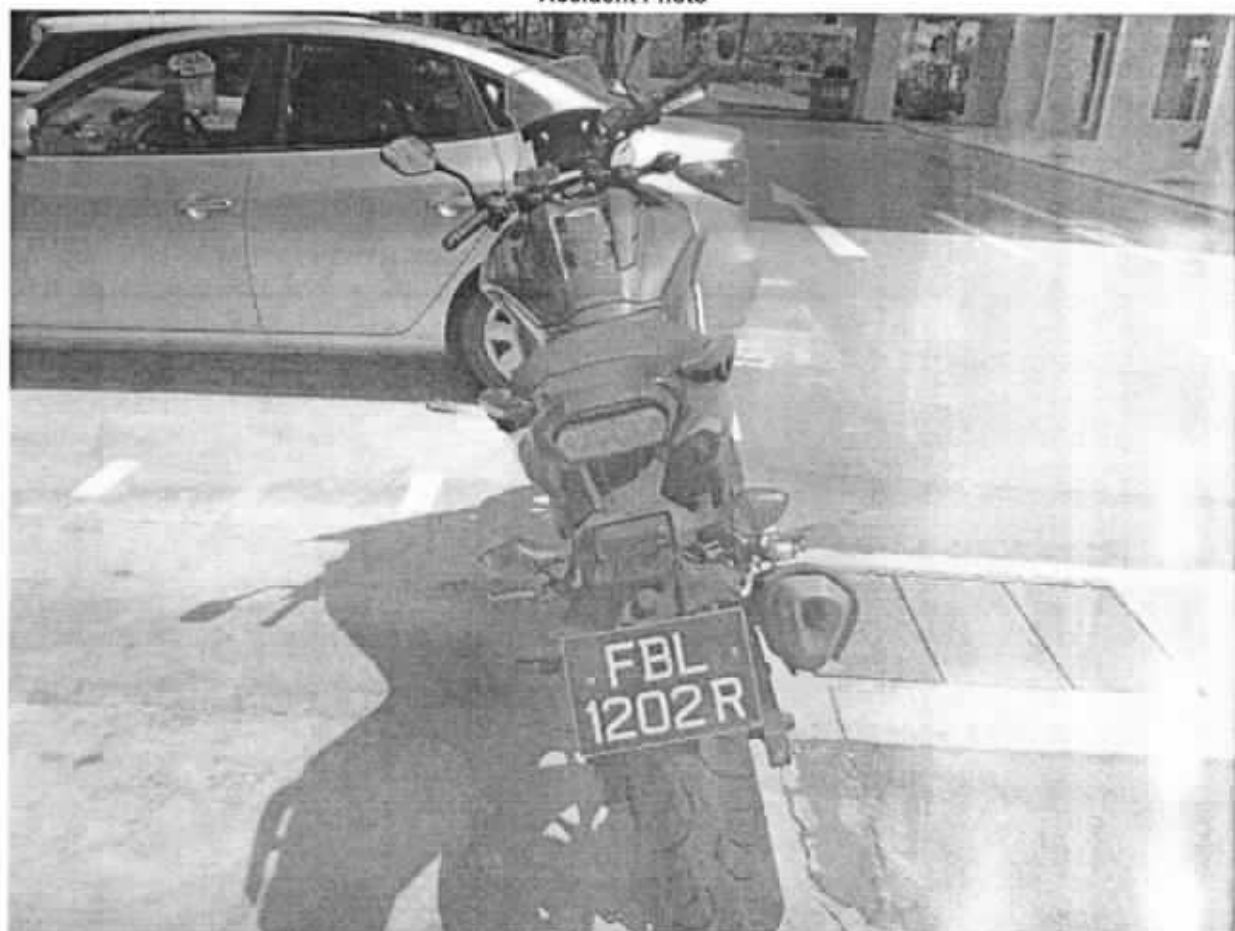
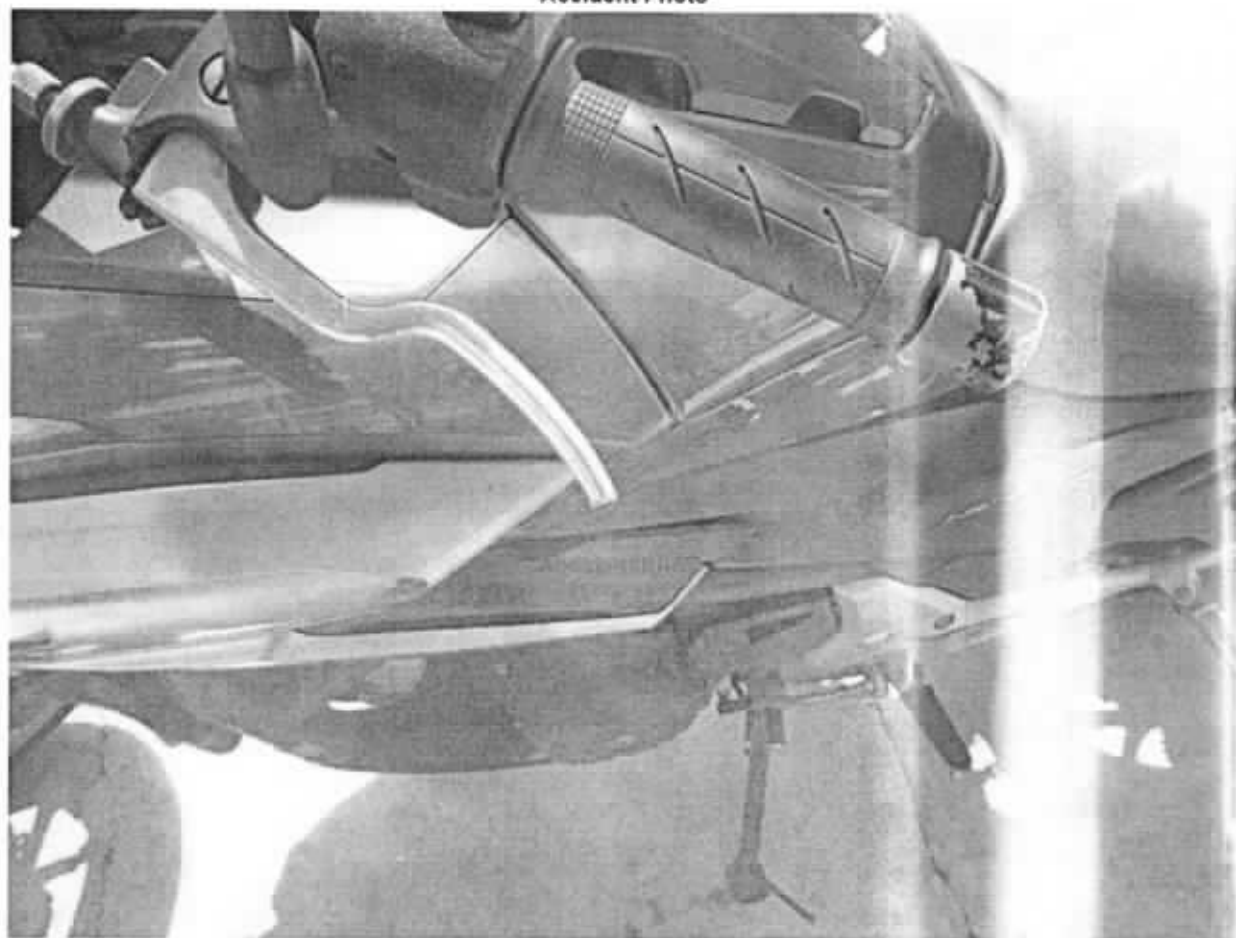
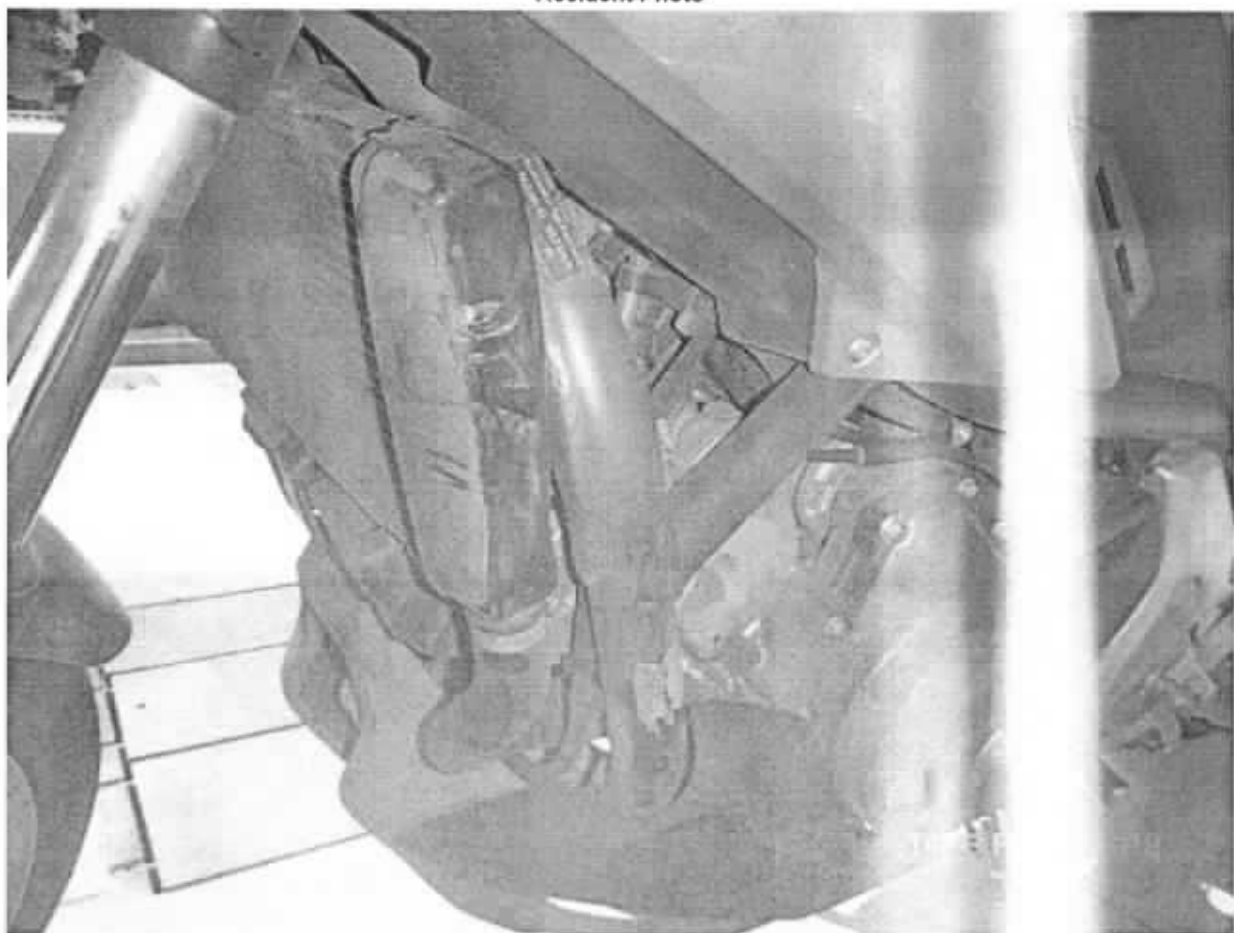
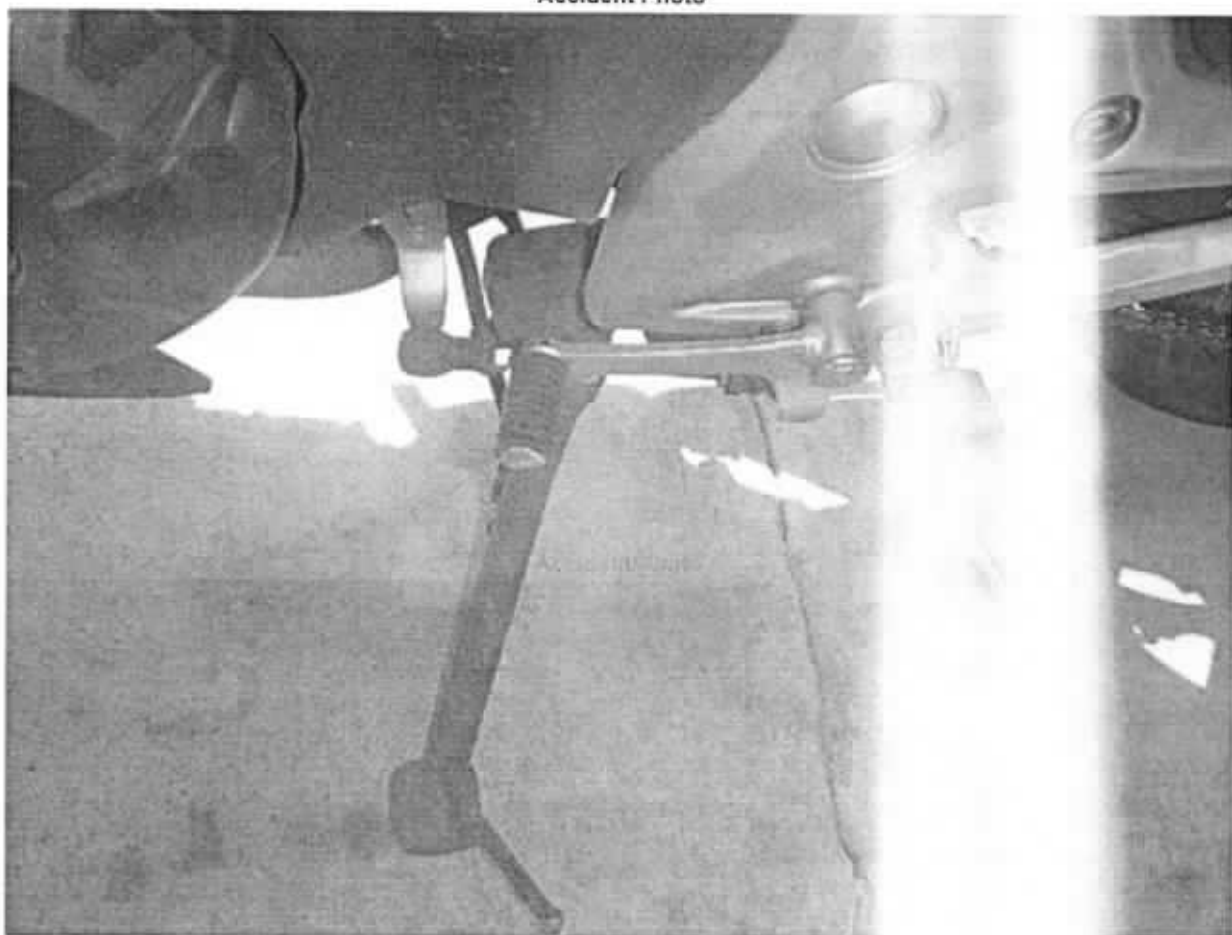
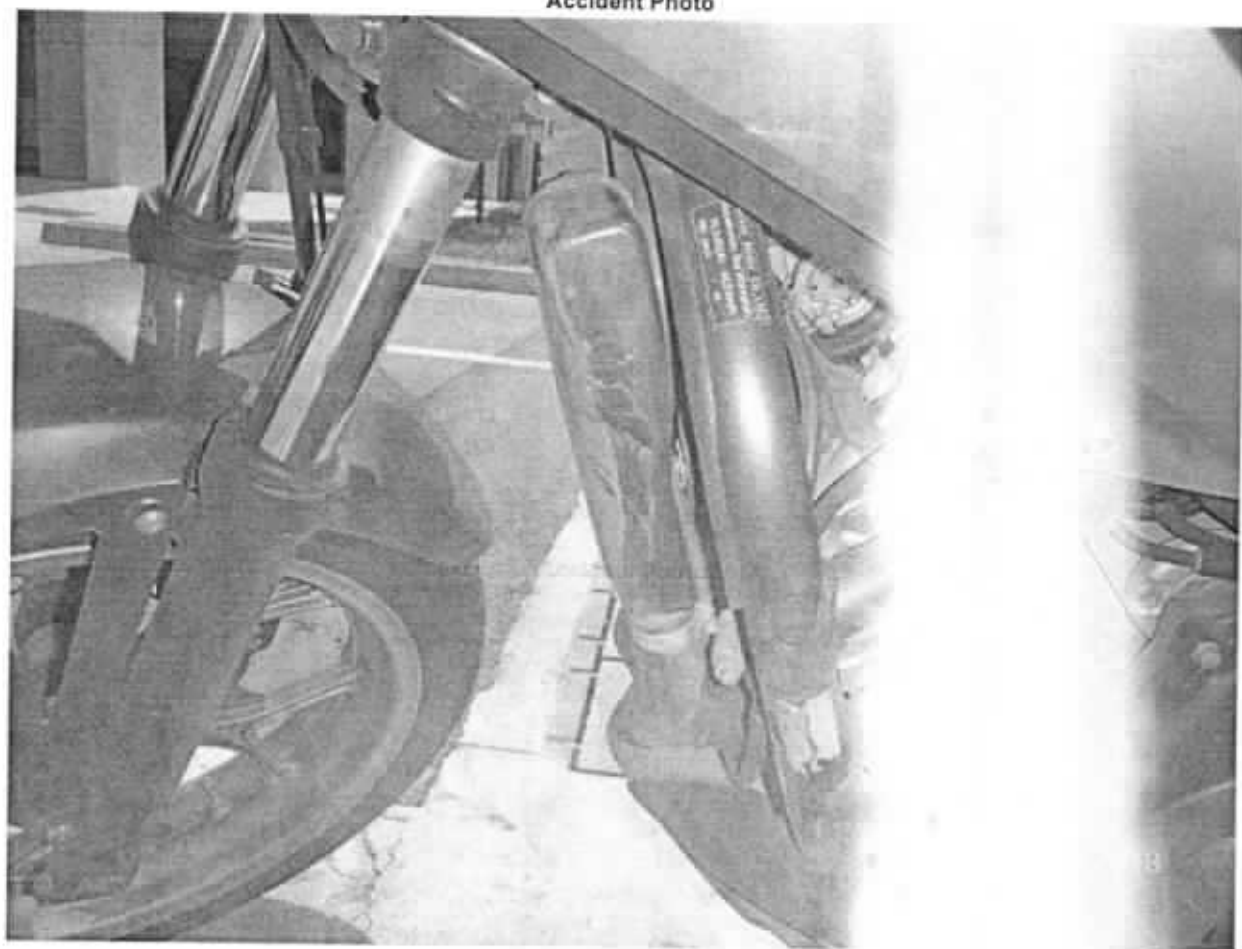
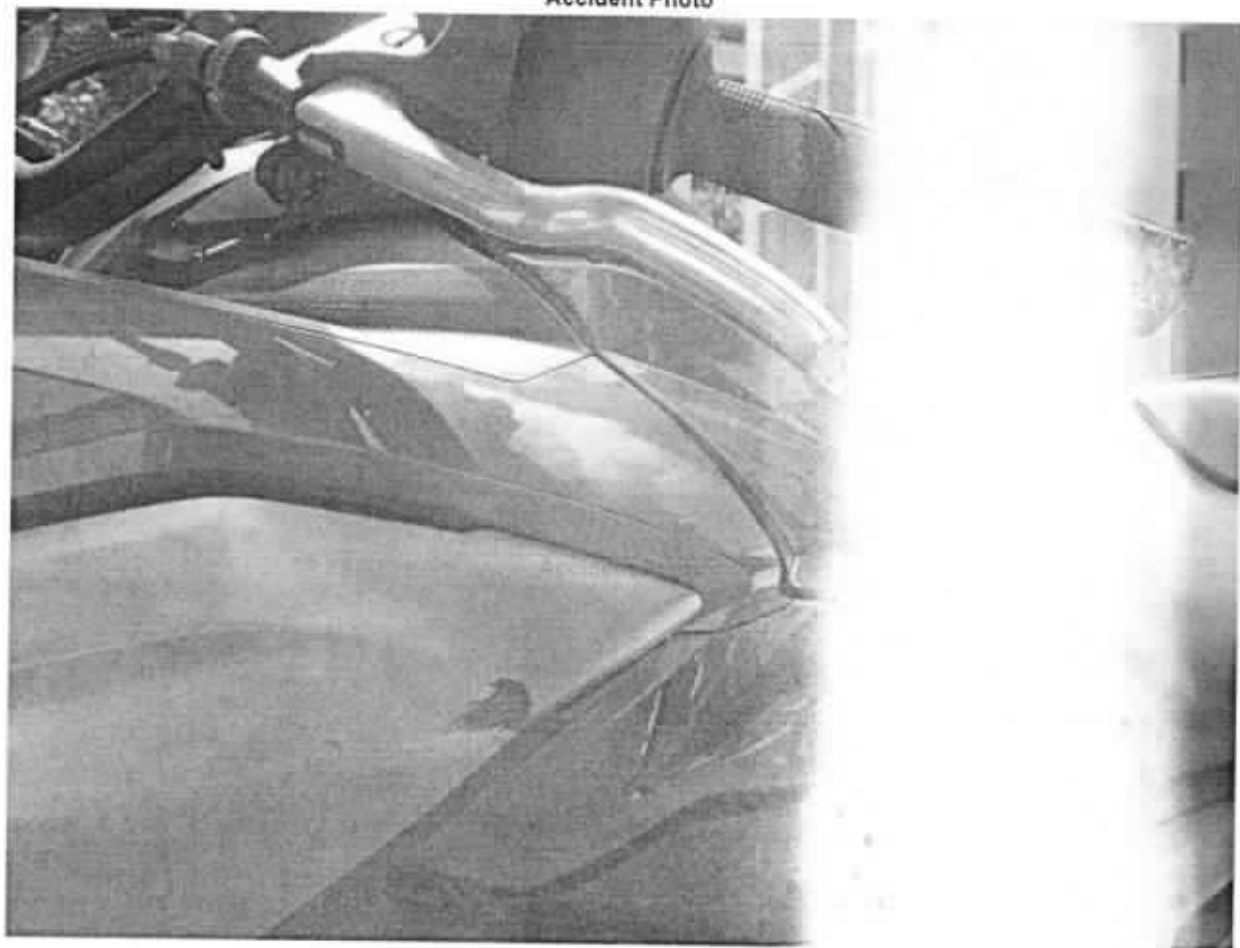
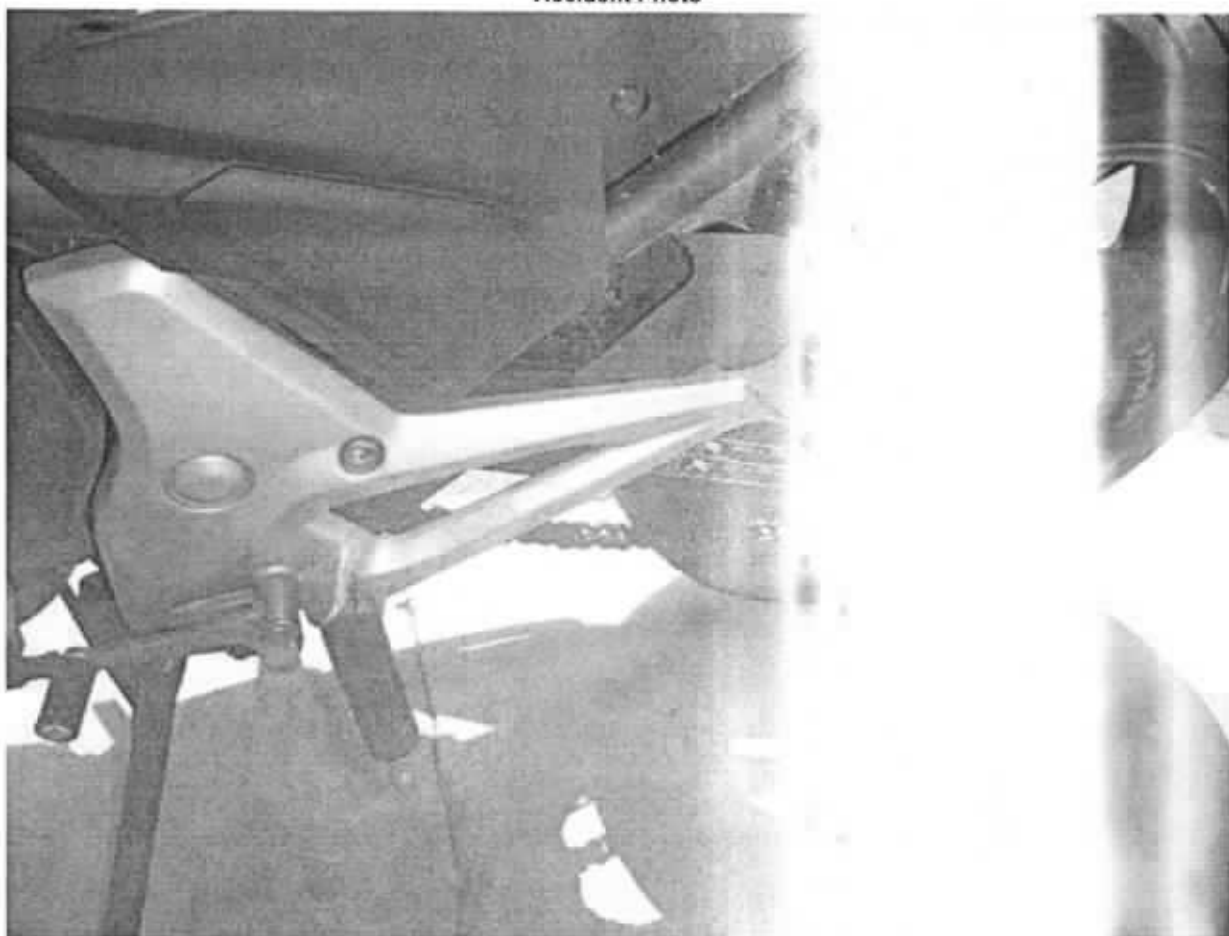
1. Clutch Lever broken
2. Handlebar bend
3. Gear pedal bend
4. Radiator dented
5. Bar end scratches
6. Left mirror scratches
7. Left flaring scratches
8. Low cowling scratches.
9. Foot rest (Rider and pillion)

The vehicle sustained an impact on the front, R/H & L/H portion.

The main body frame, handle bar, forks, fuel tank, fork, exhaust muffler were dented/bent.

The repairer has agreed to undertake repairs at our revised amount of **\$5,700.00 lump sum** corresponding to supply of parts, labour charges and spray-painting. However, we have not given instruction to authorize the repairs.

Qty	Descriptions	Conditions	Repairer's Est.	Our Revised.
		Balance b/d	\$ 8,402.00	\$ 6,038.30
	<u>Labour Charges & Misc</u>			
	To dismantle & replace damaged parts, panel beat where necessary.		550.00	450.00 300
	To putty, apply primer & spray-paint on the affected portion.		480.00	350.00 250
	To align main body frame.		320.00	250.00 150
	Transportation charges.		50.00	40.00
			<u>\$ 9,802.00</u>	<u>\$ 7,128.30</u> 700
