## REPAIR ESTIMATE\*

**1. Policy Particulars :- THIRD PARTY CLAIM**

**4. Description of Damages**

## ADJUSTMENT ON REPAIR COST FOR VEHICLE NO. SHC 813K

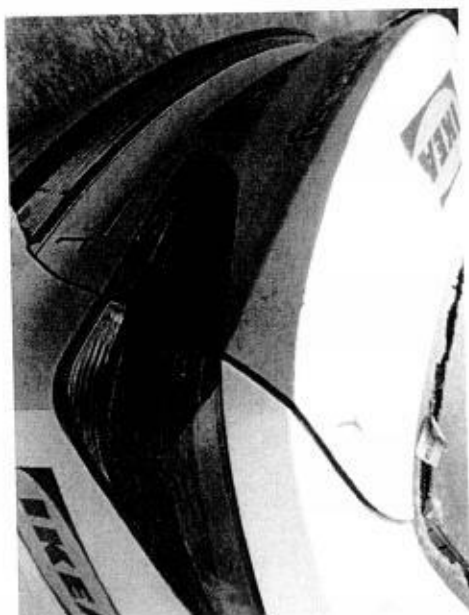
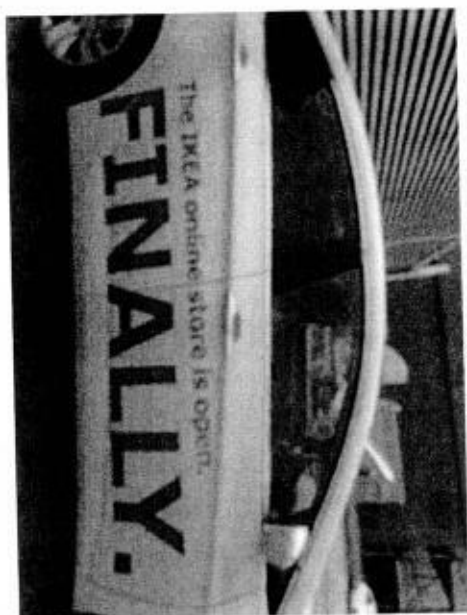
THE VEHICLE SUSTAINED DAMAGES AT THE REAR O/S PORTION.
DAMAGES SEE DETAILS.

Qty	Description of Parts	Condition	Estimate By Workshop (\$)	Our Adjusted (\$)
	<b>REPLACEMENT OF PARTS</b>			
1	BOOT LID	TO REPAIR	1,681.40	-
1	BOOT LID RUBBER	SERVICEABLE	115.80	-
1	BOOT LID LOCK UPPER	SERVICEABLE	137.90	-
1	BOOT LID LOCK LOWER	SERVICEABLE	31.70	-
1	BOOT LID "H" EMBLEM	NECESSARY	27.20	27.20
1	BOOT LID CRDI PLATE	NECESSARY	41.00	41.00
1	BOOT LID LAMP (RH)	CRACKED	556.80	556.80
1	BOOTLID MOULDING	CUT	85.00	85.00
1	BOOTLID I40 EMBLEM	NECESSARY	41.00	41.00
1	BOOTLID LOWER GARNISH	CRACKED	398.00	398.00
1	REAR BUMPER	DEFORMED	603.60	603.60
1	REAR BUMPER REINFORCEMENT	SERVICEABLE	504.35	-
2	REAR BUMPER REINFORCEMENT BRACKET (LH/RH) @\$180.00	SERVICEABLE	360.00	-
2	REAR BUMPER SIDE BRACKET @\$49.00	SERVICEABLE	98.00	-
10	REAR BUMPER CLIPS	NECESSARY	22.00	22.00
1	REAR BUMPER SPONGE	SERVICEABLE	143.40	-
1	REAR BUMPER UNDER COVER	CUT	225.00	225.00
1	REAR BUMPER REFLECTOR LAMP (RH)	CRACKED	32.00	32.00

1	TAIL LAMP (RH)	CRACKED	565.60	565.60
1	EXHAUST PIPE INSULATOR,RH	SERVICEABLE	58.55	-
1	EXHAUST SILENCER,RH	BENT	954.00	954.00
1	EXHAUST PIPE HANGER,RH	SERVICEABLE	58.55	-
1	EXHAUST PIPE CENTRE	BENT	1,150.30	1,150.30
1	REAR FENDER (RH)	TO REPAIR	2,020.10	-
1	REAR FENDER INNER LINING (RH)	SERVICEABLE	164.40	-
1	REAR WINDSCREEN MOULDING	NECESSARY	60.00	60.00
1	REAR WINDSCREEN GLASS	SHATTERED	985.50	985.50
	LESS 20% DISCOUNT		-2,224.23	-1,149.40
			8,896.92	4,597.60
