NS / INC18002857 / Hlvb2

Veh No: SHC 80899 Reg: 18 Oct 2013

## National Assessment Centre Services

NTUC INCOME INSURANCE CO-OPERATIVE LTD Ref: NS/INC18002857/K1vb				
73 BRAS BASAH ROAD #05-01 NTUC TRADE UNION HOUSESINGAPORE 189556			Date: 13-02-2018	 
Code: INC4				
<b>1. Policy Particulars :- THIRD PARTY CLAIM</b>				
Insured Veh.	GBG 9309R	Veh. Inspected	SHC 8089G	
Policy No.	5096687307	Coverage (\$)	0.00	
Claim No.		Excess (\$)	0.00	
Assign From		Assign Date	12/02/2018	
<b>2. Vehicle Particulars &amp; Condition</b>				
Make & Model		c.c	0	
Engine No.	HIDDEN	Year of Reg.		
Chassis No.		Colour		
Odometer	-	Steering		
Brakes		Modification		
General				
<b>3. Conditions of Tyres</b>				
	Size	Make	Balance	
R/H Front Tyre			mm	
L/H Front Tyre			mm	
R/H Rear Tyre			mm	
L/H Rear Tyre			mm	
<b>4. Description of Damages</b>				
<b>5. General Information</b>				
Accident Date	10/02/2018	Inspection Date	12/02/2018	
Survey held at	COMFORTDELGRO ENGINEERING PTE LTD 59 LOYANG DRIVE SINGAPORE 508969			
<b>5a. Remarks</b>

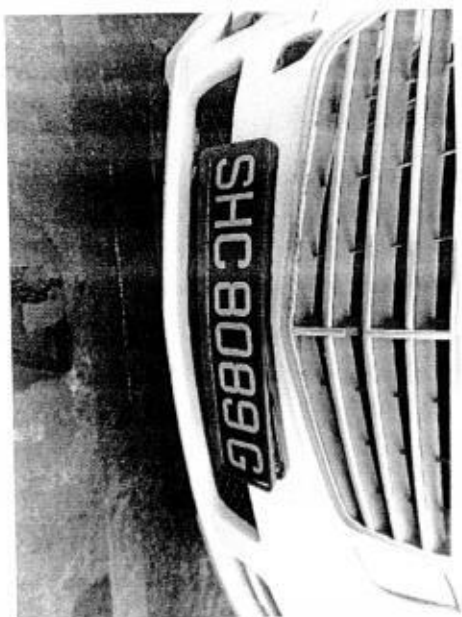
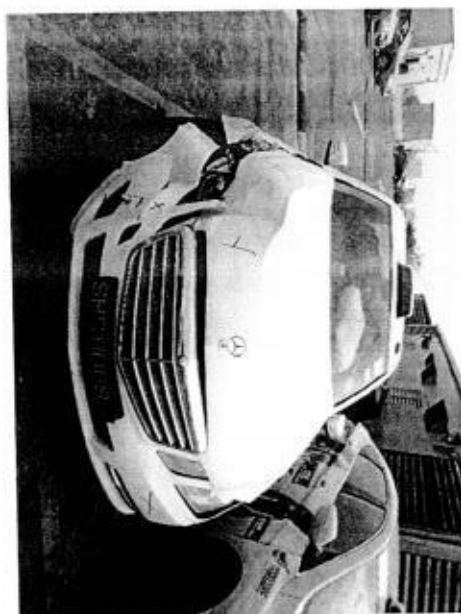
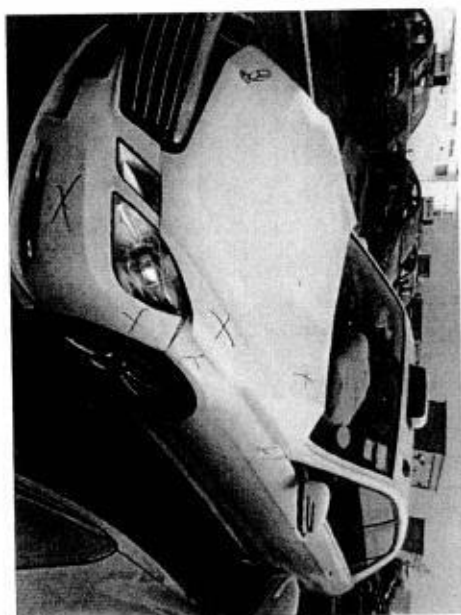
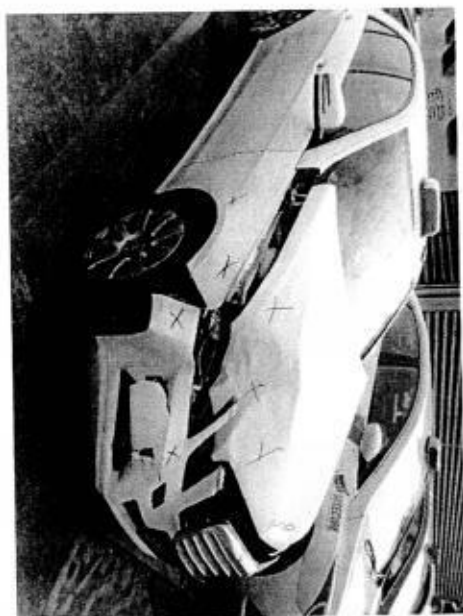
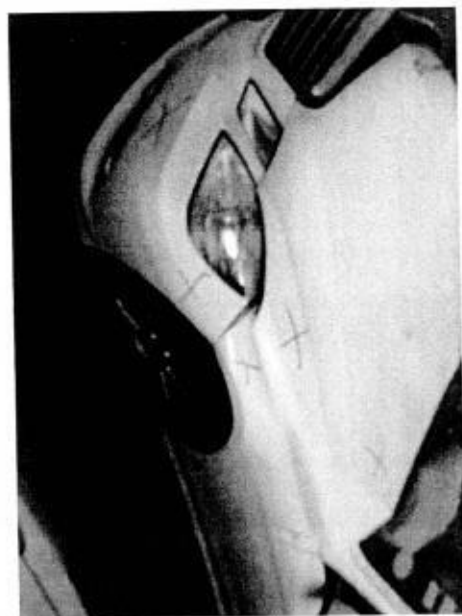
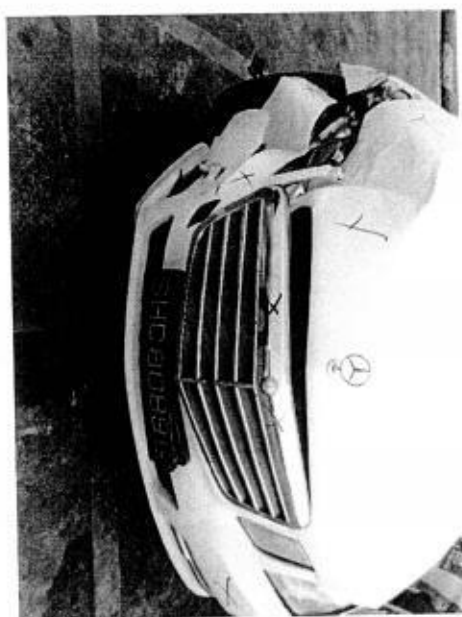
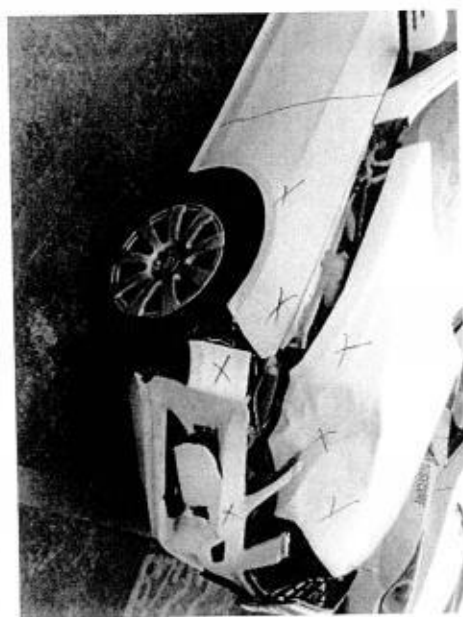
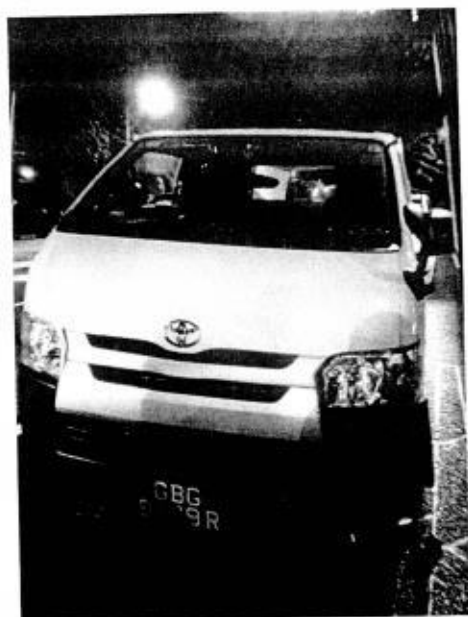
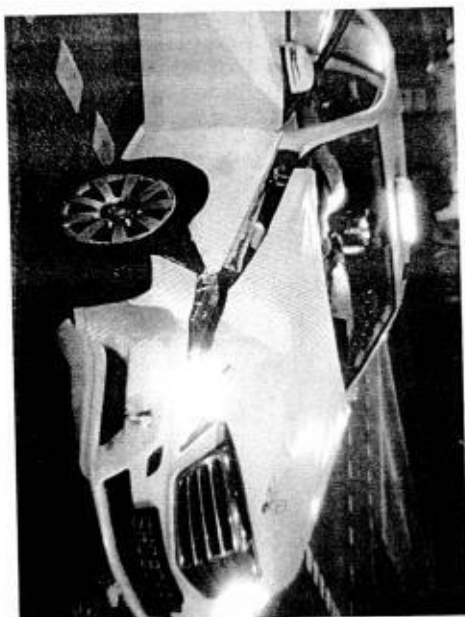
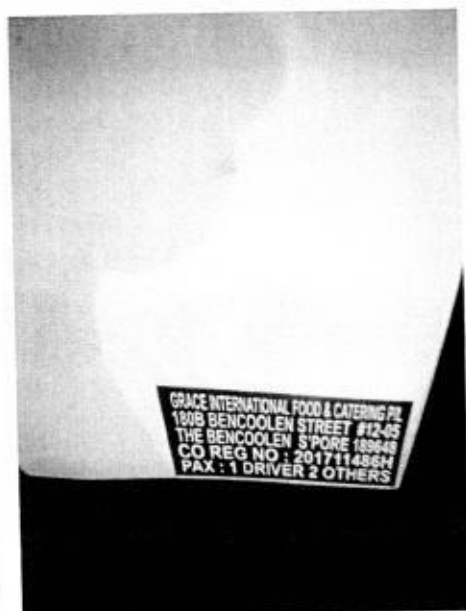
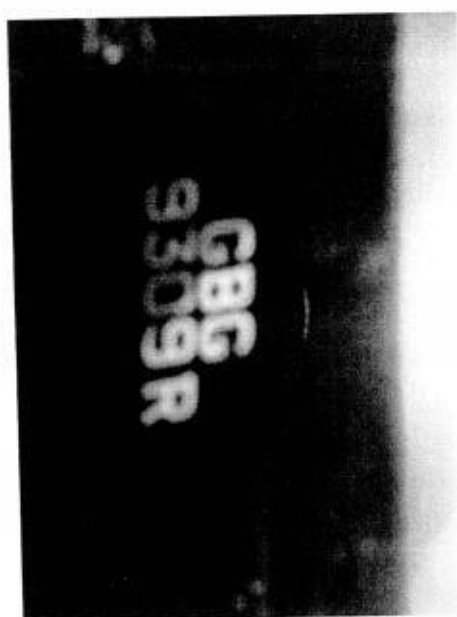
The U/C / Chassis frame / Body Structure affected due to collision.

Both front chassis damaged  
unsure to repair  
to scrap

(a) The vehicle sustained damages at the front o/s portion. (Details see photographs enclosed)

1/3/18 Submit constructive T/L - BV: \$104,214.60 LTA: \$53,911  
NV: \$50,303.60

(b) In view of this, we are of the opinion that it would be **unsafe** to proceed with the repairs due to extensive damages on the chassis under the category of **the section 2 of THE ROAD TRAFFIC ACT on THE MOTOR VEHICLES (CONSTRUCTION AND USE) (AMENDMENT NO.2) RULES 1989**, that:  
*no vehicle shall be fitted with a replacement chassis or any body part where the chassis is an integral part of the vehicle.*  
and we therefore recommend it to be written off as **"Total Loss"**
