1. Policy Particulars :- THIRD PARTY CLAIM

TP Claims against NTUC Income: Follow-Through Survey

4. Description of Damages			
THE VEHICLE SUSTAINED DAMAGES AT THE O/S REAR PORTION. DAMAGES SEE DETAILS.			
5. General Information			
Accident Date	10/02/2018	Inspection Date	12/02/2018
Survey held at	COMFORTDELGRO ENGINEERING PTE LTD 59 LOYANG DRIVE SINGAPORE 508969		
5a. Remarks			
A)THE INSPECTION WAS CONDUCTED ON A"WITHOUT PREJUDICE" BASIS. B)IN ACCORDANCE TO YOUR INSTRUCTIONS, WE HAVE NOT AUTHORISED REPAIRS.			
5b. Estimate Days of Repair			
ESTIMATED NORMAL PERIOD FOR REPAIR:		2 Working Days

ADJUSTMENT ON REPAIR COST FOR VEHICLE NO. SHC 8886Y

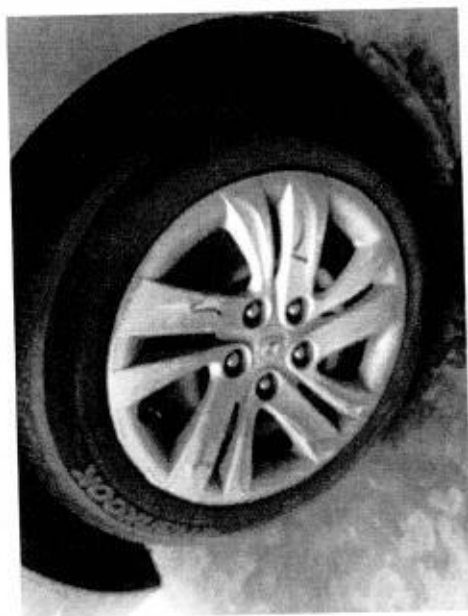
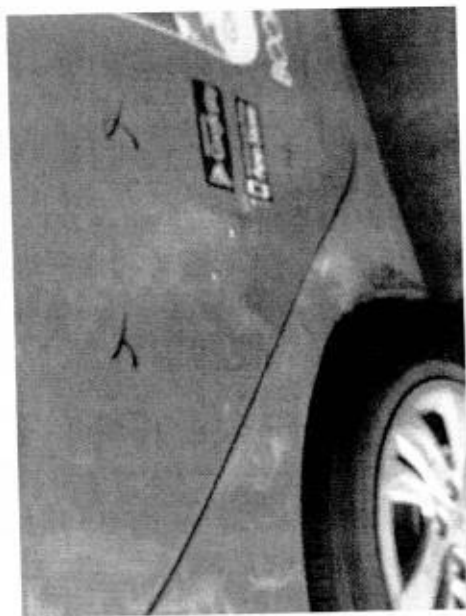
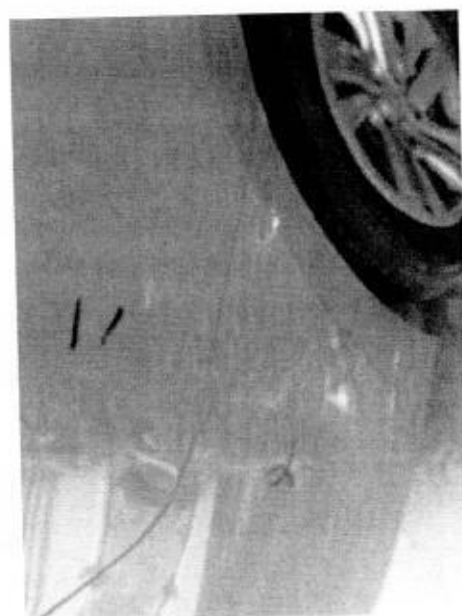
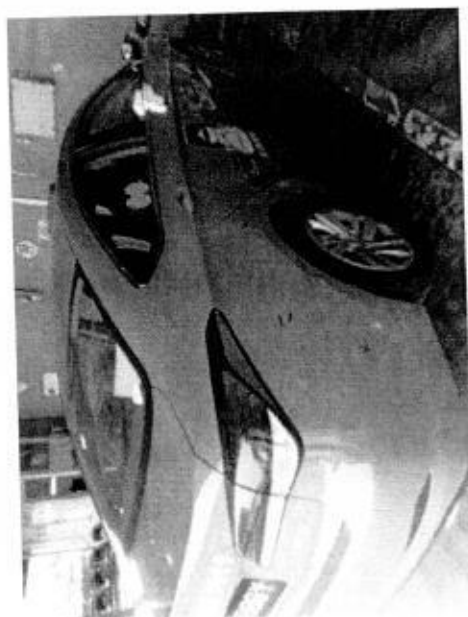
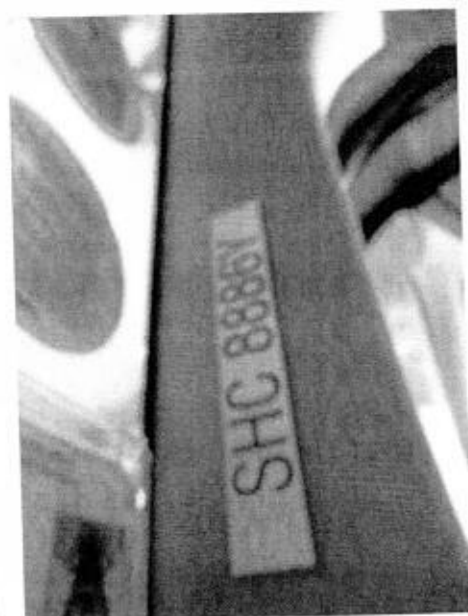
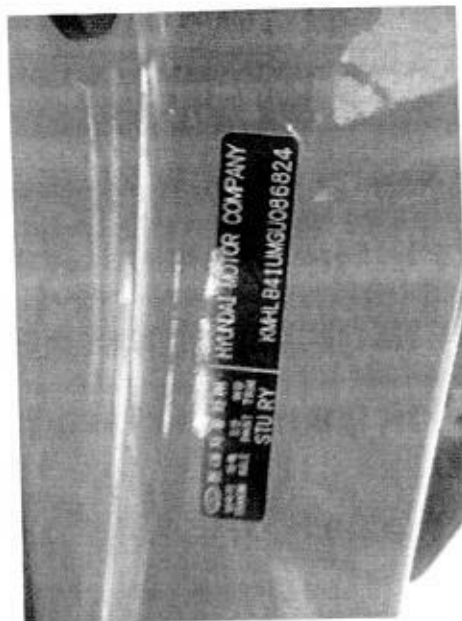
The U/C / Chassis frame / Body Structure affected due to collision.

Qty	Description of Parts	Condition	Estimate By Workshop (\$)	Our Adjusted (\$)
	<u>REPLACEMENT OF PARTS</u>			
1	I40VC PANEL ASSY-RR DR RH	DENTED	1,351.00	1,351.00
1	I40V2 PANEL ASSY-QUARTER	TO REPAIR	2,020.10	-
1	I40VC COVER ASSY-RR BUMPE	TO REPAIR	603.60	-
1	I40VC CAP ASSY-WHEEL HUB	GRAZED	150.70	150.70
1	ROCKER PANEL GARNISH (RH)	CRACKED	483.60	483.60
	LESS 20% DISCOUNT		-921.80	-397.06
			3,687.20	1,588.24
	<u>SPECIAL NETT ITEMS</u>			
1	I40V3 APP LOGO REAR DOOR (SN)	NECESSARY	80.00	80.00
			80.00	80.00
	<u>LABOUR</u>			
	THATCHAM STANDARD REPAIR TIME ON BODY WORKS.		680.00	350.00
	THATCHAM TTS STANDARD SPRAY PAINTING COST AND LABOUR.		700.00	560.00
			1,380.00	910.00
	GRAND TOTAL		5,147.20	2,578.24
RECOMMENDED COST OF REPAIRS (CONFIRMED)				2,578.24
