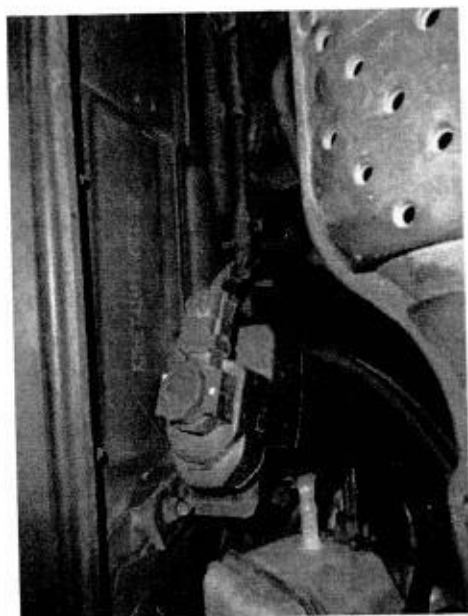
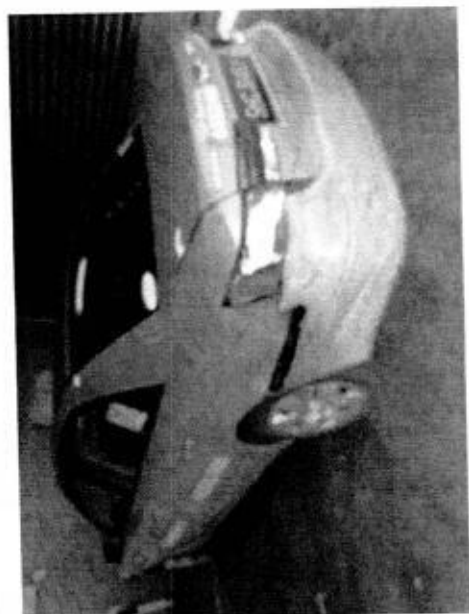
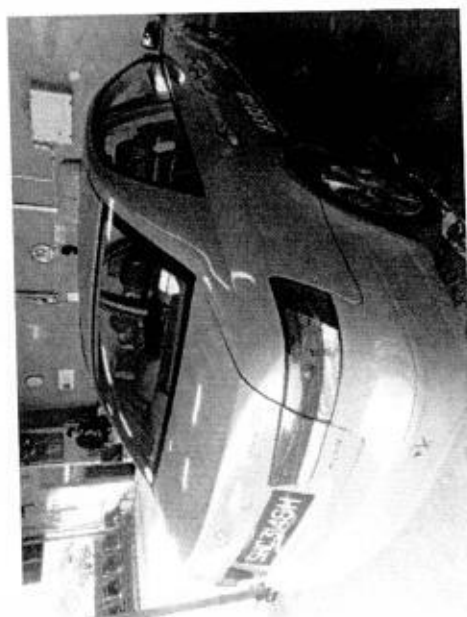
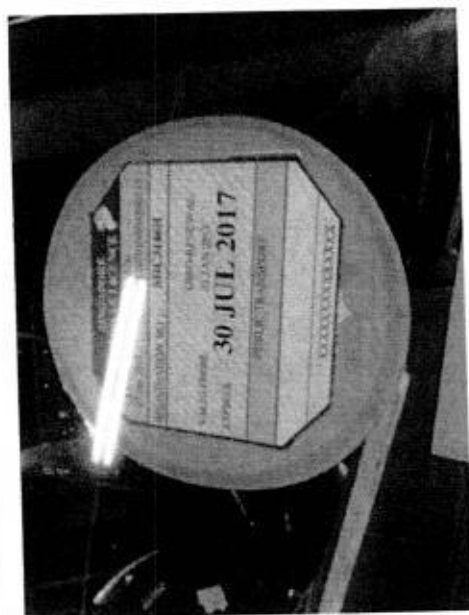
THE VEHICLE SUSTAINED DAMAGES AT THE REAR N/S PORTION. DAMAGES SEE DETAILS.
--

GRAND TOTAL		7,114.10	4,391.38
RECOMMENDED COST OF LUMP SUM REPAIRS (TO ITS PRE-ACCIDENT CONDITION) (CONFIRMED)			3,500.00
