NTUC INCOME INSURANCE CO-OPERATIVE LTD Ref: NS/INC18002948/K1qbn2			
73 BRAS BASAH ROAD #05-01 NTUC TRADE UNION HOUSESINGAPORE 189556		Date: 02-03-2018

Code: INC4			
<b>1. Policy Particulars :- THIRD PARTY CLAIM</b>			
Insured Veh.	FBL 894A	Veh. Inspected	SHB 6683J
Policy No.	5071932749-02	Coverage (\$)	0.00
Claim No.	MT/0983229-002	Excess (\$)	0.00
Assign From		Assign Date	13/02/2018
<b>2. Vehicle Particulars &amp; Condition</b>			
Make & Model	MERCEDES BENZ VIANO	c.c	2143
Engine No.	HIDDEN	Year of Reg.	2013
Chassis No.	WDF63981323810313	Colour	WHITE
Odometer	537067	Steering	IN ORDER
Brakes	IN ORDER	Modification	STANDARD ALLOY RIM
General	FAIR		
<b>3. Conditions of Tyres</b>			
	Size	Make	Balance
R/H Front Tyre	225/60 R16C	HANKOOK	7 mm
L/H Front Tyre	225/60 R16C	HANKOOK	7 mm
R/H Rear Tyre	225/60 R16C	HANKOOK	7 mm
L/H Rear Tyre	225/60 R16C	HANKOOK	7 mm
<b>4. Description of Damages</b>			
THE VEHICLE SUSTAINED DAMAGES AT THE N/S WING MIRROR. DAMAGES SEE DETAILS.

## ADJUSTMENT ON REPAIR COST FOR VEHICLE NO. SHB 6683J

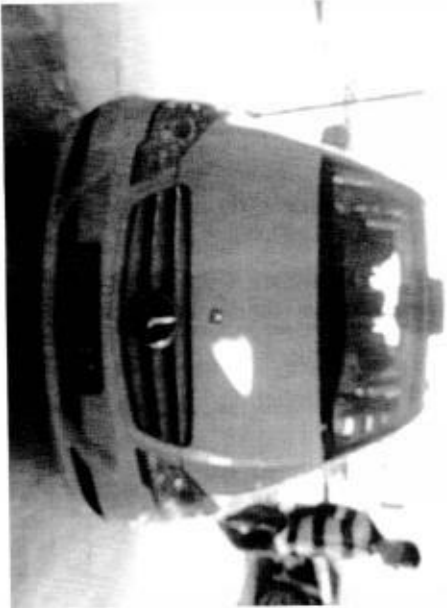
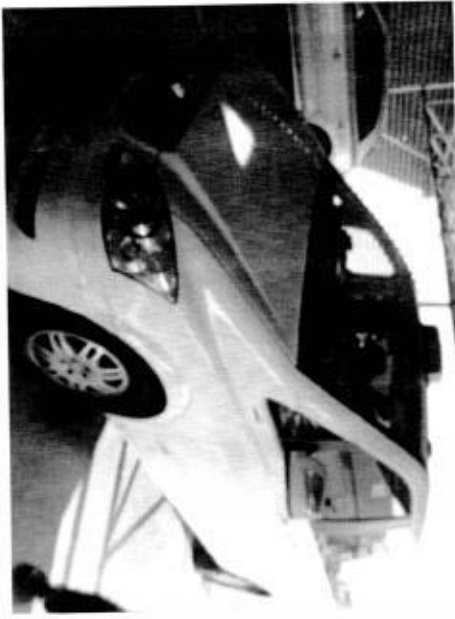
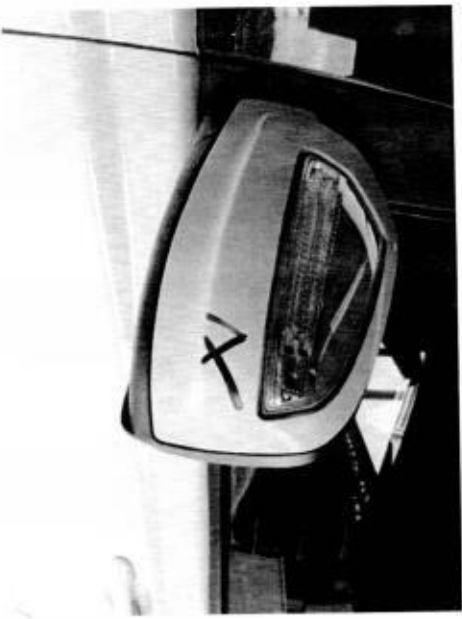
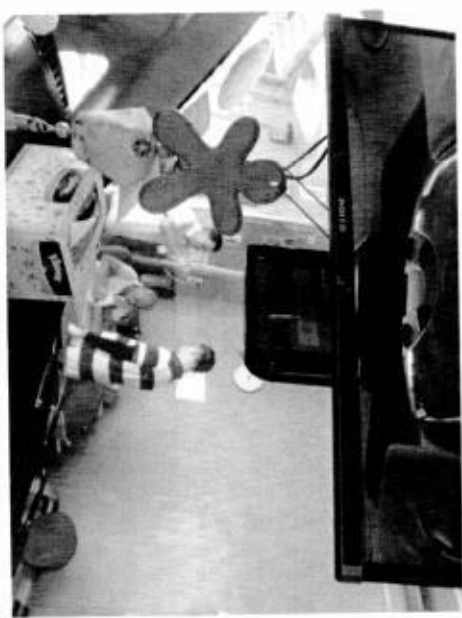
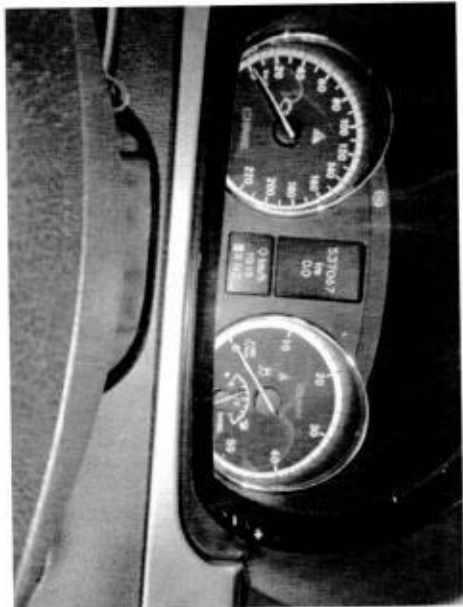
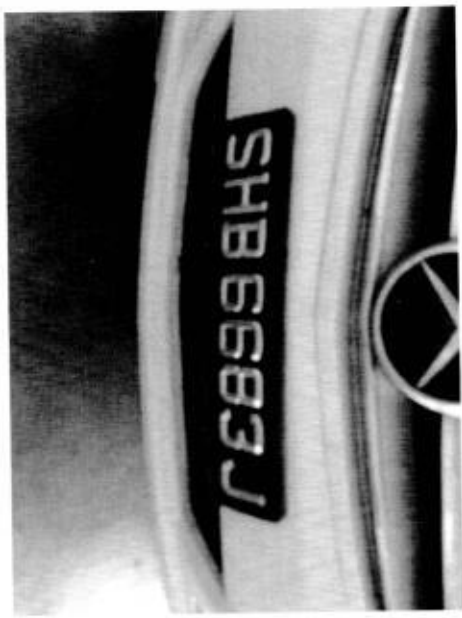
Qty	Description of Parts	Condition	Estimate By Workshop (\$)	Our Adjusted (\$)
	<b>REPLACEMENT OF PARTS</b>			
1	MIRROR ASSY,FRT,LH	CRACKED	1,195.02	1,195.02
1	MIRROR GLASS,FRT,LH	CRACKED	219.58	219.58
	LESS 20% DISCOUNT		-282.92	-282.92
			1,131.68	1,131.68
	<b>LABOUR</b>			
	THATCHAM STANDARD REPAIR TIME ON BODY WORKS.		330.00	120.00
	THATCHAM TTS STANDARD SPRAY PAINTING COST AND LABOUR.		200.00	50.00
			530.00	170.00
	<b>GRAND TOTAL</b>		<b>1,661.68</b>	<b>1,301.68</b>
	<b>RECOMMENDED COST OF LUMP SUM REPAIRS (TO ITS PRE-ACCIDENT CONDITION) (CONFIRMED)</b>			<b>1,050.00</b>

<b>5. General Information</b>			
Accident Date	12/02/2018	Inspection Date	13/02/2018
Survey held at	COMFORTDELGRO ENGINEERING PTE LTD 59 LOYANG DRIVE SINGAPORE 508969		
<b>5a. Remarks</b>			
A)THE INSPECTION WAS CONDUCTED ON A"WITHOUT PREJUDICE" BASIS. B)IN ACCORDANCE TO YOUR INSTRUCTIONS, WE HAVE NOT AUTHORISED REPAIRS.			
<b>5b. Estimate Days of Repair</b>			
ESTIMATED NORMAL PERIOD FOR REPAIR:		1 Working Days
