Insured: SJF 1757 TPolicy No. 5082744693-01 - 26/12/2017Claims No. MT/0982613-002

Veh No: SHA 619 R Yr Regn: 17 Sep, 2014

4. Description of Damages

ADJUSTMENT ON REPAIR COST FOR VEHICLE NO. SHA 619R

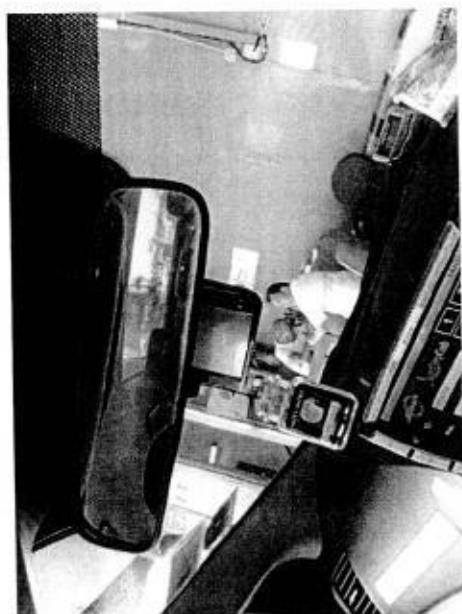
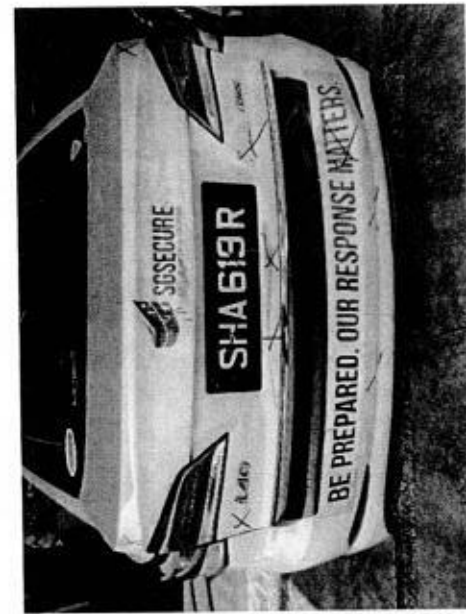
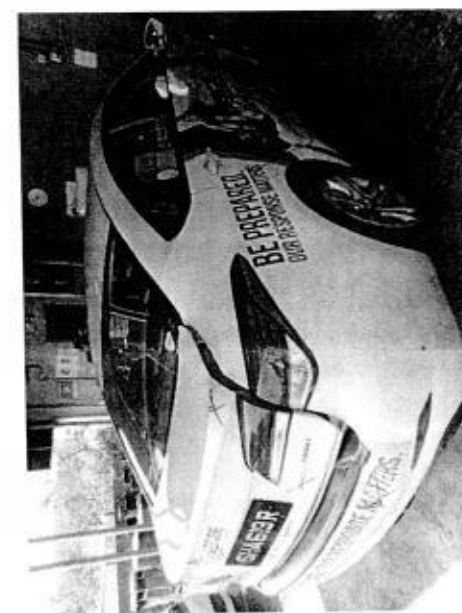
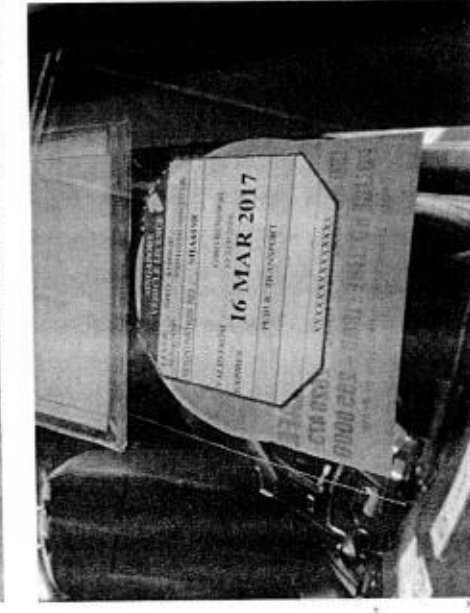
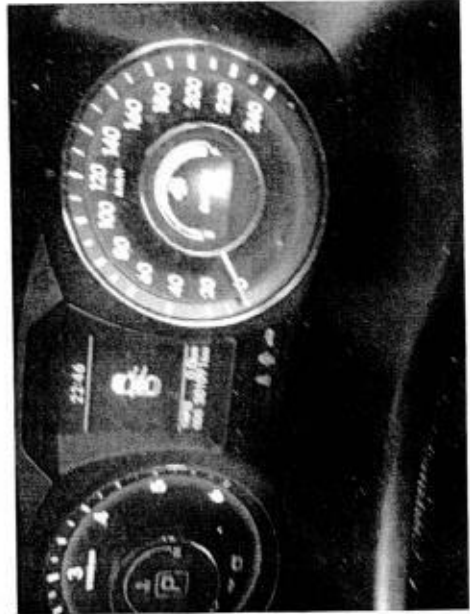
Rear d/s

The U/C / Chassis frame / Body Structure affected due to collision.

THE VEHICLE SUSTAINED DAMAGES AT THE REAR O/S PORTION. DAMAGES SEE DETAILS.
--

Qty	Description of Parts	Condition	Estimate By Workshop (\$)	Our Adjusted (\$)
REPLACEMENT OF PARTS				
1	BOOT LID	DENTED	1,681.40	1,681.40
1	BOOT LID RUBBER	SERVICEABLE	115.80	-
1	BOOT LID LOCK UPPER	SERVICEABLE	137.90	-
1	BOOT LID LOCK LOWER	SERVICEABLE	31.70	-
1	BOOT LID "H" EMBLEM	NECESSARY	27.20	27.20
1	BOOT LID CRDI PLATE	NECESSARY	41.00	41.00
1	BOOTLID MOULDING	CUT	85.00	85.00
1	BOOTLID I40 EMBLEM	NECESSARY	41.00	41.00
1	BOOTLID LOWER GARNISH	CRACKED	398.00	398.00
1	REAR BUMPER	DEFORMED	603.60	603.60
1	REAR BUMPER REINFORCEMENT	CRACKED	504.35	504.35
2	REAR BUMPER REINFORCEMENT BRACKET (LH/RH) @\$180.00	BENT	360.00	360.00
2	REAR BUMPER SIDE BRACKET @\$49.00	SERVICEABLE	98.00	-
10	REAR BUMPER CLIPS	NECESSARY	22.00	22.00
1	REAR BUMPER SPONGE	SERVICEABLE	143.40	-
1	REAR BUMPER UNDER COVER	CUT	225.00	225.00
1	REAR PANEL	TO REPAIR	592.30	-
1	REAR PANEL GARNISH	SERVICEABLE	57.70	-
1	REAR PANEL LOWER PANEL	TO REPAIR	495.50	-

Qty	Description of Parts	Condition	Estimate By Workshop (\$)	Our Adjusted (\$)
2	REAR FENDER ADVERTISEMENT LOGO (LH/RH) @\$100.00 (SN) <u>LABOUR</u> THATCHAM STANDARD REPAIR TIME ON BODY WORKS. THATCHAM TTS STANDARD SPRAY PAINTING COST AND LABOUR.	NECESSARY	200.00	200.00
			350.00	350.00
			1,020.00	620.00
			650.00	560.00
			1,670.00	1,180.00
GRAND TOTAL			6,714.38	4,869.97
RECOMMENDED COST OF LUMP SUM REPAIRS (TO ITS PRE-ACCIDENT CONDITION) (CONFIRMED)				3,900.00
