REF: NS/INC 18003117/K14d3n2

VEHICLE NO : SHA 3542H

4. Description of Damages

ADJUSTMENT ON REPAIR COST FOR VEHICLE NO. SHA 3542H

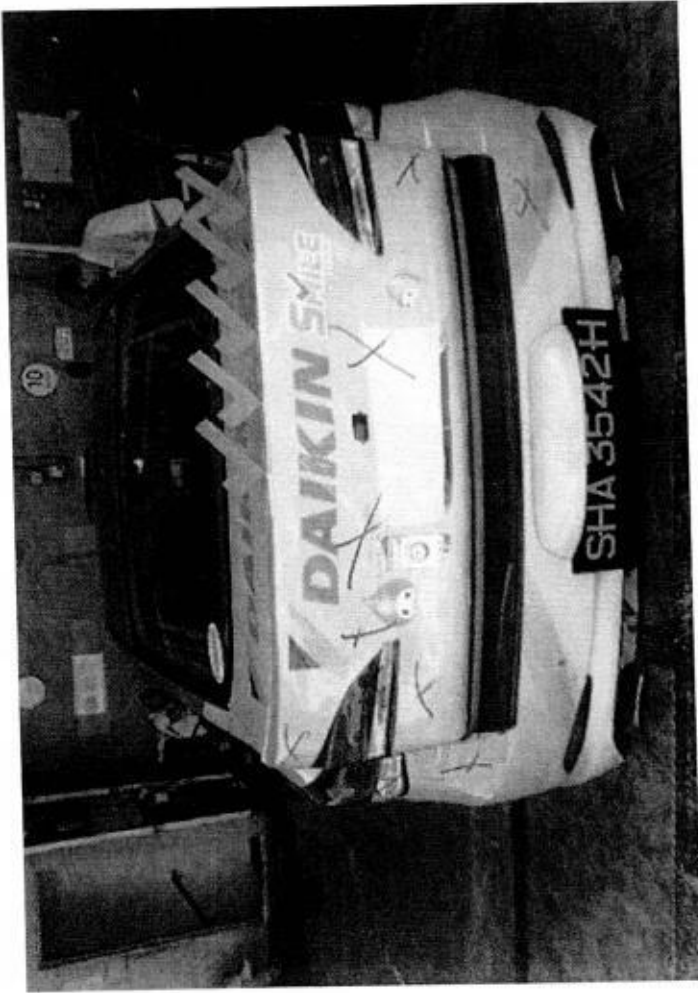
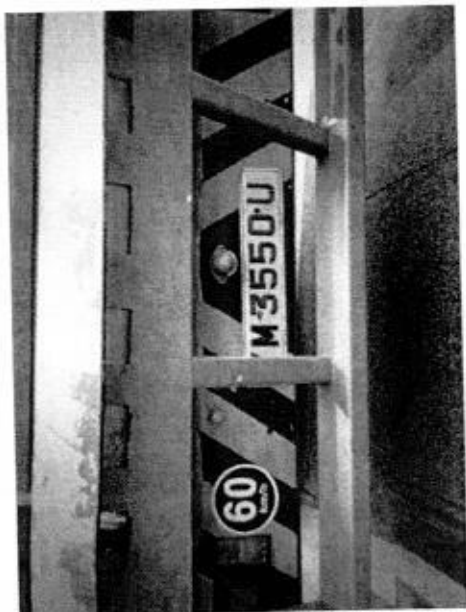
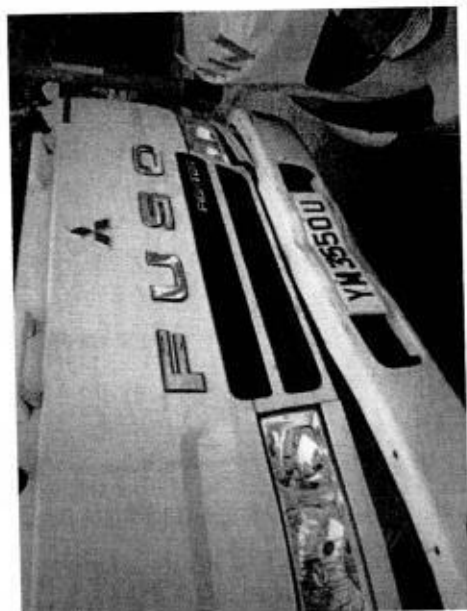
The U/C / Chassis frame / Body Structure affected due to collision.

THE VEHICLE SUSTAINED DAMAGES AT THE REAR PORTION. DAMAGES SEE DETAILS.
--

Qty	Description of Parts	Condition	Estimate By Workshop (\$)	Our Adjusted (\$)
<u>REPLACEMENT OF PARTS</u>				
1	BOOT LID	DENTED	1,681.40	1,681.40
1	BOOT LID RUBBER	SERVICEABLE	115.80	-
1	BOOT LID LOCK UPPER	SERVICEABLE	137.90	-
1	BOOT LID LOCK LOWER	SERVICEABLE	31.70	-
1	BOOT LID "H" EMBLEM	NOT NECESSARY	27.20	-
1	BOOT LID CRDI PLATE	SERVICEABLE	41.00	-
2	BOOT LID LAMP (LH/RH) @\$556.80	CRACKED	1,113.60	1,113.60
1	BOOTLID MOULDING	SERVICEABLE	85.00	-
1	BOOTLID I40 EMBLEM	SERVICEABLE	41.00	-
1	BOOTLID LOWER GARNISH	TO REPAIR	398.00	-
1	REAR BUMPER	DEFORMED	603.60	603.60
1	REAR BUMPER REINFORCEMENT	SERVICEABLE	504.35	-
2	REAR BUMPER REINFORCEMENT BRACKET (LH/RH) @\$180.00	SERVICEABLE	360.00	-
2	REAR BUMPER SIDE BRACKET @\$49.00	SERVICEABLE	98.00	-
10	REAR BUMPER CLIPS	NECESSARY	22.00	22.00
1	REAR BUMPER SPONGE	SERVICEABLE	143.40	-
1	REAR BUMPER UNDER COVER	SERVICEABLE	225.00	-
2	REAR BUMPER REFLECTOR LAMP (LH/RH) @\$32.00	SERVICEABLE	64.00	-

2	TAIL LAMP (LH/RH) @\$565.60	N/S CRACKED / O/S SERVICEABLE	1,131.20	565.60
1	REAR PANEL	TO REPAIR	592.30	-
1	REAR PANEL GARNISH	CRACKED	57.70	57.70
1	REAR PANEL LOWER PANEL	TO REPAIR	495.50	-
1	REAR FENDER (LH)	TO REPAIR	2,020.10	-
1	REAR WINDSCREEN MOULDING	NOT NECESSARY	60.00	-
	LESS 20% DISCOUNT		-2,009.95	-808.78
			8,039.80	3,235.12
<u>SPECIAL NETT ITEMS</u>				
1	BOOT LID COMFORT LOGO & TEL NO STICKER (SN)	NOT NECESSARY	30.00	-
