VEHICLE DAMAGE INSPECTION REPORT

Our File No: CS/MSG18003326/R1TBQ2

Claimant Vehicle No: SKB9800H

Make & Model: BMW 523i, 2.5 (A)

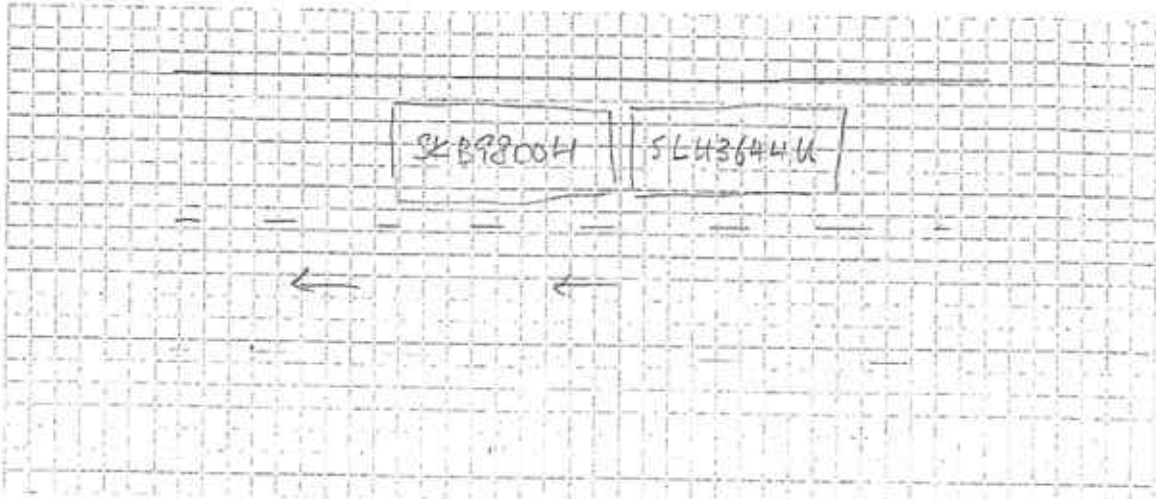
SKETCH PLAN

LICENSE PLATE: SKB 9800 H	ACCIDENT DATE & TIME: 15/2/18, 0845 hrs.
CONTACT NUMBER: 98205940	E-MAIL ADDRESS: okw77@hotmail.com
LOCATION: AYE approaching CTE	
<p>I was on the AYE approaching CTE on the right most lane. The cars in front of me came to a stop due to traffic and I came to a stop too. The car behind me couldn't brake in time and bumped into my car's behind.</p> <p>My wife, Ong Shei Kim, was in the passenger seat. The lady driver behind me was Lee Pei San (S9333795F). The car number is SLU3644U. Contact 97242225.</p>	
<p>NOTE: PLEASE NOTE THAT YOUR INSURER MAY HAVE 14 DAYS TIME FRAME FOR YOU TO SUBMIT AN OWN DAMAGE CLAIM UNDER YOUR OWN POLICY. PLEASE CHECK YOUR POLICY FOR MORE INFORMATION</p>	
Please state:	
<input type="checkbox"/> Claim Own Policy <input type="checkbox"/> Claim Third Party <input type="checkbox"/> Claim OD/TP at other workshop <input checked="" type="checkbox"/> Reporting Only
