## Preliminary Advice

| Vehicle No | : SLH57C | Accident Date | : 13/02/2018 |
| Make | : MERCEDES-BENZ C180 | Policy No. | : 28809291QMY |

## VEHICLE DAMAGE INSPECTION REPORT

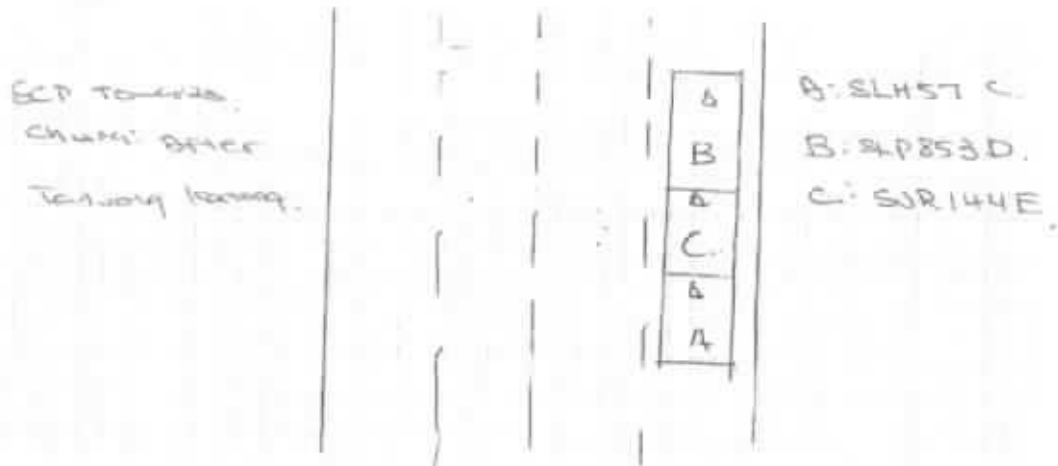
SKETCH PLAN

On 13/02/2012 at about 17:30pm. I was  
 travelling along ECF Towards Changi After.  
 Tanjong Katong. I hit the front vehicle.  
 I was involved in a three vehicles crash.  
 Collision.
