REF: NS/INC18003659/Klvbnz

Job Name: ARC Repair TP(CFSO)1

4. Description of Damages			
THE VEHICLE SUSTAINED DAMAGES AT THE N/S FRONT PORTION. DAMAGES SEE DETAILS.			
5. General Information			
Accident Date	15/02/2018	Inspection Date	22/02/2018
Survey held at	COMFORTDELGRO ENGINEERING PTE LTD 59 LOYANG DRIVE SINGAPORE 508969		
5a. Remarks			
A)THE INSPECTION WAS CONDUCTED ON A"WITHOUT PREJUDICE" BASIS. B)IN ACCORDANCE TO YOUR INSTRUCTIONS, WE HAVE NOT AUTHORISED REPAIRS.			
5b. Estimate Days of Repair			
ESTIMATED NORMAL PERIOD FOR REPAIR:		2 Working Days

ADJUSTMENT ON REPAIR COST FOR VEHICLE NO. SHD 8845K

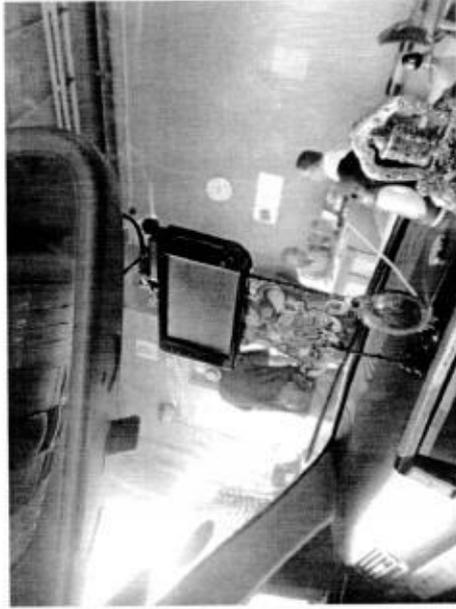
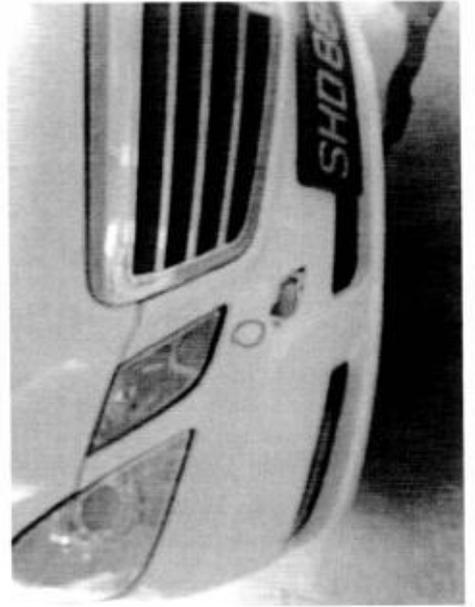
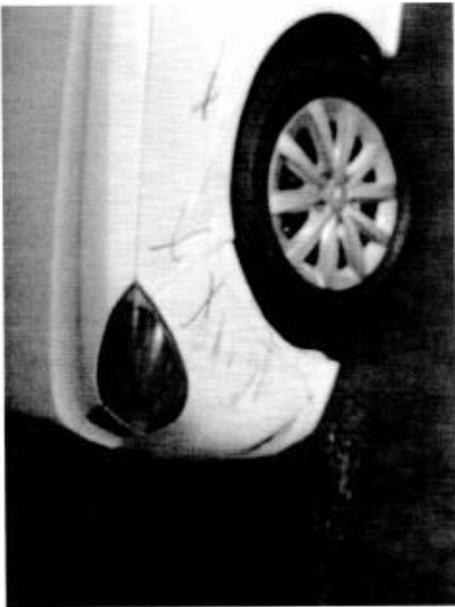
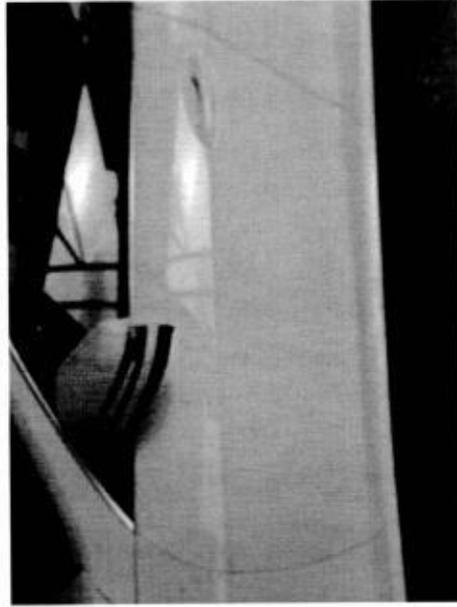
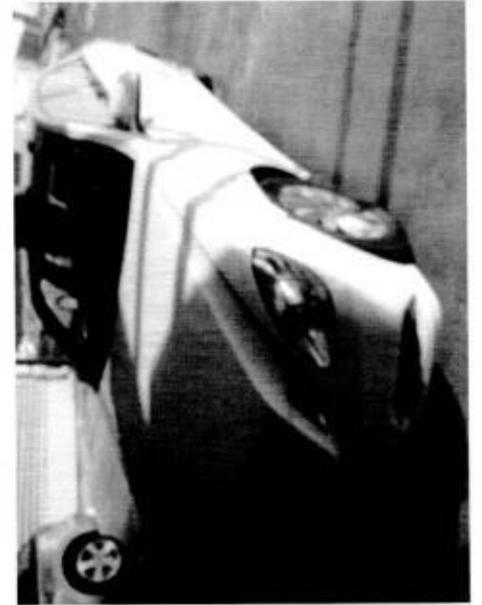
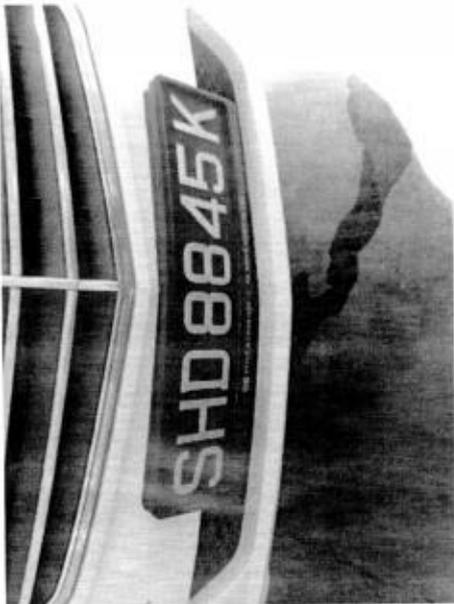
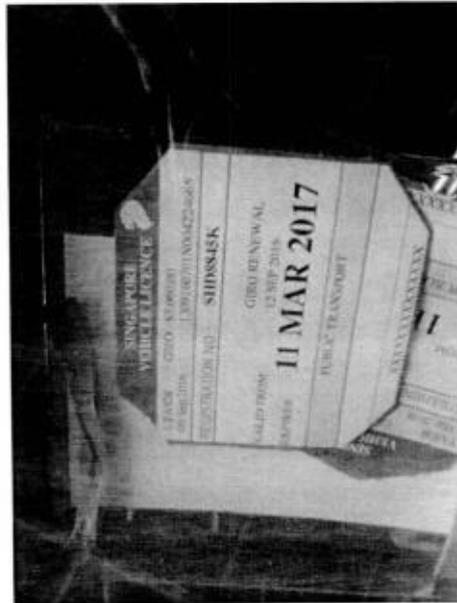
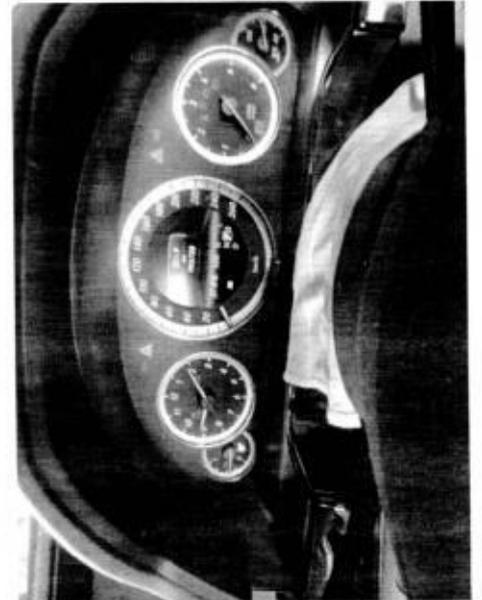
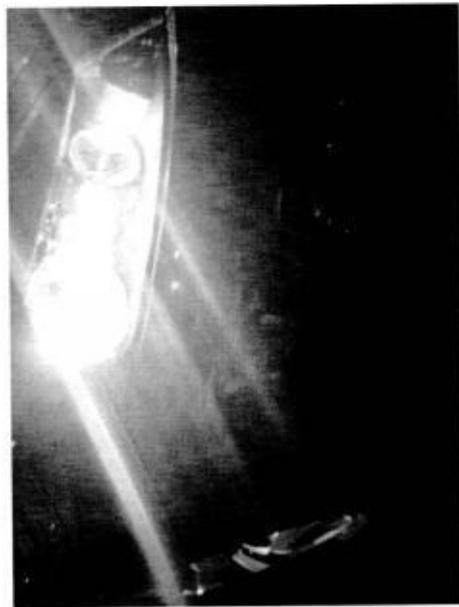
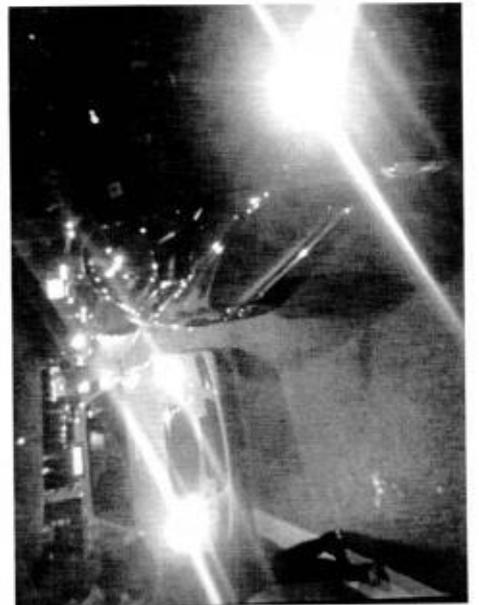
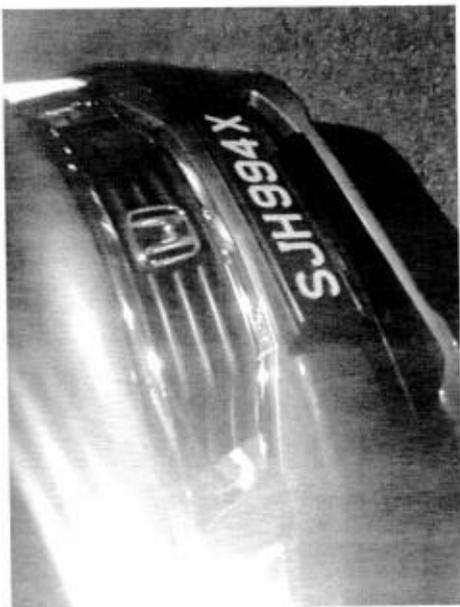
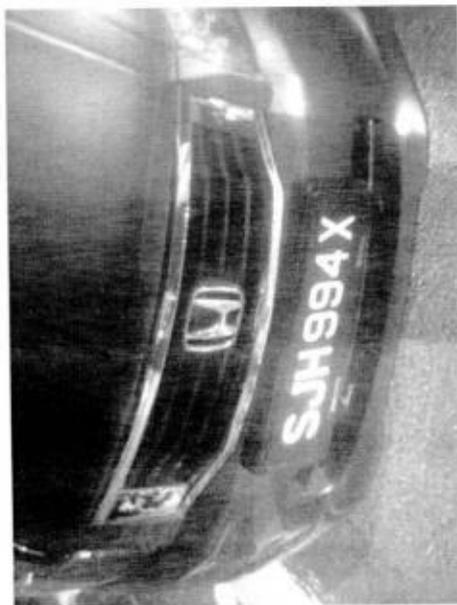
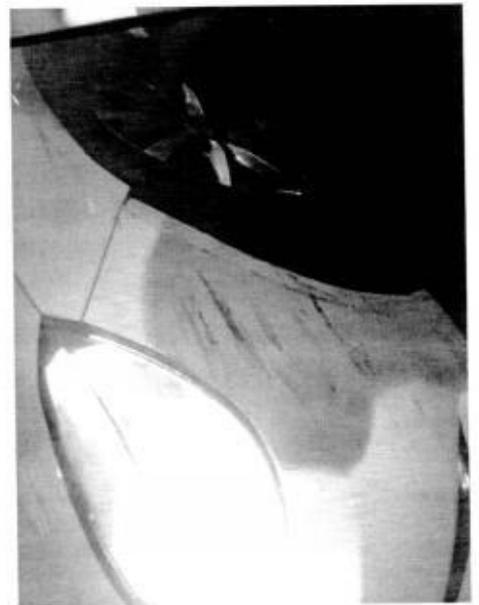
Qty	Description of Parts	Condition	Estimate By Workshop (\$)	Our Adjusted (\$)
REPLACEMENT OF PARTS				
1	BUMPER ASSY,FRT	DEFORMED	1,890.50	1,890.50
1	BUMPER BRACKET,FRT/LH	SERVICEABLE	95.00	-
10	BUMPER INNER CLIP,FRT	NECESSARY	22.00	22.00
1	HEAD LAMP ASSY (LH)	GRAZED	2,380.00	2,380.00
1	FENDER,FRT/LH	DENTED	966.00	966.00
1	FENDER SPLASHSHIELD,FRT/LH (FRONT)	SERVICEABLE	257.00	-
	LESS 20% DISCOUNT		-1,122.10	-1,051.70
			4,488.40	4,206.80
LABOUR				
	THATCHAM STANDARD REPAIR TIME ON BODY WORKS.		650.00	320.00
	THATCHAM TTS STANDARD SPRAY PAINTING COST AND LABOUR.		550.00	380.00
			1,200.00	700.00
GRAND TOTAL			5,688.40	4,906.80
RECOMMENDED COST OF LUMP SUM REPAIRS (TO ITS PRE-ACCIDENT CONDITION) (CONFIRMED)				3,900.00

1. The repair job shall bill to: NTUC SJH994X
2. The finalized amount shall be:
 - (a) Spare Parts after List discount _____
 - (b) Labour Charges _____
 - Total for Part-By-Part Repair Cost** _____
 - (c) Lumpsum Repair (if applicable)
Total for Lumpsum repair cost after Less: _____
Final Lumpsum Repair cost \$3,900.00
