TP Claims against NTUC Income: Follow-Through Survey

SINGAPORE ACCIDENT STATEMENT

NTUC INCOME INSURANCE CO-OPERATIVE LTD Ref: NS/INC18003662/K1tbn2

ADJUSTMENT ON REPAIR COST FOR VEHICLE NO. SHD 4270U

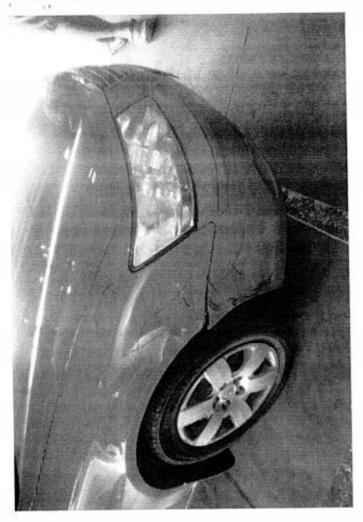
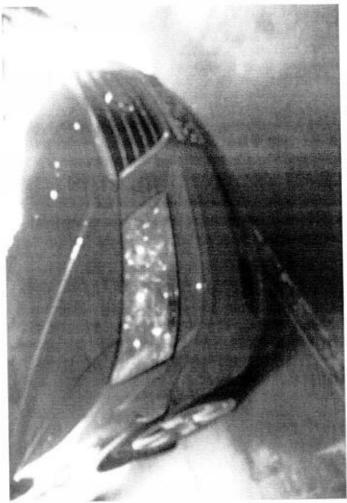
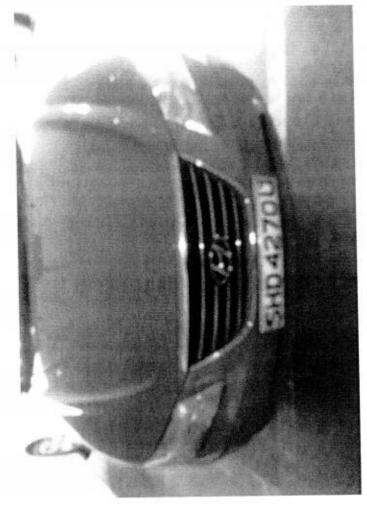
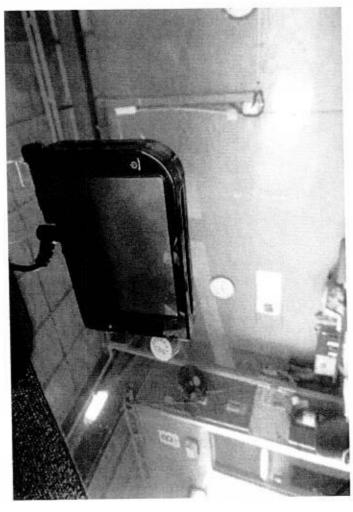
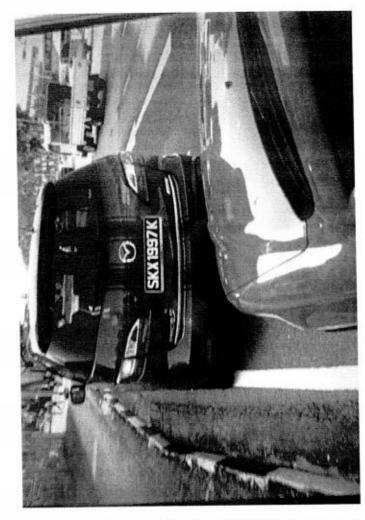
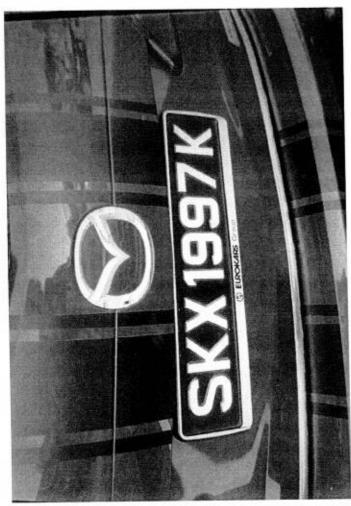
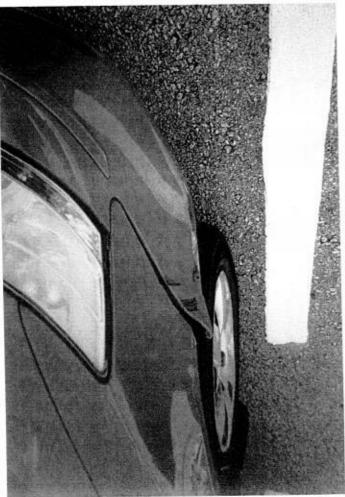
4.		Descript	AND DESCRIPTION OF THE PARTY OF	CONTRACTOR OF THE PARTY OF THE			
	THE VEHICLE SU	STAINED DAMAGES AT THE O/	S FRON	T PORTION.			
	DAMAGES SEE D	ETAILS.

Qty	Description of Parts	Condition	Estimate By Workshop (\$)	Our Adjusted (\$)
	REPLACEMENT OF PARTS			
1	FRONT BUMPER COVER	DEFORMED	538.80	538.80
1	FRONT BUMPER BRACKET TOP (RH)	SERVICEABLE	22.40	
1	FRONT BUMPER SIDE BRACKET	SERVICEABLE	14.30	
1	FRONT FENDER (RH)	DENTED	593.00	593.00
-1	FRONT FENDER SHIELD (RH)	SERVICEABLE	86.00	3.
1	FRONT FENDER RETAINER	SERVICEABLE	9.20	
1	FRONT WHEEL HUB CAP (RH)	SERVICEABLE	145.00	81
	LESS 20% DISCOUNT	To control of the transport of the second control of the second co	-281.74	-226.36
			1,126.96	905.44
	LABOUR			
	THATCHAM STANDARD REPAIR TIME ON BODY WORKS.		680.00	300.00
	THATCHAM TTS STANDARD SPRAY PAINTING COST AND LABOUR.		450.00	360.00
			1,130.00	660.00
	GRAND TOTAL		2,256.96	1,565.44
	RECOMMENDED COST OF LUMP SUM REPAIRS (TO ITS PRE-ACCIDENT CONDITION)		N STORY OF THE	1,250.00
