## 1. Policy Particulars :- THIRD PARTY CLAIM

VEHICLE NO : SH 7441Y

#05-01 NTUC TRADE UNION HOUSESINGAPORE 189556			
		Date: 02-03-2018	
		Code: INC4	
<b>1. Policy Particulars :- THIRD PARTY CLAIM</b>			
Insured Veh.	SGV 7511Y	Veh. Inspected	SH 7441Y
Policy No.	5091479234	Coverage (\$)	0.00
Claim No.	MT/0983124-002	Excess (\$)	0.00
Assign From		Assign Date	21/02/2018
<b>2. Vehicle Particulars &amp; Condition</b>			
Make & Model	HYUNDAI SONATA	c.c	1991
Engine No.	HIDDEN	Year of Reg.	2011
Chassis No.	KMHET41VMBA807319	Colour	BLUE
Odometer	306851	Steering	IN ORDER
Brakes	IN ORDER	Modification	STANDARD ALLOY RIM
General	FAIR		
<b>3. Conditions of Tyres</b>			
	Size	Make	Balance
R/H Front Tyre	215/60 R16	MAXXIS	7 mm
L/H Front Tyre	215/60 R16	MAXXIS	7 mm
R/H Rear Tyre	215/60 R16	MAXXIS	7 mm
L/H Rear Tyre	215/60 R16	MAXXIS	7 mm
<b>4. Description of Damages</b>			
THE VEHICLE SUSTAINED DAMAGES AT THE O/S FRONT PORTION.

## ADJUSTMENT ON REPAIR COST FOR VEHICLE NO. SH 7441Y

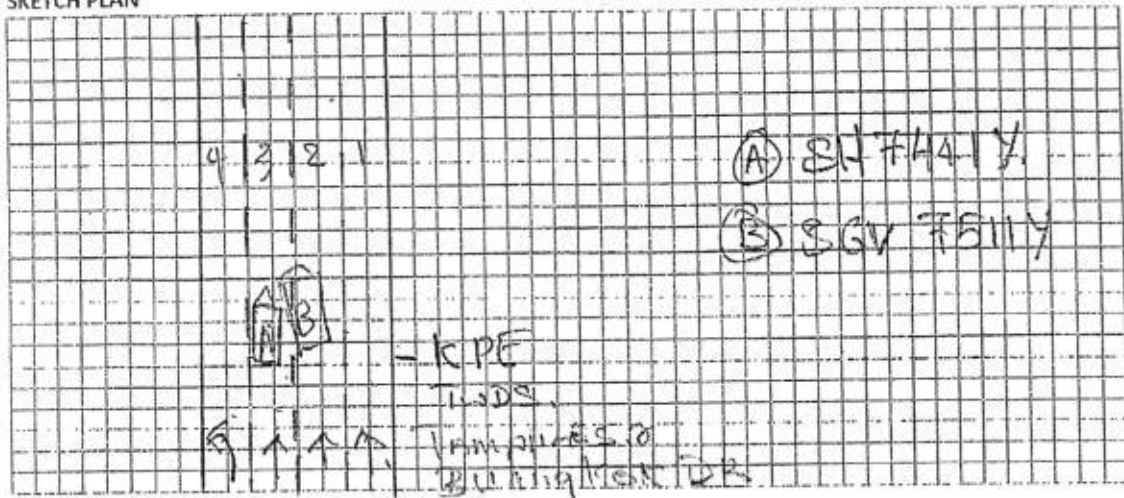
## SKETCH PLAN

On 21/02/18 at about 0015hrs, I vehicle A was travelling along KPE toward Tampines on lane 3. While I going straight suddenly vehicle B come from lane 2 and cut into my lane and grazed against my right front portion causing the damages. Due to impact causing my shoulder and neck pain.

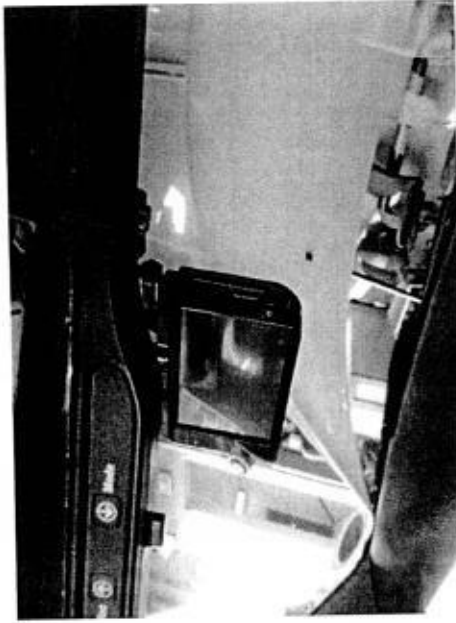
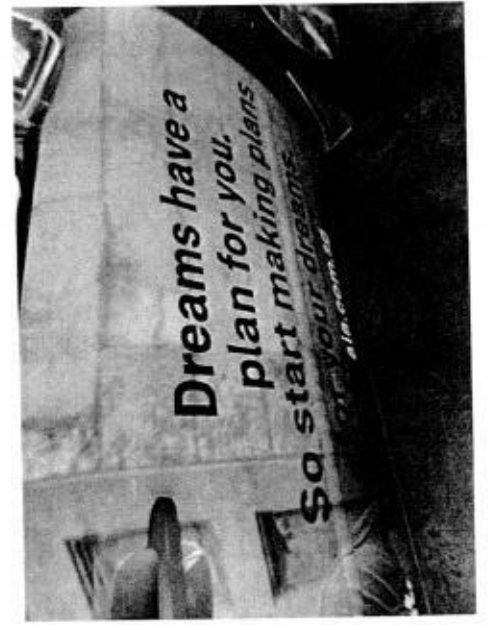
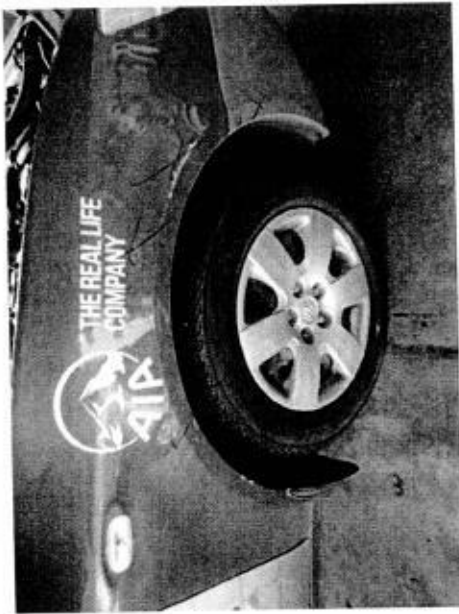
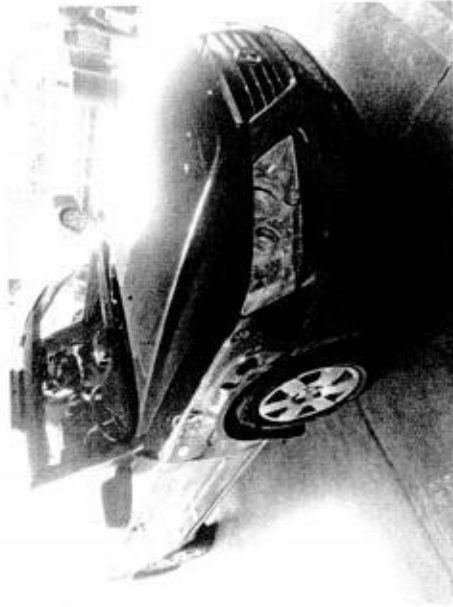
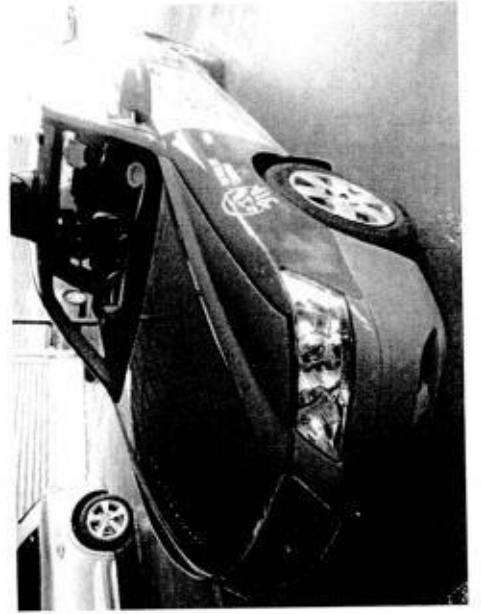
DAMAGES SEE DETAILS.			
<b>5. General Information</b>			
Accident Date	21/02/2018	Inspection Date	21/02/2018
Survey held at	COMFORTDELGRO ENGINEERING PTE LTD 59 LOYANG DRIVE SINGAPORE 508969		
<b>5a. Remarks</b>			
A)THE INSPECTION WAS CONDUCTED ON A"WITHOUT PREJUDICE" BASIS. B)IN ACCORDANCE TO YOUR INSTRUCTIONS, WE HAVE NOT AUTHORISED REPAIRS.			
<b>5b. Estimate Days of Repair</b>			
ESTIMATED NORMAL PERIOD FOR REPAIR:		2 Working Days

Qty	Description of Parts	Condition	Estimate By Workshop (\$)	Our Adjusted (\$)
<b>REPLACEMENT OF PARTS</b>				
1	FRONT FENDER (RH)	TO REPAIR	593.00	-
1	FRONT FENDER SHIELD (RH)	SERVICEABLE	86.00	-
1	FRONT FENDER RETAINER	SERVICEABLE	9.20	-
1	FRONT WHEEL HUB CAP (RH)	SERVICEABLE	145.00	-
	LESS 20% DISCOUNT		-166.64	-
			666.56	-
<b>SPECIAL NETT ITEMS</b>				
1	FRONT FENDER ADVERTISEMENT LOGO (RH)(SN)	NECESSARY	100.00	100.00
			100.00	100.00
<b>LABOUR</b>				
	THATCHAM STANDARD REPAIR TIME ON BODY WORKS.		680.00	200.00
	THATCHAM TTS STANDARD SPRAY PAINTING COST AND LABOUR.		450.00	360.00
			1,130.00	560.00
<b>GRAND TOTAL</b>			<b>1,896.56</b>	<b>660.00</b>
<b>RECOMMENDED COST OF REPAIRS (CONFIRMED)</b>				<b>660.00</b>
