ASSIGNMENT

NTUC INCOME INSURANCE CO-OPERATIVE LTD Ref: NS/INC18003670/K1vb

1. Policy Particulars :- THIRD PARTY CLAIM

ADJUSTMENT ON REPAIR COST FOR VEHICLE NO. SHA 4339Y

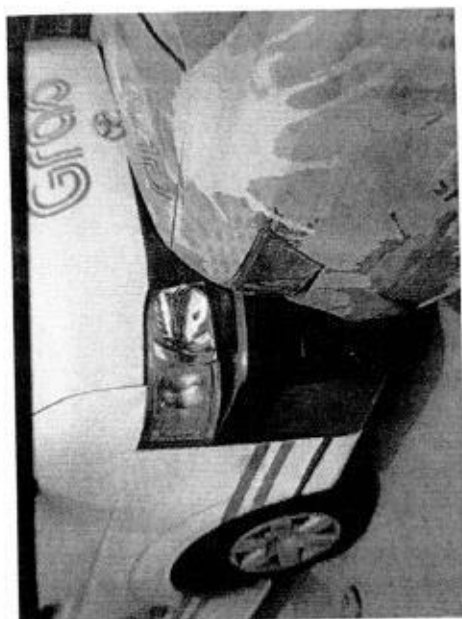
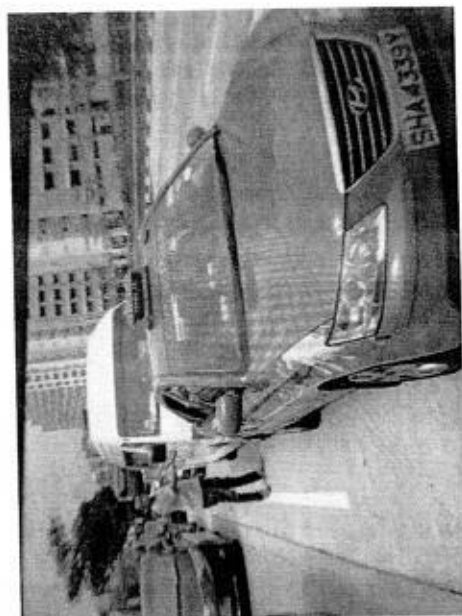
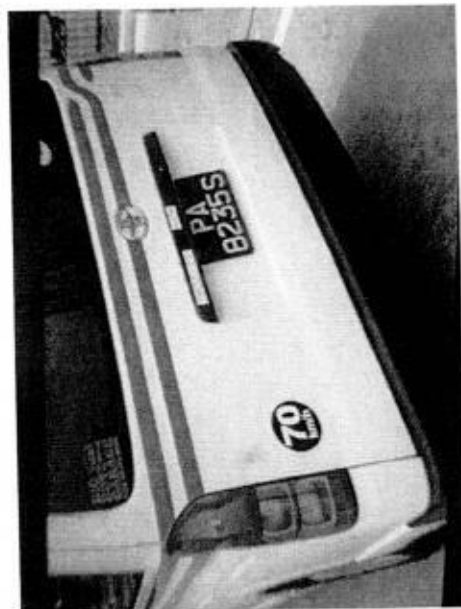
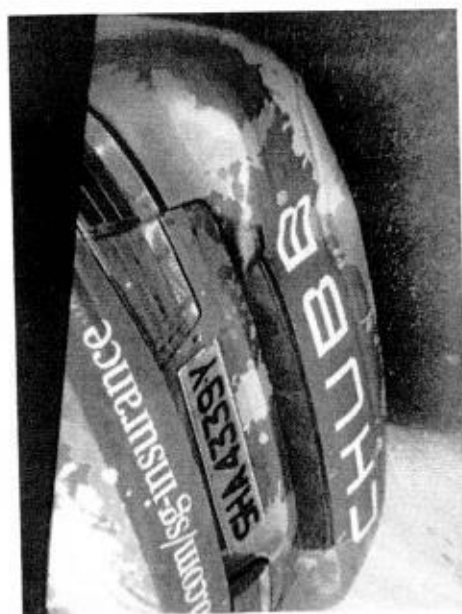
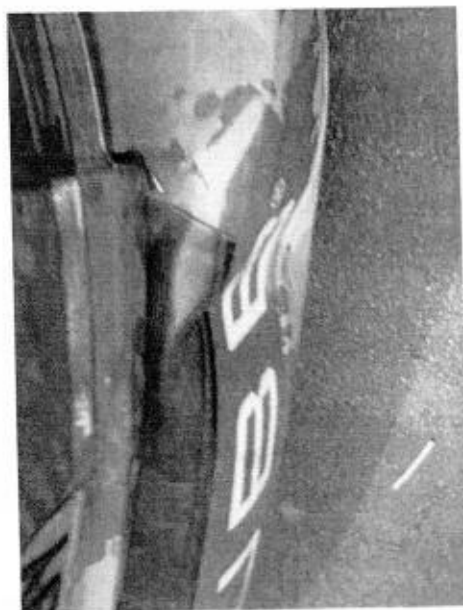
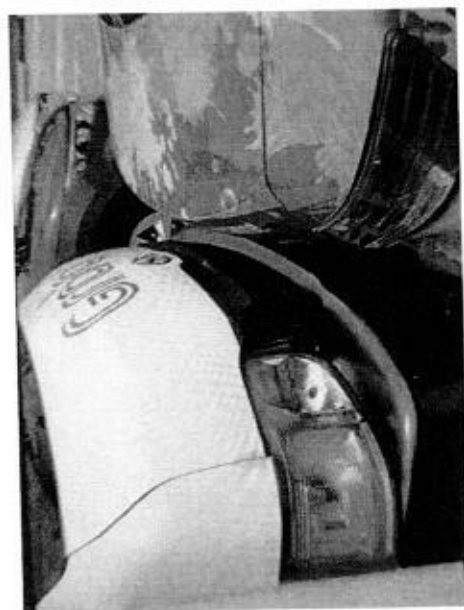
THE VEHICLE SUSTAINED DAMAGES AT THE REAR PORTION. DAMAGES SEE DETAILS.
--

Qty	Description of Parts	Condition	Estimate By Workshop (\$)	Our Adjusted (\$)
<u>REPLACEMENT OF PARTS</u>				
1	BOOT LID	DENTED	1,349.50	1,349.50
1	BOOT LID RUBBER	SERVICEABLE	110.90	-
1	BOOT LID LOCK UPPER	SERVICEABLE	132.10	-
1	BOOT LID LOCK LOWER	SERVICEABLE	30.30	-
1	BOOT LID SONATA PLATE	NECESSARY	43.60	43.60
1	BOOT LID HYUNDAI PLATE	NECESSARY	24.20	24.20
1	BOOT LID "H" EMBLEM	NECESSARY	26.10	26.10
1	BOOT LID CRDI PLATE	NECESSARY	22.70	22.70
2	BOOT LID LAMP (LH/RH) @\$230.20	SERVICEABLE	460.40	-
1	BOOT LID TRIMBOARD	SERVICEABLE	165.40	-
10	BOOT LID TRIMBOARD CLIPS	NOT NECESSARY	10.00	-
1	REAR BUMPER	DEFORMED	578.40	578.40
1	REAR BUMPER REINFORCEMENT	CRACKED	483.30	483.30
10	REAR BUMPER CLIP	NECESSARY	22.00	22.00
1	REAR BUMPER SPONGE	SERVICEABLE	137.40	-
1	REAR BUMPER UNDER COVER	SERVICEABLE	185.80	-
2	REAR BUMPER PROTECTOR (LH/RH) @\$38.00	TO REPAIR	76.00	-
2	TAIL LAMP (LH/RH) @\$344.00	SERVICEABLE	688.00	-

1	TAIL LAMP QUARTER PANEL (RH)	TO REPAIR	93.80	-
1	REAR PANEL	TO REPAIR	391.80	-
1	REAR PANEL GARNISH	SERVICEABLE	95.80	-
1	REAR RH FENDER (NPA)	TO REPAIR	-	-
	LESS 20% DISCOUNT		-1,025.50	-509.96
			4,102.00	2,039.84
<u>SPECIAL NETT ITEMS</u>				
1	BOOT LID COMFORT LOGO & TEL NO STICKER (SN)	NECESSARY	30.00	30.00
1	BOOT LID ADVERTISEMENT LOGO (SN)	NECESSARY	100.00	100.00
1	REAR BUMPER REVERSE SENSOR (SN)	SHORTED	135.70	135.70
1	REAR BUMPER ADVERTISEMENT LOGO (SN)	NECESSARY	50.00	50.00
1	REAR BUMPER RUBBER MAT (SN)	NECESSARY	50.00	50.00

Qty	Description of Parts	Condition	Estimate By Workshop (\$)	Our Adjusted (\$)
2	REAR FENDER ADVERTISEMENT LOGO (LH/RH) @\$100.00 (SN)	NECESSARY	200.00	200.00
1	REAR FENDER COMFORT STICKER (RH)(SN)	NECESSARY	30.00	30.00
			595.70	595.70
	LABOUR			
	THATCHAM STANDARD REPAIR TIME ON BODY WORKS.		1,170.00	620.00
	THATCHAM TTS STANDARD SPRAY PAINTING COST AND LABOUR.		850.00	740.00
			2,020.00	1,360.00
GRAND TOTAL			6,717.70	3,995.54
RECOMMENDED COST OF LUMP SUM REPAIRS (TO ITS PRE-ACCIDENT CONDITION) (CONFIRMED)				3,200.00
