1. Policy Particulars :- THIRD PARTY CLAIM

THE VEHICLE SUSTAINED DAMAGES AT THE O/S REAR PORTION. DAMAGES SEE DETAILS.
--

ADJUSTMENT ON REPAIR COST FOR VEHICLE NO. SHC 3372X

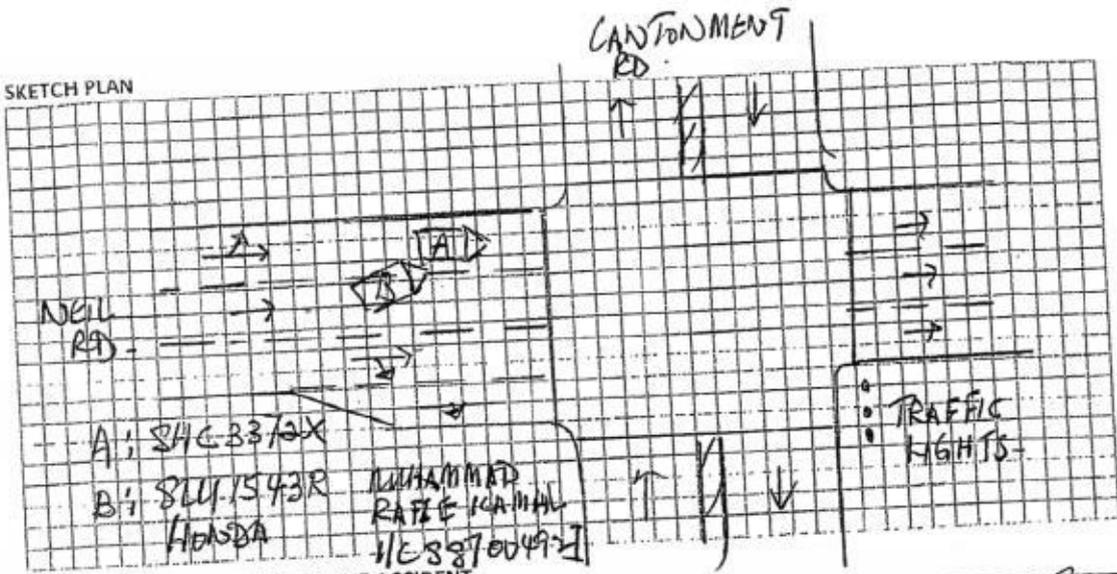
SKETCH PLAN

On 18/02/2018 at 0535hrs, I was travelling along Neil Road on the extreme left lane and the traffic light was green at the junction of Cantonment Road. As I was turning left, a car SLU1543R collided with the rear (right side bumper) of my taxi. The car was also turning left however I was not aware the car was there until the accident happen.

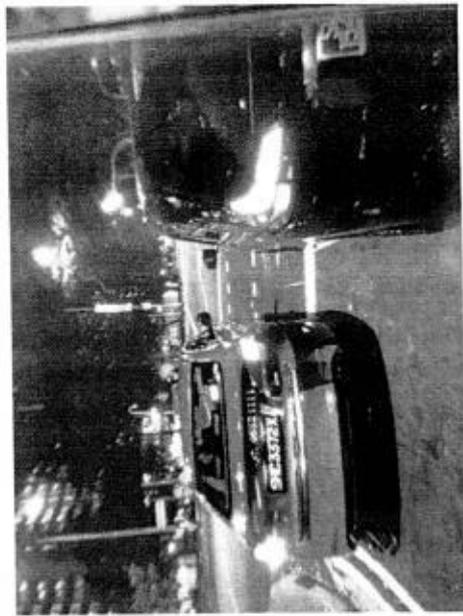
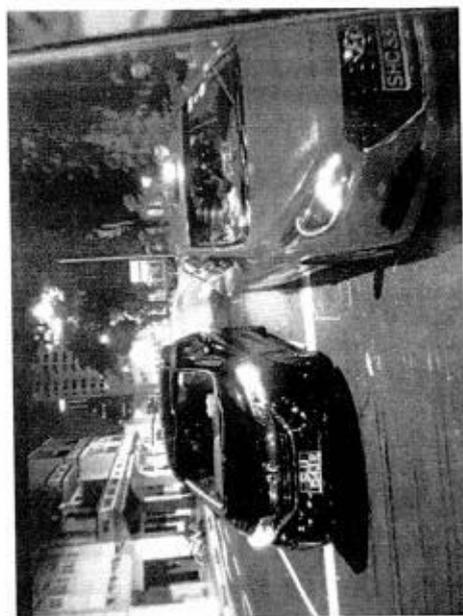
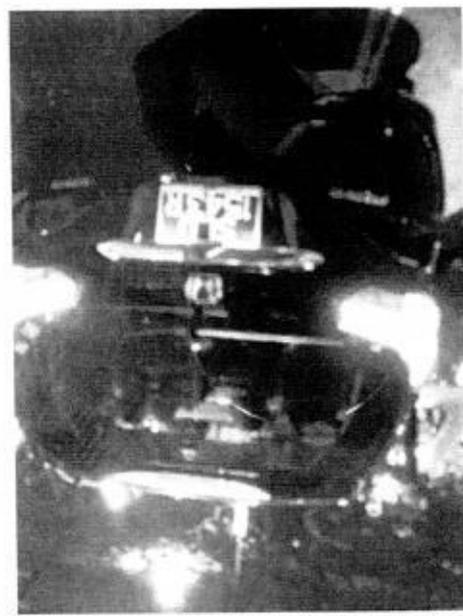
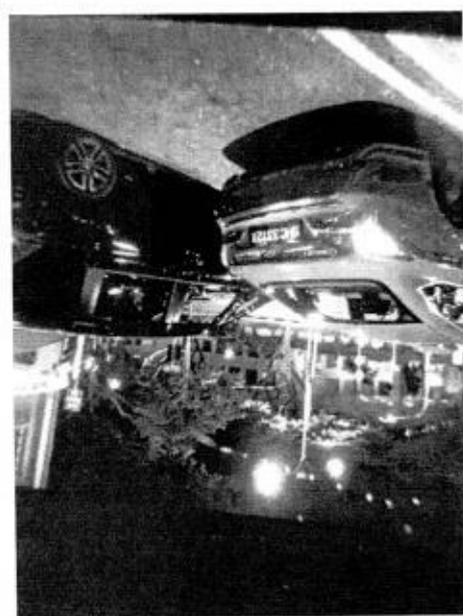
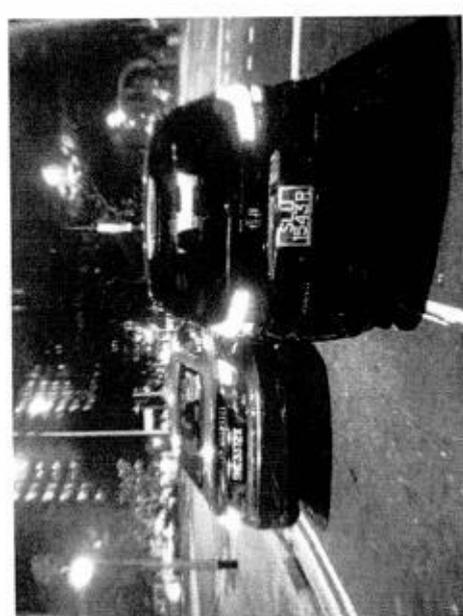
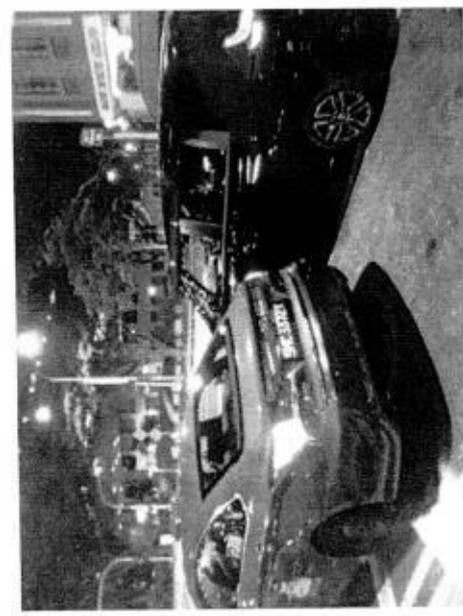
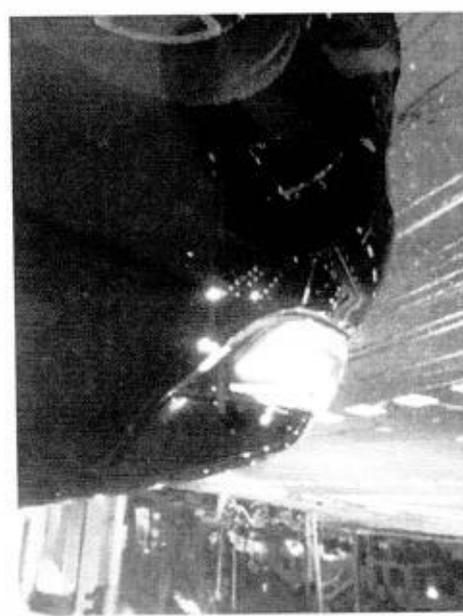
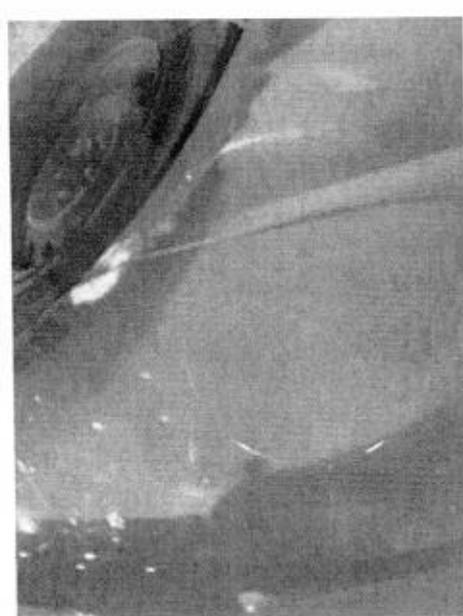
I and my passenger were not injured. I got out of my taxi and spoke to the driver of the other car. He and his passenger were also not injured. My taxi right rear bumper was scratched. I took the driver's particulars but strangely he did not take mine. He informed he wanted to settle the matter privately. As I was thinking about my passenger, I left the scene after taking the driver's particulars (without his contact number)

Qty	Description of Parts	Condition	Estimate By Workshop (\$)	Our Adjusted (\$)
REPLACEMENT OF PARTS				
1	REAR BUMPER	TO REPAIR	603.60	-
10	REAR BUMPER CLIPS	NOT NECESSARY	22.00	-
1	REAR FENDER (LH)	TO REPAIR	2,020.10	-
1	REAR FENDER INNER LINING (LH)	SERVICEABLE	164.40	-
1	REAR WINDSCREEN MOULDING	NOT NECESSARY	60.00	-
	LESS 20% DISCOUNT		-574.02	-
			2,296.08	-
SPECIAL NETT ITEMS				
1	REAR BUMPER RUBBER MAT (SN)	NOT NECESSARY	50.00	-
1	REAR WINDSCREEN SEALANT (SN)	NOT NECESSARY	46.00	-
			96.00	-
LABOUR				
	THATCHAM STANDARD REPAIR TIME ON BODY WORKS.		1,290.00	200.00
	THATCHAM TTS STANDARD SPRAY PAINTING COST AND LABOUR.		450.00	360.00
			1,740.00	560.00
GRAND TOTAL			4,132.08	560.00
RECOMMENDED COST OF REPAIRS (CONFIRMED)				560.00
