NTUC INCOME INSURANCE CO-OPERATIVE LTD Ref: NS/INC18003688/K1rb				
73 BRAS BASAH ROAD #05-01 NTUC TRADE UNION HOUSESINGAPORE 189556			Date: 26-02-2018	
			Code: INC4

1. Policy Particulars :- THIRD PARTY CLAIM

4. Description of Damages

ADJUSTMENT ON REPAIR COST FOR VEHICLE NO. SHD 4934M

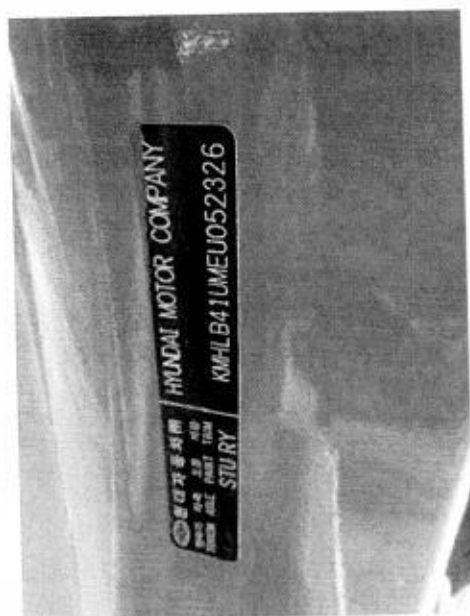
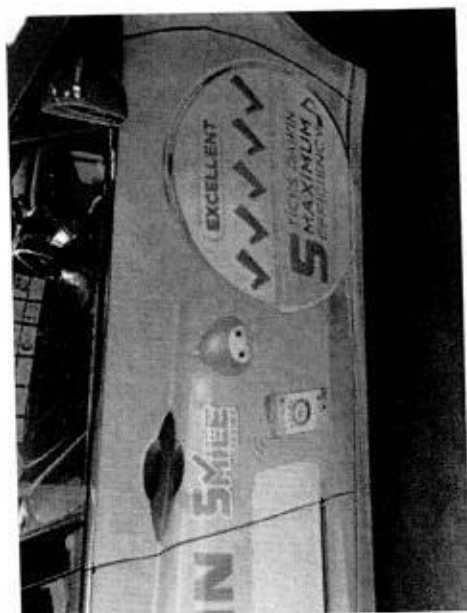
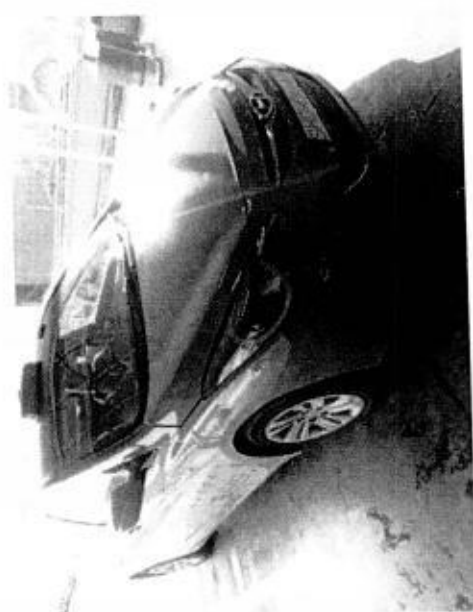
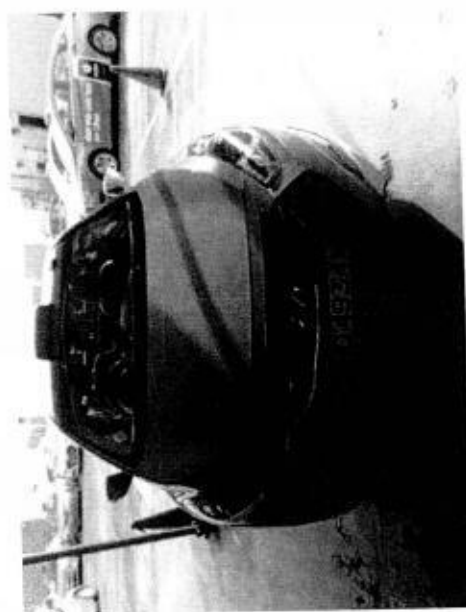
Front o/s

The U/C / Chassis frame / Body Structure affected due to collision.

THE VEHICLE SUSTAINED DAMAGES AT THE FRONT O/S PORTION. DAMAGES SEE DETAILS.

Qty	Description of Parts	Condition	Estimate By Workshop (\$)	Our Adjusted (\$)
REPLACEMENT OF PARTS				
1	FRONT BUMPER COVER	DEFORMED	562.30	562.30
1	FRONT BUMPER SPONGE	SERVICEABLE	142.20	-
1	FRONT BUMPER REINFORCEMENT	SERVICEABLE	526.10	-
1	FRONT BUMPER GRILLE (RH)	CUT	40.30	40.30
1	FRONT BUMPER BRACKET TOP (RH)	CRACKED	22.40	22.40
1	FRONT BUMPER RETAINER MOUNTING	SERVICEABLE	9.20	-
1	FRONT RH HEADLAMP	GRAZED	1,388.00	1,388.00
	LESS 20% DISCOUNT		-538.10	-402.60
			2,152.40	1,610.40
LABOUR				
	THATCHAM STANDARD REPAIR TIME ON BODY WORKS.		400.00	220.00
	THATCHAM TTS STANDARD SPRAY PAINTING COST AND LABOUR.		200.00	180.00
			600.00	400.00
GRAND TOTAL			2,752.40	2,010.40
RECOMMENDED COST OF LUMP SUM REPAIRS (TO ITS PRE-ACCIDENT CONDITION) (CONFIRMED)				1,600.00
