1. Policy Particulars :- THIRD PARTY CLAIM

Make & Model	HYUNDAI SONATA	c.c	1991
Engine No.	HIDDEN	Year of Reg.	2011
Chassis No.	KMHET41VMBA805968	Colour	BLUE
Odometer	465617	Steering	IN ORDER
Brakes	IN ORDER	Modification	STANDARD ALLOY RIM
General	FAIR

THE VEHICLE SUSTAINED DAMAGES AT THE FRONT PORTION. DAMAGES SEE DETAILS.

ADJUSTMENT ON REPAIR COST FOR VEHICLE NO. SH 8764J

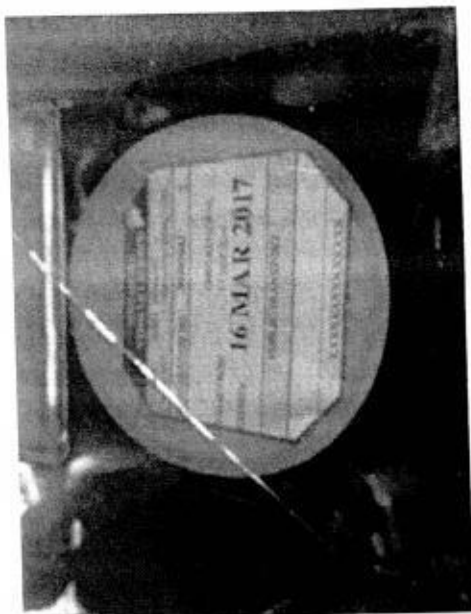
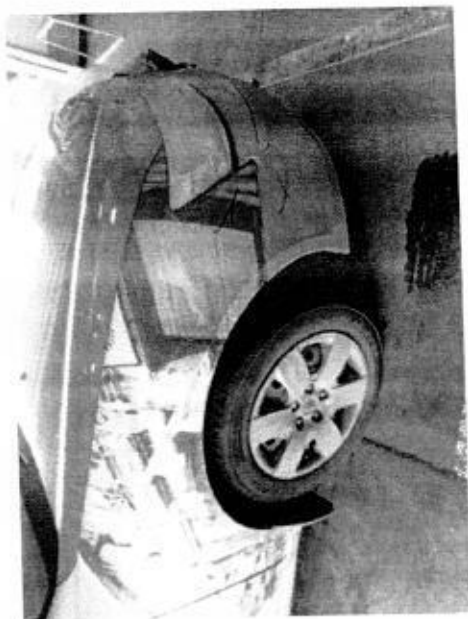
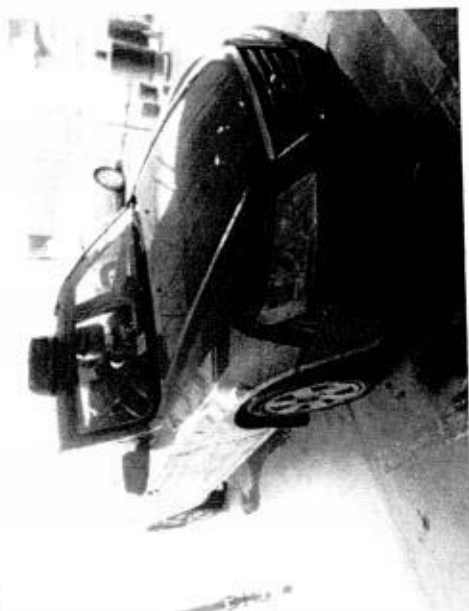
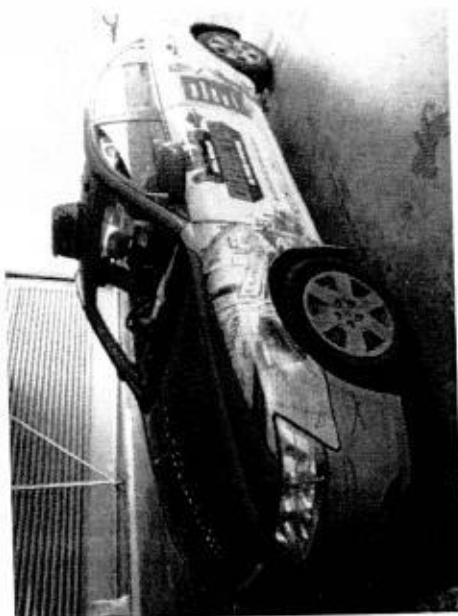
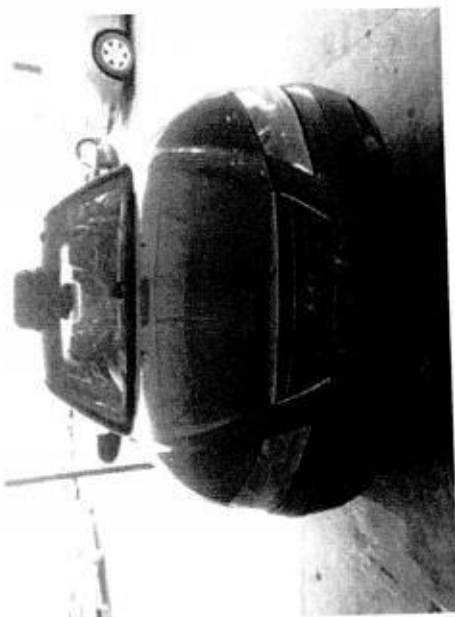
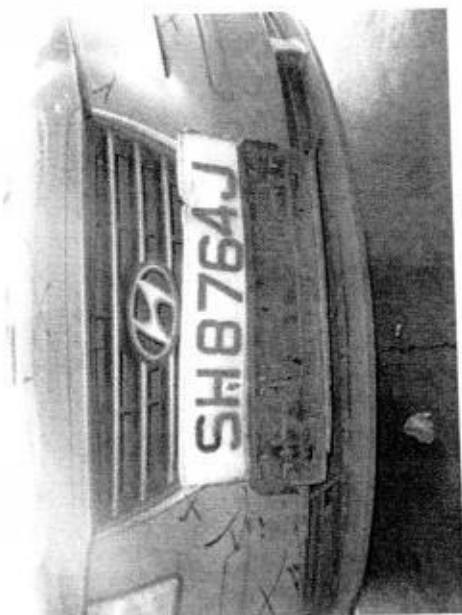
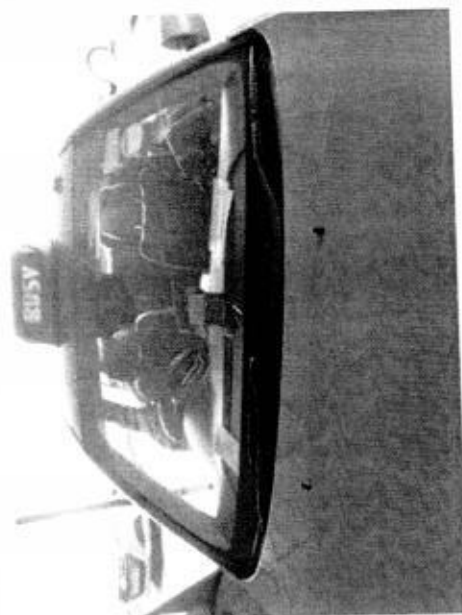
The U/C / Chassis frame / Body Structure affected due to collision.

Qty	Description of Parts	Condition	Estimate By Workshop (\$)	Our Adjusted (\$)
<u>REPLACEMENT OF PARTS</u>				
1	BONNET	DENTED	1,151.80	1,151.80
1	BONNET MOULDING	TO REPAIR	120.90	-
1	BONNET INSULATOR	SERVICEABLE	232.80	-
1	BONNET INSULATOR CLIPS	NOT NECESSARY	10.00	-
1	RADIATOR GRILLE	SERVICEABLE	282.10	-
1	RADIATOR GRILLE U MOULDING	SERVICEABLE	108.90	-
1	FRONT BUMPER COVER	DEFORMED	538.80	538.80
1	FRONT BUMPER SPONGE	SERVICEABLE	136.30	-
1	FRONT BUMPER REINFORCEMENT	SERVICEABLE	504.10	-
1	FRONT BUMPER CENTRE GRILLE	SERVICEABLE	131.10	-
1	FRONT BUMPER LIP	SERVICEABLE	59.90	-
2	FRONT BUMPER BRACKET TOP (LH/RH) @\$22.40	SERVICEABLE	44.80	-
2	FRONT BUMPER PROTECTOR (LH/RH) @\$29.20	SERVICEABLE	58.40	-
2	FRONT BUMPER BRACKET (LH/RH) @\$20.10	SERVICEABLE	40.20	-
2	HEADLAMP (LH/RH) @\$797.90	O/S CRACKED / N/S SERVICEABLE	1,595.80	797.90
1	FRONT WINDSCREEN GLASS	CRACKED	1,015.00	1,015.00
1	FRONT WINDSCREEN MOULDING	NOT NECESSARY	60.00	-

Qty	Description of Parts	Condition	Estimate By Workshop (\$)	Our Adjusted (\$)
	THATCHAM TTS STANDARD SPRAY PAINTING COST AND LABOUR.		600.00	360.00
			1,460.00	880.00
GRAND TOTAL			6,563.72	3,737.80
RECOMMENDED COST OF LUMP SUM REPAIRS (TO ITS PRE-ACCIDENT CONDITION) (CONFIRMED)				2,800.00
