(08/11/13)

1. Policy Particulars :- THIRD PARTY CLAIM

4. Description of Damages

ADJUSTMENT ON REPAIR COST FOR VEHICLE NO. SHB 4346X

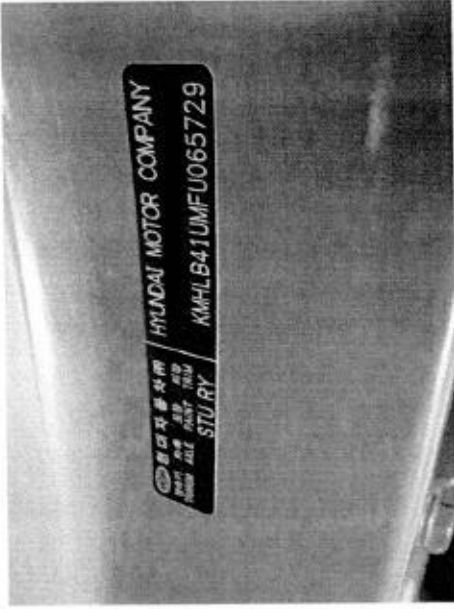
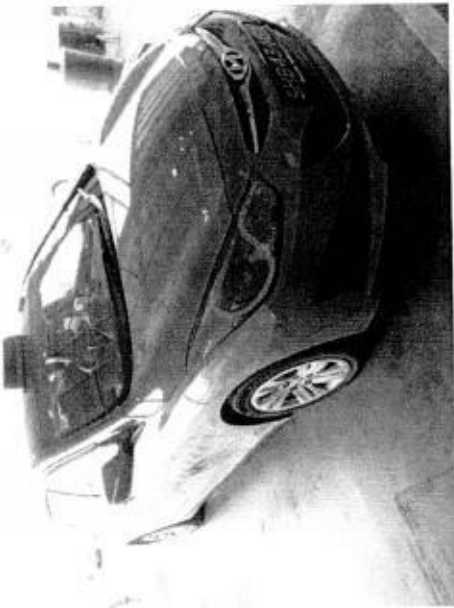
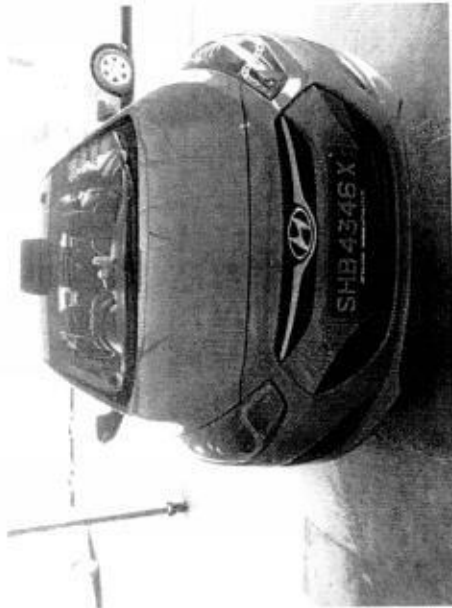
Suddenly a black Toyota car SKR659A coming from my right cut into my lane across the Chervon Lines towards the slip road in a careless manner. As a result of this, the left hand side front of the car hit and grazed the right hand side front and right hand side front door of my taxi thus damaging them in the process.

4. Description of Damages				
THE VEHICLE SUSTAINED DAMAGES AT THE O/S BODY.				
DAMAGES SEE DETAILS.				
5. General Information				
Accident Date	23/02/2018	Inspection Date	26/02/2018	
Survey held at	COMFORTDELGRO ENGINEERING PTE LTD			
	59 LOYANG DRIVE			
	SINGAPORE 508969			
5a. Remarks				
A)THE INSPECTION WAS CONDUCTED ON A"WITHOUT PREJUDICE" BASIS.				
B)IN ACCORDANCE TO YOUR INSTRUCTIONS, WE HAVE NOT AUTHORISED REPAIRS.				
5b. Estimate Days of Repair				
ESTIMATED NORMAL PERIOD FOR REPAIR:		2 Working Days

Qty	Description of Parts	Condition	Estimate By Workshop (\$)	Our Adjusted (\$)
REPLACEMENT OF PARTS				
1	FRONT DOOR (RH)	DENTED	1,403.00	1,403.00
1	FRONT FENDER (RH)(NPA)	TO REPAIR	-	-
	LESS 20% DISCOUNT		-280.60	-280.60
			1,122.40	1,122.40
NETT ITEMS				
1	FRONT DOOR COMFORT LOGO (RH)(N)	NECESSARY	75.00	75.00
	LESS 10% DISCOUNT		-	-7.50
			75.00	67.50
SPECIAL NETT ITEMS				
1	FRONT FENDER ADVERTISEMENT LOGO (RH)(SN)	NOT NECESSARY	100.00	-
1	FRONT DOOR ADVERTISEMENT LOGO (RH)(SN)	NECESSARY	100.00	100.00
			200.00	100.00
LABOUR				
	THATCHAM STANDARD REPAIR TIME ON BODY WORKS.		470.00	150.00
	THATCHAM TTS STANDARD SPRAY PAINTING COST AND LABOUR.		450.00	380.00
			920.00	530.00
GRAND TOTAL			2,317.40	1,819.90
RECOMMENDED COST OF LUMP SUM REPAIRS (TO ITS PRE-ACCIDENT CONDITION) (CONFIRMED)				1,400.00
