Survey Kolvin

REF: NS/TNC18003773/KHbn2

TP Claims against NTUC Income: Follow-Through Survey

## ADJUSTMENT ON REPAIR COST FOR VEHICLE NO. SHC 890L

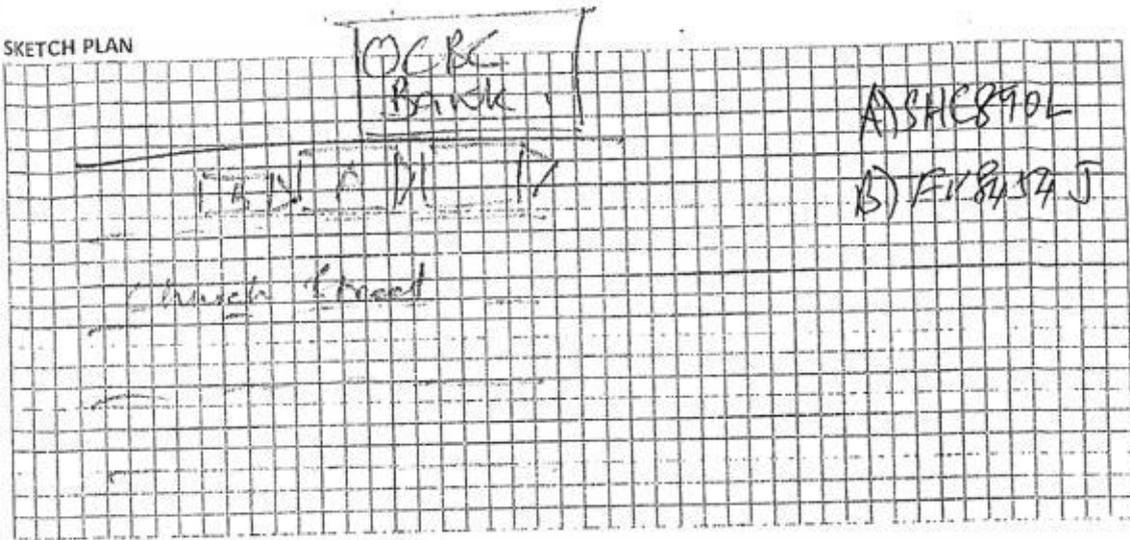
SKETCH PLAN

On 22/2/18 at about 09:30hrs while I Veh A gradually slowed down because a vehicle stopped in front to alight a passenger. Veh B collided on the right rear portion of my stationary vehicle.

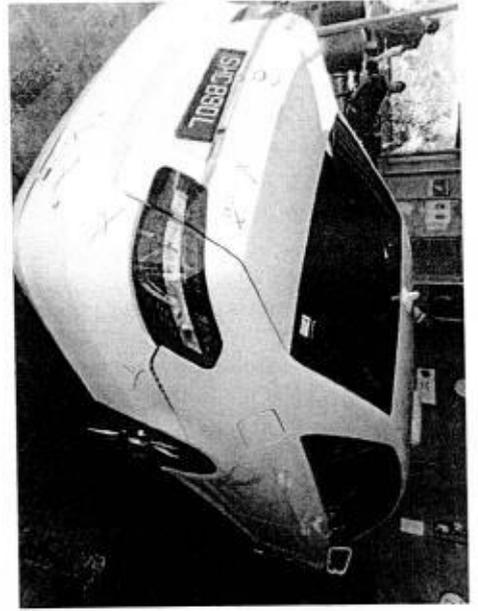
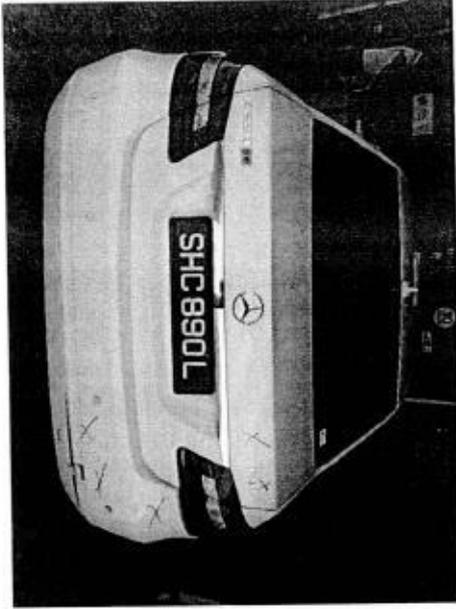
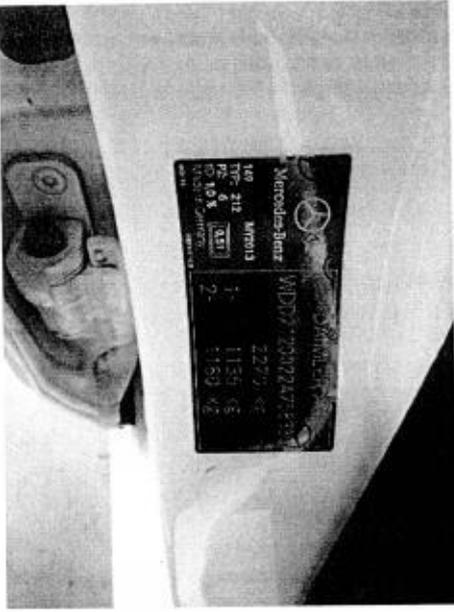
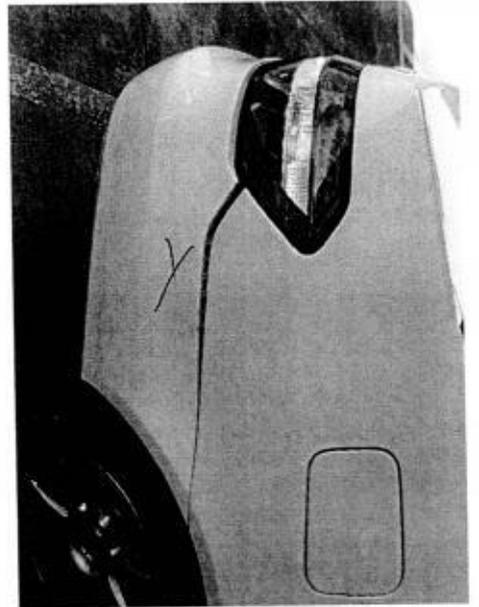
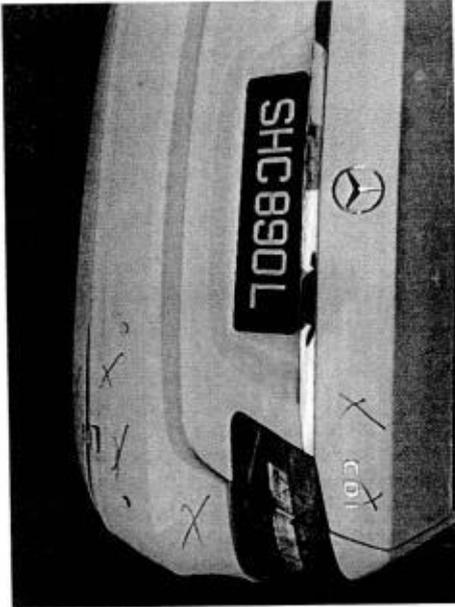
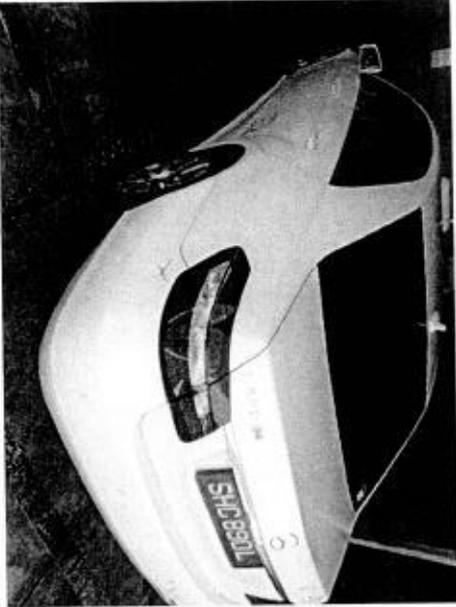
Veh No: SHC 890L Yr Regn: 25J4 23  
 Type: M.Car / M.Cycle / Bus / Van / Lorry / T/O / Prime Mover /  
 Truck / Trailer or \_\_\_\_\_  
 Make: Mercedes Benz E220 cc 2143  
 Colour: white A/C: Ins ed / Std / NI / NA  
 Sp. Reading: 7 2223 T/Radio: Ins ed / Std / NI / NA  
 Eng/No: \_\_\_\_\_  
 C/No: WPD2120022A 758330  
 Gen. Cond: Good / air / Poor / Burnt  
 Steering: In ok / Jammed / Leaked / Burnt or \_\_\_\_\_  
 Brake: In ok / Jammed / Leaked / Burnt or \_\_\_\_\_  
 Modi: Nil / S/Rim / STD / Rim or \_\_\_\_\_  
 Tyre Size: F: 205/60R16  
 R: \_\_\_\_\_  
89 / DUN / EXNOVA / GY / FS / LIZA / MIC / OHTSU / PIR / SUMI /  
 TOYO / YOKO or \_\_\_\_\_  
 Front \_\_\_\_\_ Rear \_\_\_\_\_  
 R/Bal. 7 mm R/Bal. 7 mm  
 L/Bal. 7 mm L/Bal. 7 mm  
 D.O.A. 22/2/8 D.O.I. 23/2/8  
 Survey held at COBE (Klang)  
 Des. of Damages: Frt / Rear / O/S / N/S / U/C / Rooftop or \_\_\_\_\_  
Rear o/s  
 The U/C / Chassis frame / Body Structure affected due to collision.

Code: INC4			
<b>1. Policy Particulars :- THIRD PARTY CLAIM</b>			
Insured Veh.	FV 8454J	Veh. Inspected	SHC 890L
Policy No.	5097760252	Coverage (\$)	0.00
Claim No.	MT/0983670-002	Excess (\$)	0.00
Assign From		Assign Date	23/02/2018
<b>2. Vehicle Particulars &amp; Condition</b>			
Make & Model	MERCEDES BENZ E220	c.c	2143
Engine No.	HIDDEN	Year of Reg.	2013
Chassis No.	WDD2120022A758330	Colour	WHITE
Odometer	722223	Steering	IN ORDER
Brakes	IN ORDER	Modification	STANDARD ALLOY RIM
General	FAIR		
<b>3. Conditions of Tyres</b>			
	Size	Make	Balance
R/H Front Tyre	205/60 R16	BRIDGESTONE	7 mm
L/H Front Tyre	205/60 R16	BRIDGESTONE	7 mm
R/H Rear Tyre	205/60 R16	BRIDGESTONE	7 mm
L/H Rear Tyre	205/60 R16	BRIDGESTONE	7 mm
<b>4. Description of Damages</b>			
THE VEHICLE SUSTAINED DAMAGES AT THE REAR O/S PORTION. DAMAGES SEE DETAILS.

<b>RECOMMENDED COST OF LUMP SUM REPAIRS (TO ITS PRE-ACCIDENT CONDITION) (CONFIRMED)</b>			<b>3,250.00</b>
---	--	--	-----------------
