# National Assessment Centre Services

# Survey Department Check List (Case Handler)

### 4. Description of Damages

**ADJUSTMENT ON REPAIR COST FOR VEHICLE NO. SHA 2563D**

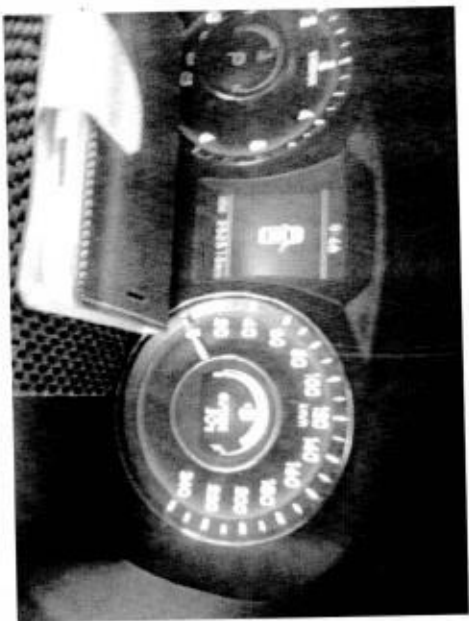
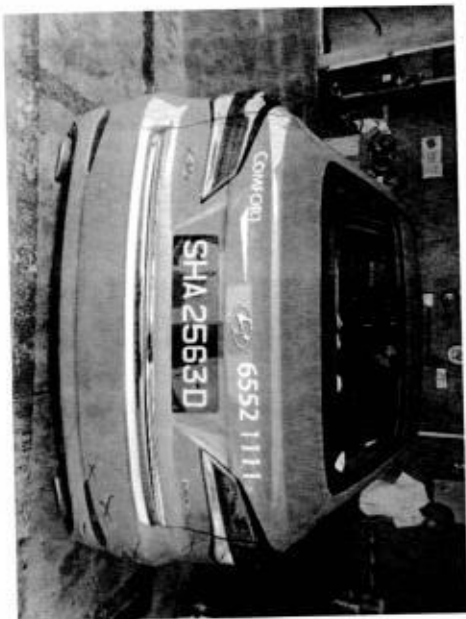
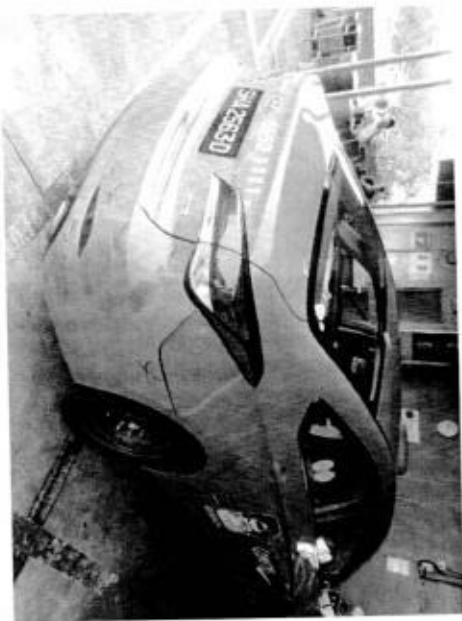
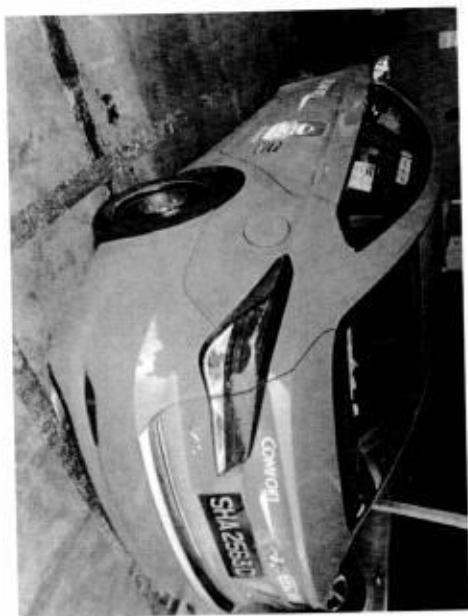
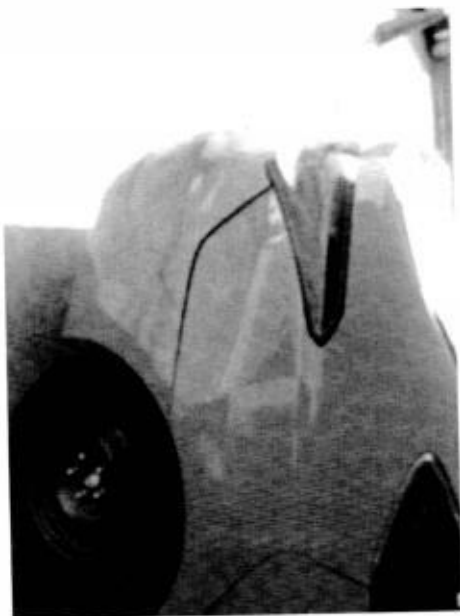
THE VEHICLE SUSTAINED DAMAGES AT THE REAR O/S PORTION. DAMAGES SEE DETAILS.
--

Qty	Description of Parts	Condition	Estimate By Workshop (\$)	Our Adjusted (\$)
<b><u>REPLACEMENT OF PARTS</u></b>				
1	REAR BUMPER	DEFORMED	603.60	603.60
1	REAR BUMPER REINFORCEMENT	SERVICEABLE	504.35	-
2	REAR BUMPER REINFORCEMENT BRACKET (LH/RH) @\$180.00	SERVICEABLE	360.00	-
1	REAR BUMPER SIDE BRACKET	SERVICEABLE	49.00	-
10	REAR BUMPER CLIPS	NECESSARY	22.00	22.00
1	REAR BUMPER SPONGE	SERVICEABLE	143.40	-
1	REAR BUMPER UNDER COVER	SERVICEABLE	225.00	-
1	REAR BUMPER REFLECTOR LAMP (RH)	CRACKED	32.00	32.00
1	TAIL LAMP (RH)	CRACKED	565.60	545.90
	LESS 20% DISCOUNT		-500.99	-240.70
			2,003.96	962.80
<b><u>SPECIAL NETT ITEMS</u></b>				
1	REAR BUMPER REVERSE SENSOR (SN)	NOT NECESSARY	135.70	-
1	REAR BUMPER I40 PLATE (SN)	NECESSARY	50.00	50.00

185.70	50.00
<b><u>LABOUR</u></b>				
	THATCHAM STANDARD REPAIR TIME ON BODY WORKS.		550.00	220.00
	THATCHAM TTS STANDARD SPRAY PAINTING COST AND LABOUR.		200.00	180.00
