**1. Policy Particulars :- THIRD PARTY CLAIM**

**4. Description of Damages**

THE VEHICLE SUSTAINED DAMAGES AT THE REAR O/S PORTION. DAMAGES SEE DETAILS.
--

**ADJUSTMENT ON REPAIR COST FOR VEHICLE NO. SHC 8332D**

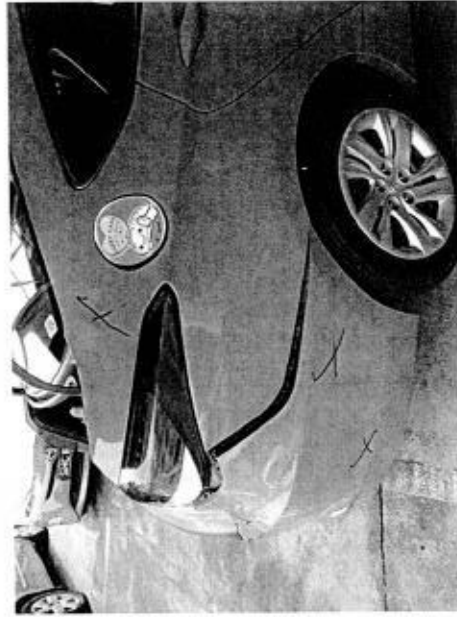
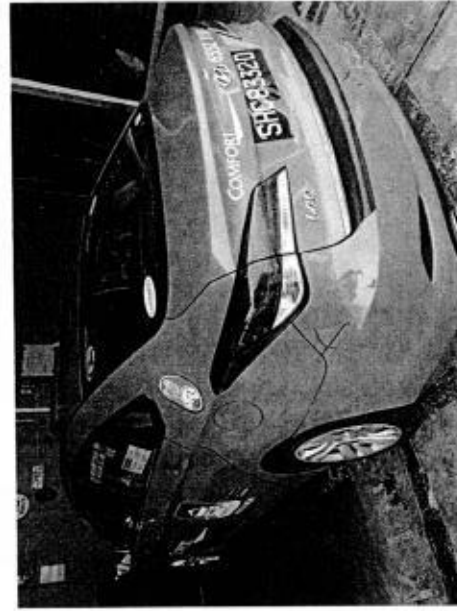
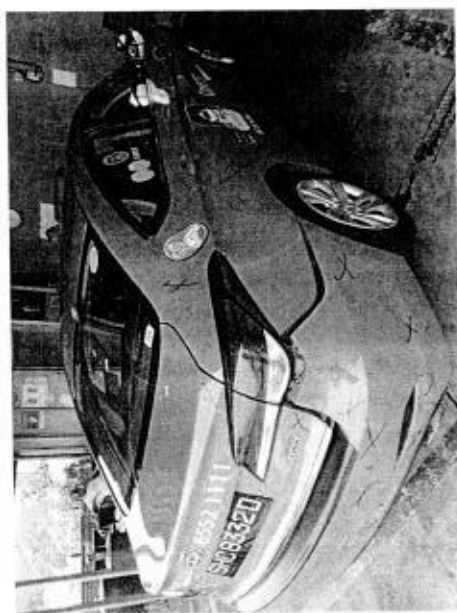
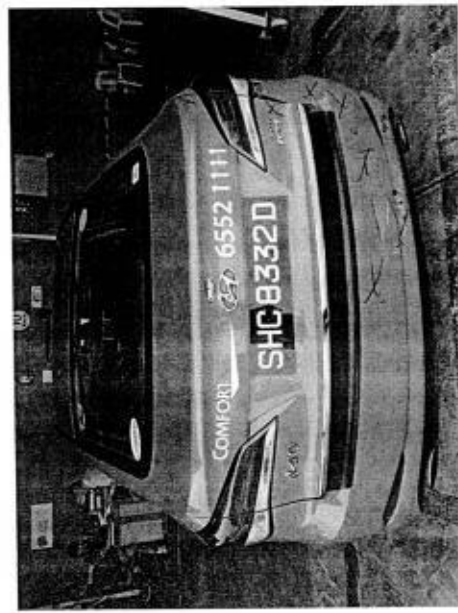
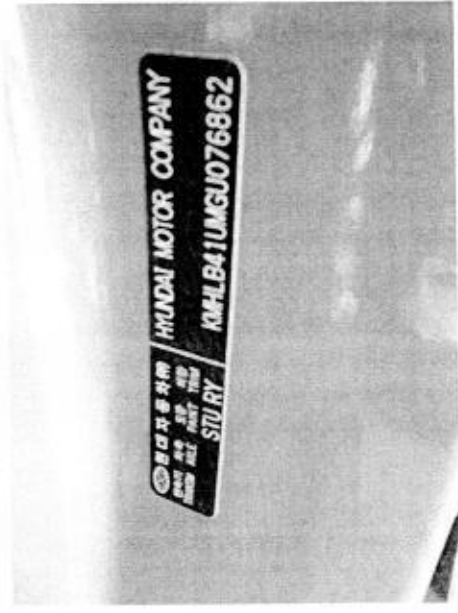
Qty	Description of Parts	Condition	Estimate By Workshop (\$)	Our Adjusted (\$)
<b><u>REPLACEMENT OF PARTS</u></b>				
1	BOOT LID	SERVICEABLE	1,681.40	-
1	BOOT LID RUBBER	SERVICEABLE	115.80	-
1	BOOT LID LOCK UPPER	SERVICEABLE	137.90	-
1	BOOT LID LOCK LOWER	SERVICEABLE	31.70	-
1	BOOT LID "H" EMBLEM	NOT NECESSARY	27.20	-
1	BOOT LID CRDI PLATE	NOT NECESSARY	41.00	-
1	BOOTLID MOULDING	SERVICEABLE	85.00	-
1	BOOTLID I40 EMBLEM	NOT NECESSARY	41.00	-
1	BOOTLID LOWER GARNISH	SERVICEABLE	398.00	-
1	REAR BUMPER	DEFORMED	603.60	603.60
1	REAR BUMPER REINFORCEMENT	SERVICEABLE	504.35	-
2	REAR BUMPER REINFORCEMENT BRACKET (LH/RH) @\$180.00	O/S BENT / N/S SERVICEABLE	360.00	180.00
2	REAR BUMPER SIDE BRACKET @\$49.00	SERVICEABLE	98.00	-
10	REAR BUMPER CLIPS	NECESSARY	22.00	22.00
1	REAR BUMPER SPONGE	TORN	143.40	143.40
1	REAR BUMPER UNDER COVER	CRACKED	225.00	225.00
1	REAR BUMPER REFLECTOR LAMP (RH)	CRACKED	32.00	32.00
1	EXHAUST PIPE INSULATOR,RH	SERVICEABLE	58.55	-

1	EXHAUST SILENCER,RH	BENT	954.00	954.00
1	EXHAUST PIPE HANGER,RH	SERVICEABLE	58.55	-
1	EXHAUST PIPE CENTRE	SERVICEABLE	1,150.30	-
1	REAR FENDER (RH)	TO REPAIR	2,020.10	-
1	REAR FENDER INNER LINING (RH)	SERVICEABLE	164.40	-
1	REAR WINDSCREEN MOULDING	NOT NECESSARY	60.00	-
	LESS 20% DISCOUNT		-1,802.65	-432.00
			7,210.60	1,728.00
<b><u>SPECIAL NETT ITEMS</u></b>				
1	BOOT LID COMFORT LOGO & TEL NO STICKER (SN)	NOT NECESSARY	30.00	-
1	REAR BUMPER REVERSE SENSOR (SN)	SHORTED	135.70	135.70

Qty	Description of Parts	Condition	Estimate By Workshop (\$)	Our Adjusted (\$)
1	REAR BUMPER RUBBER MAT (SN)	NECESSARY	50.00	50.00
1	REAR WINDSCREEN SEALANT (SN)	NOT NECESSARY	46.00	-
			261.70	185.70
	<b>LABOUR</b>			
	THATCHAM STANDARD REPAIR TIME ON BODY WORKS.		1,790.00	450.00
	THATCHAM TTS STANDARD SPRAY PAINTING COST AND LABOUR.		650.00	360.00
			2,440.00	810.00
	<b>GRAND TOTAL</b>		<b>9,912.30</b>	<b>2,723.70</b>
<b>RECOMMENDED COST OF LUMP SUM REPAIRS (TO ITS PRE-ACCIDENT CONDITION) (CONFIRMED)</b>				<b>2,150.00</b>
