Affiliated to Federation Internationale Des Experts En Automobile				
MSIG INSURANCE (SINGAPORE) PTE LTD		Ref : CS/MSG18003913/T1vb		
16 RAFFLES QUAY #24-01 HONG LEONG BLDG SINGAPORE 048581		Date : 28-02-2018		 
		Code : MSG

To: MSIG Insurance (Singapore) Pte. Ltd. 4 Shenton Way #21-01 SGX Centre 2 Singapore 068807	From: LKK Auto Consultants Pte Ltd 51 Ubi Ave 1 #01-25 Paya Ubi Industrial Park Singapore 408933
Attn: Joslin Lim	Date: 01 Mar 2018
Preliminary Advice

Vehicle No	: SKN2595H	Accident Date	: 25/02/2018
Make	: VOLKSWAGEN JETTA	Policy No.	: A80430752AVW
Assignment Date	: 28/02/2018	Excess	: S\$500.00
Date of Inspection	: 28/02/2018	Est. Duration of Repair	: 0.00
Inspection At	VOLKSWAGEN CENTRE SINGAPORE - TUAS (HQ) 17 TUAS AVE 9 SINGAPORE 639197

VEHICLE DAMAGE INSPECTION REPORT

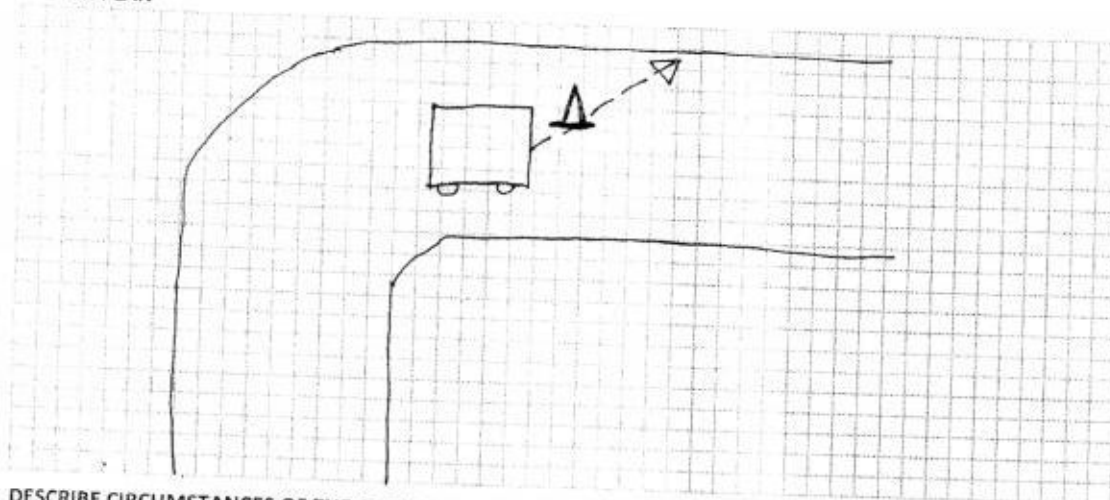
SKETCH PLAN

As I was exiting the basement carpark of Shermood Condominium on Sunday, 25 Feb, at 6:15pm, I saw a pylon in the middle of the driveway. The pylon had not been there before. ~~I was~~ In order to avoid the pylon, I swerved and I hit the wall of the driveway. (Please refer to In-car camera footage for the details.) The weather at that time was fair and visibility was clear.
