NTUC INCOME INSURANCE CO-OPERATIVE LTD Ref: NS/INC18004360/Svb

1. Policy Particulars - THIRD PARTY CLAIM

4. Description of Damages				
THE VEHICLE SUSTAINED DAMAGES AT THE O/S FRONT PORTION. DAMAGES SEE DETAILS.				
5. General Information				
Accident Date	23/02/2018	Inspection Date	05/03/2018	
Survey held at	SMRT AUTOMOTIVE SERVICES PTE LTD 60 WOODLANDS INDUSTRIAL PARK E4 SINGAPORE 757705			
5a. Remarks				
A)THE INSPECTION WAS CONDUCTED ON A "WITHOUT PREJUDICE" BASIS. B)IN ACCORDANCE TO YOUR INSTRUCTIONS, WE HAVE NOT AUTHORISED REPAIRS.				
5b. Estimate Days of Repair				
ESTIMATED NORMAL PERIOD FOR REPAIR:		2 Working Days

ADJUSTMENT ON REPAIR COST FOR VEHICLE NO. SMB 108J

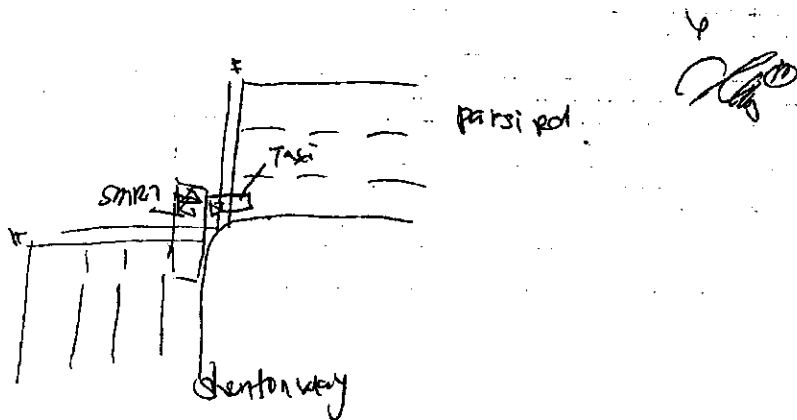
SKETCH PLAN

Bus was crossing the junction of Shenton Way, one taxi that exited from Parsi Rd failed to observe for oncoming traffic had collided into the right front of the bus. For the alleged accident nobody was injured.

As per the bus report.

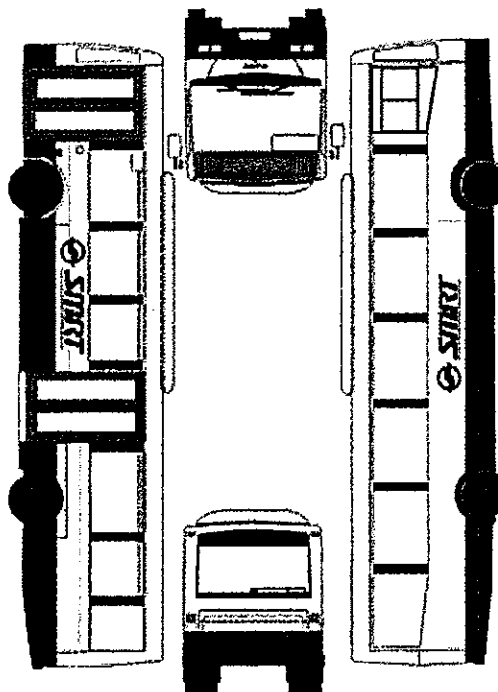
SMB108J - RIGHT FRONT PORTION
SHD2286M (TP) - PRIME TAXI. INSURED WITH NTUC
Prepared Date : 01/03/2018 09:40:40 AM

Job Scope	Quotation from ARC	Adjusted by Surveyor, if applicable
TO REMOVE & INSTALL ALL ABOVE ITEMS AND REPAIR OTHERS DAMAGED AFFECTED AREAS.	1,325.00	795.00 /
Total Labour	1,325.00	795.00

Job Scope	Quotation from ARC	Adjusted by Surveyor, if applicable
PROVIDE LABOUR AND MATERIAL TO PUTTY AND RESPRAY ABOVE REPAIR ITEMS	616.00	528.00 /
Total Spray Painting & Panel Beating	616.00	528.00

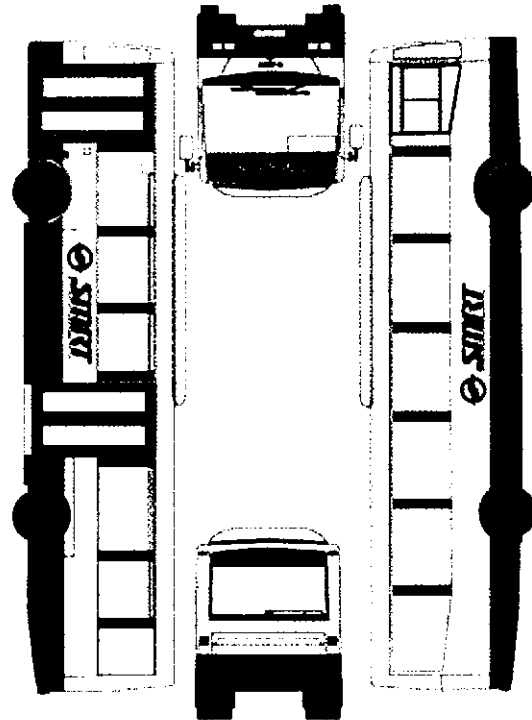
Reg. No : SMB108J
 Ref. No : BUS/02/18/5028
 Reg. Date : 01/03/2018
 Vehicle Type : BUS -12M
 Make : MBOC500 (MERCEDES)
 Model : MERCEDES MBOC500
 Name of Driver : Mohd Haszreen Bin Razali
 Type of Accident : SIDE SWIPE
 Date / Time of Accident : 23/02/2018 09:00:00 AM
 Accident Reported Date / Time : 26/02/2018 12:00:00 AM
 Surveyor is Required? : Yes
 Survey by : IDAC
 Vehicle is Towed Back? : No
 Towed Back Date/Time :
 Replacement Vehicle issued? : No
 Accident Repair Job Card No :
 Special Instruction to ARC,if any :
 SMB108J - RIGHT FRONT PORTION
 SHD2286M (TP) - PRIME TAXI. INSURED WITH NTUC
 Prepared Date : 01/03/2018 09:40:40 AM

Job Scope	Quotation from ARC	Adjusted by Surveyor, if applicable
TO REMOVE & INSTALL ALL ABOVE ITEMS AND REPAIR OTHERS DAMAGED AFFECTED AREAS.	1,325.00	795.00
Total Labour	1,325.00	795.00

Job Scope	Quotation from ARC	Adjusted by Surveyor, if applicable
PROVIDE LABOUR AND MATERIAL TO PUTTY AND RESPRAY ABOVE REPAIR ITEMS	616.00	528.00
Total Spray Painting & Panel Beating	616.00	528.00
