INVESTIGATION REPORT:

Our Ref : CI/AIG18004450/N
Claim No : 7900170904SG
Insured : SGD 696M
Date of Accident : 7 January 2018
Location : Woodlands Road turning right into Senja Way

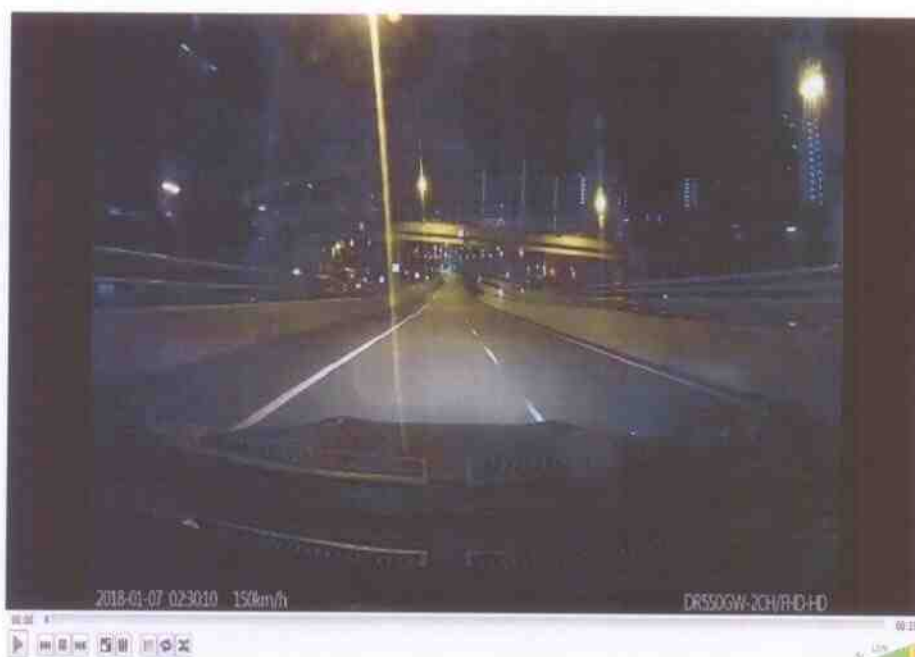
Screenshot 1 of the video recording from the video recording device that was mounted onto the front windscreen of the Insured Vehicle shows Mr Chee driving the Insured Vehicle along the 2nd lane of Woodlands Road.

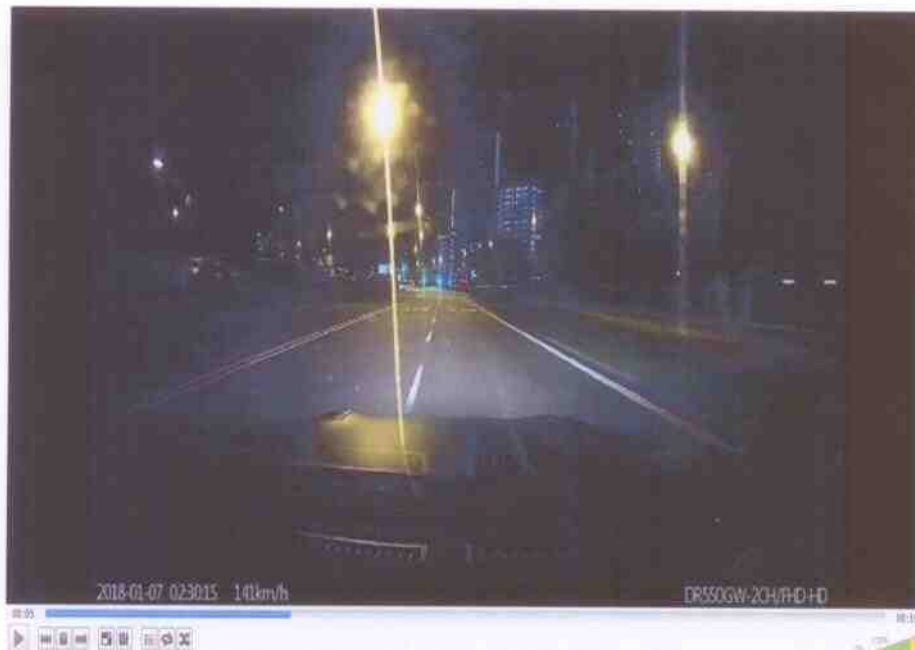
Screenshot 2 of the video recording from the video recording device that was mounted onto the front windscreen of the Insured Vehicle shows Mr Chee gradually switching to the 1st lane along Woodlands Road.

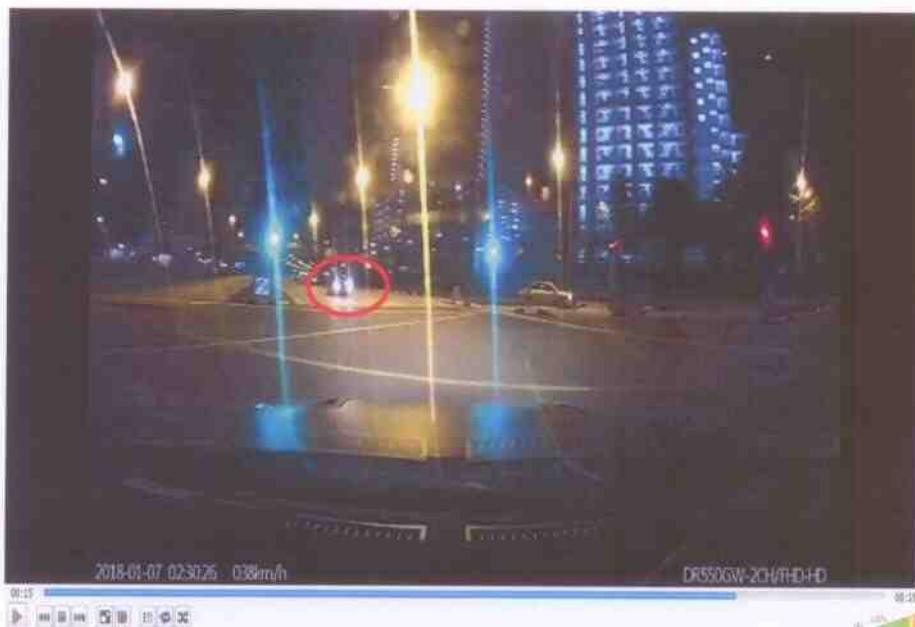
Screenshot 3 of the video recording from the video recording device that was mounted onto the front windscreen of the Insured Vehicle shows Mr Chee slowing down at the right- turn pocket of the T- junction of Woodlands Road and Senja Way. At the 15- second mark of the video recording, Mr Chee proceeded to turn right even though there was an approaching vehicle (circled).

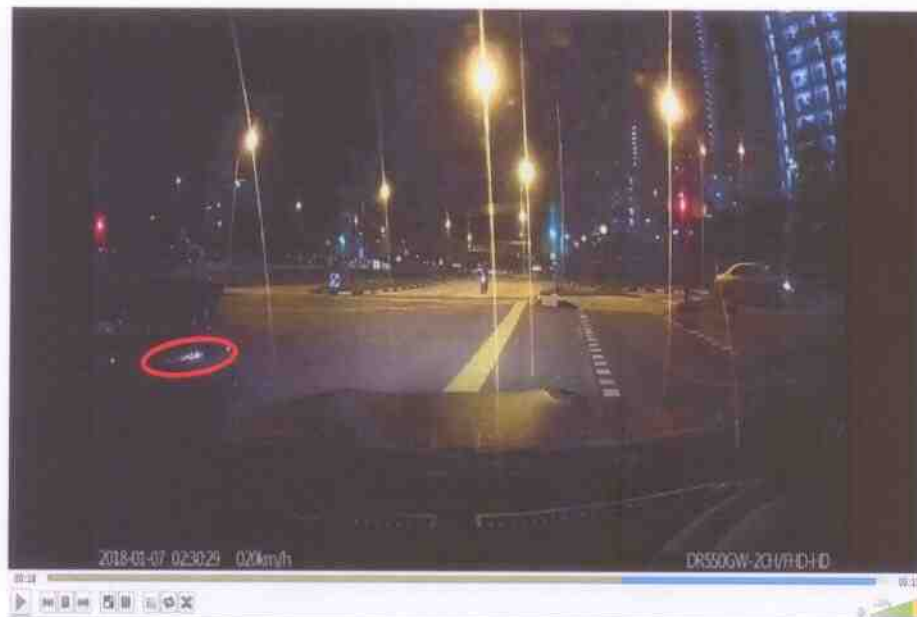
ScreenShot 4 of the video recording from the video recording device that was mounted onto the front windscreen of the Insured Vehicle shows the collision occurring at the 17- second mark of the video recording, where the vehicle bearing registration number SJS 6113A (circled) collided into the left portion of the Insured Vehicle, causing the Insured Vehicle to spin towards the left and stop, facing the oncoming traffic.

26. Basing on the available evidence gathered during the course of our investigations, we are of the view that the damages to the Insured Vehicle SGD 696M are consistent to the circumstances of the accident, where it was reported that before making a right turn into Senja Way from Woodlands Road, Mr Chee failed to look out for oncoming traffic which resulted in a collision of the Insured Vehicle on its left portion with an oncoming vehicle.

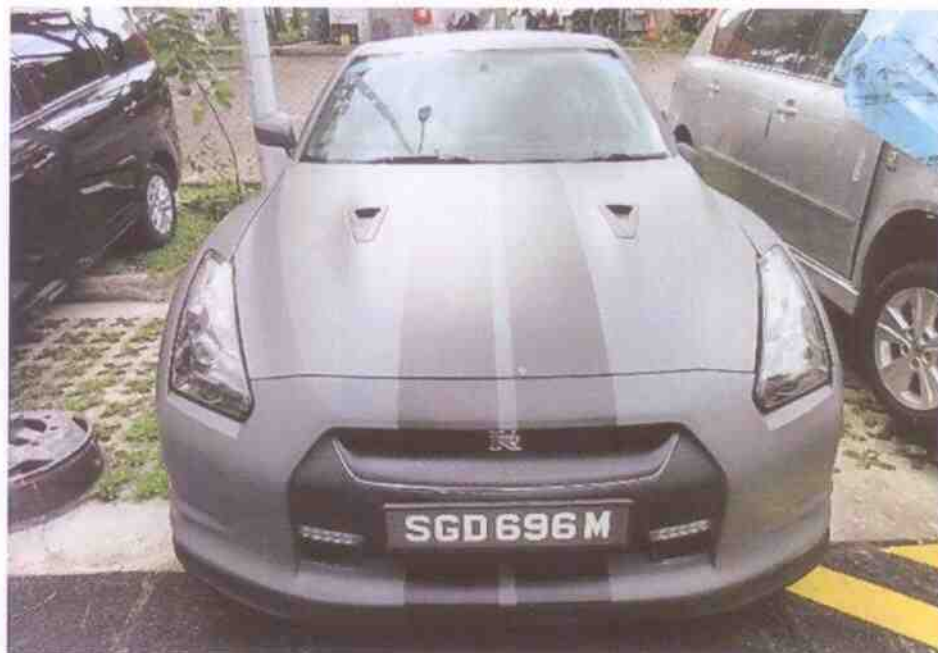
Photo 1 shows a view of the front portion of the Insured Vehicle during the accident reporting. The front portion was undamaged by the accident.

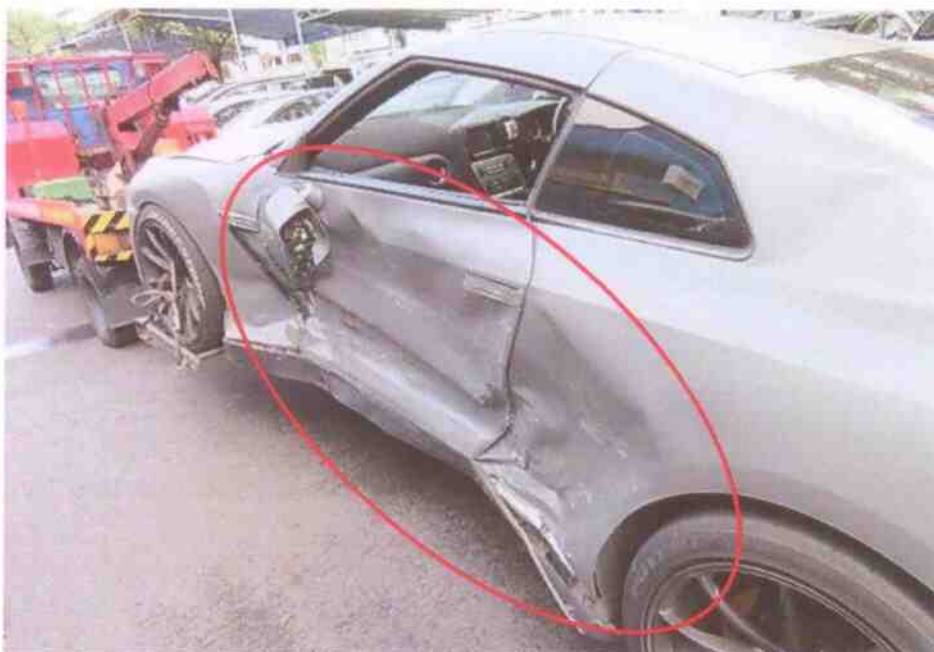
19. Although we could not inspect the accident location closer, we managed to obtain some photographs that were taken during the accident reporting by Progressive on 17 January 2018, 10 days after the accident. The damages on the Insured Vehicle based on our review of the photographs during the accident reporting would appear to correspond to the Insured Vehicle being hit by another vehicle at its left portion. See photos 1 & 2 below.

Photo 2 shows the left portion of the Insured Vehicle during the accident reporting. The extensive damages sustained seem to correlate with the Insured Vehicle being hit by another vehicle at its left portion (circled).
