VEHICLE DAMAGE INSPECTION REPORT

Our File No: CS/CT18004506/T1VBQ2

Reg No: EZ78E

Make & Model: MERCEDES-BENZ 200E, 2.0 (A) Engine No: 27194130560901

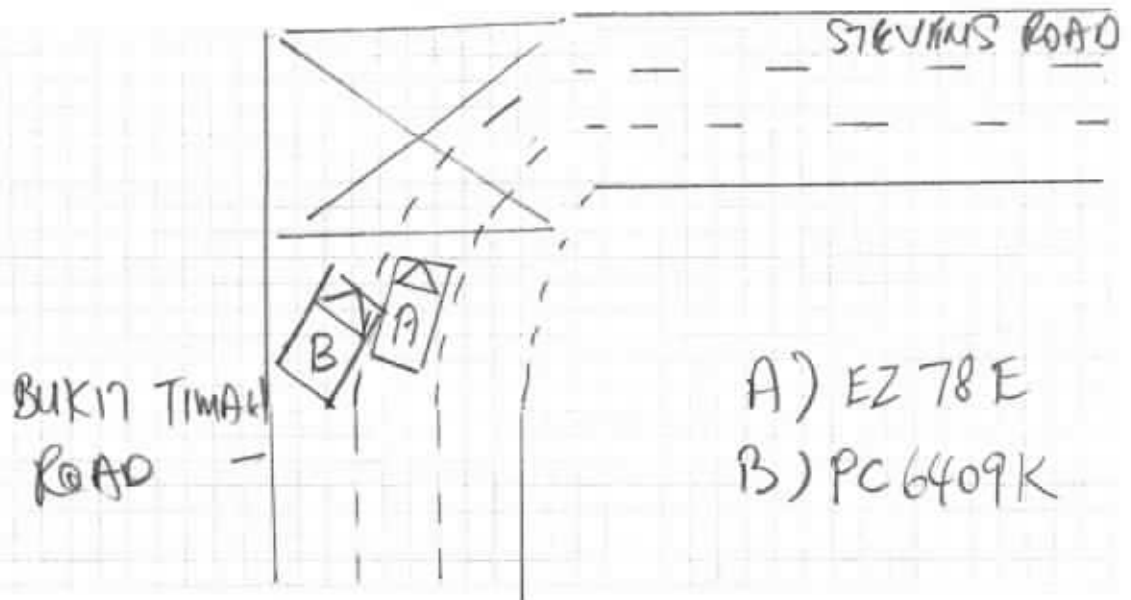
SKETCH PLAN

DESCRIBE CIRCUMSTANCES OF THE ACCIDENT

I was at the junction of Bukit Timah / Stevens Road Junction when I heard a loud bang on the side of my car. I then realised that a bus No. PC 6409K had hit ~~the~~ the left back door of my car. The left back door is badly crumpled by the impact. The bus driver turned right too fast and hit the side of my car.
