Your Ref: Honda Engine Our Ref: CI/TP18004590/D 08 March 2018

INSPECTION REPORT OF A HONDA ENGINE

Inspection of the Honda Engine

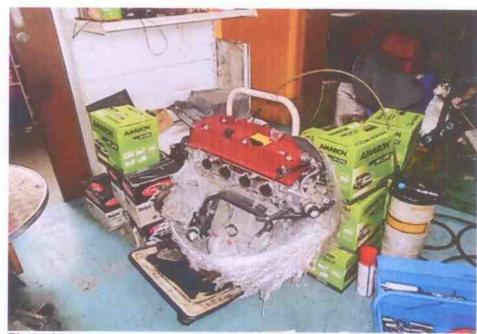
Photo 1 shows a general view of the Honda engine that I had inspected. The Honda engine was observed to be a used engine and was not fitted on any motor car. It was also observed to be a complete assembly with all mechanical parts still intact, within the engine housing.

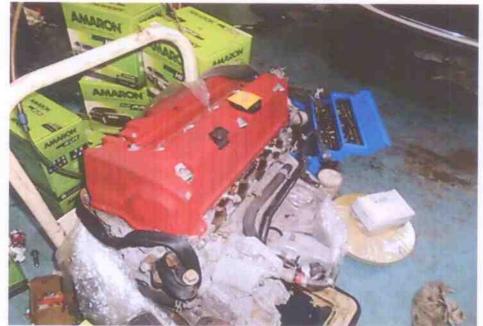
Photo 2 shows a general view of the Honda engine that I had inspected. The Honda engine was not fitted on any motor car. It was observed to be a complete assembly with all mechanical parts still intact, within the engine housing.

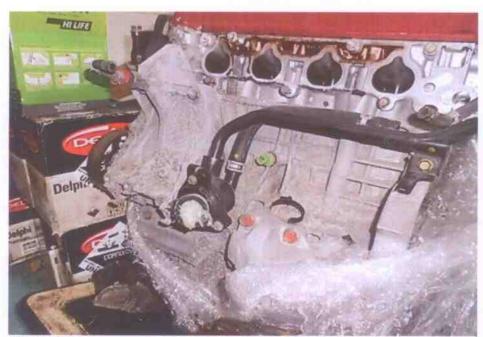
Photo 3 shows a general view of the Honda engine that I had inspected. My visual examination of the engine housing revealed the housing to be of serviceable/satisfactory condition. There was no crack and/or hole observed on the engine housing.

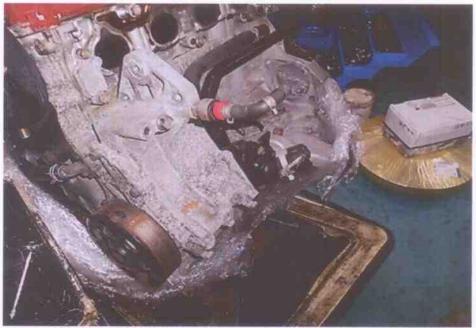
Photo 4 shows a general view of the Honda engine that I had inspected. My visual examination of the engine housing revealed the housing to be of serviceable/satisfactory condition. There was no crack and/or hole observed on the engine housing.

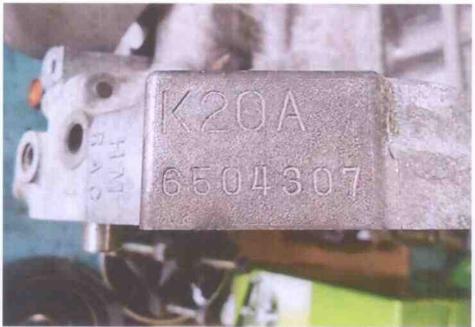
Photo 5 shows the engine number engraved on the housing of the Honda engine that I had inspected. The engine number was K20A6504307.

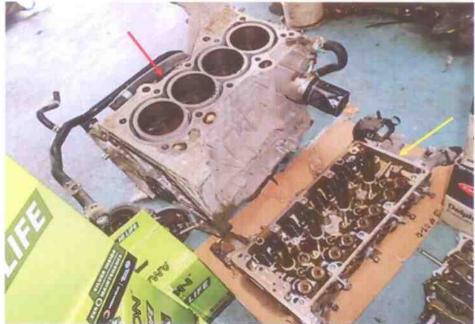
Photo 6 shows the top block (yellow arrow) of the Honda engine separated from its bottom block (red arrow). This was to enable me to carry out measurements of its cylinders, in particular the bore and stroke measurements of each cylinder, which typically can be used to determine the engine displacement or more commonly referred to as engine cc.

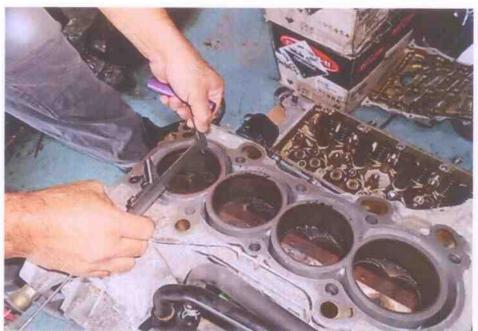
Photo 7 shows measurement being carried out to the bore of cylinder 1 of the Honda engine. The bore and stroke measurements of the Honda engine were carried out using a Vernier Caliper.

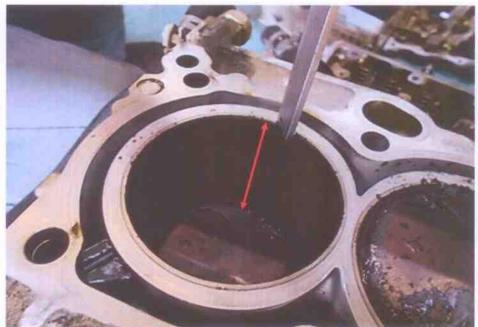
Photo 10 shows measurement being carried out to the stroke of cylinder 1 of the Honda engine. The bore and stroke measurements of the Honda engine were carried out using a Vernier Caliper.

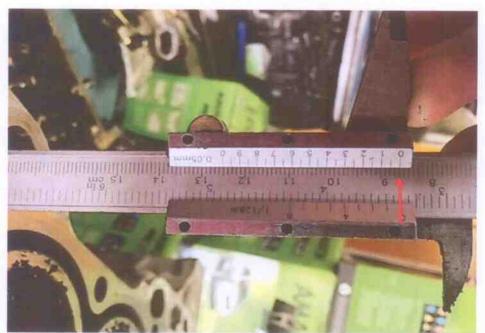
Photo 11 shows the stroke measurement of cylinder 1, which was recorded to be 86.00mm.

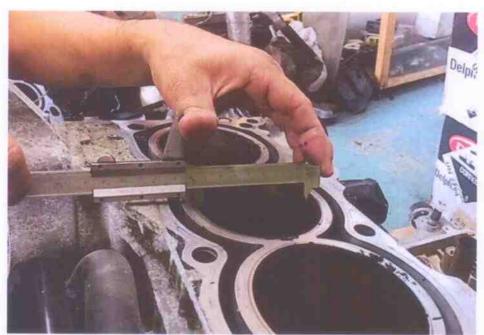
Photo 12 shows measurement being carried out to the bore of cylinder 2 of the Honda engine. The bore and stroke measurements of the Honda engine were carried out using a Vernier Caliper.

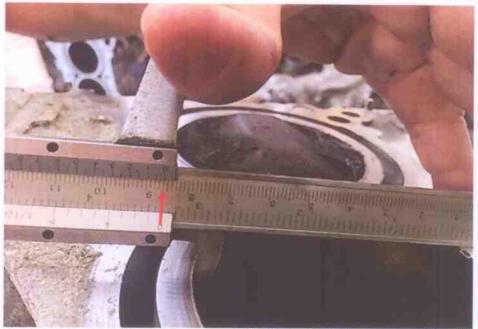
Photo 13 shows the bore measurement of cylinder 2, which was recorded to be 86.00mm.

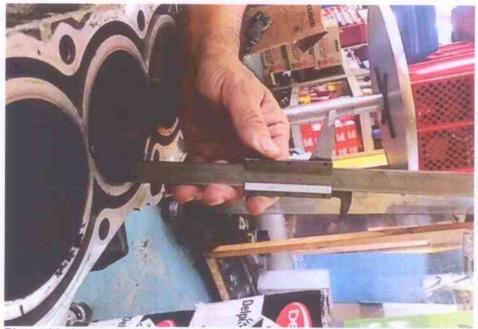
Photo 14 shows measurement of the stroke for cylinder 2 of the Honda engine that I had inspected.

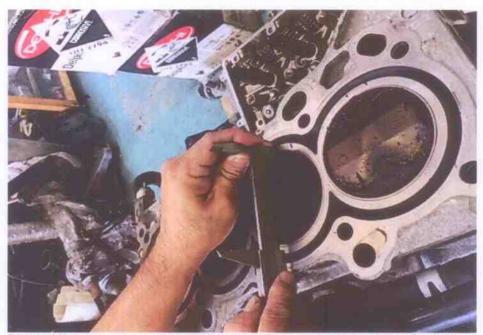
Photo 16 shows measurement being carried out to the bore of cylinder 3 of the Honda engine. The bore and stroke measurements of the Honda engine were carried out using a Vernier Caliper.

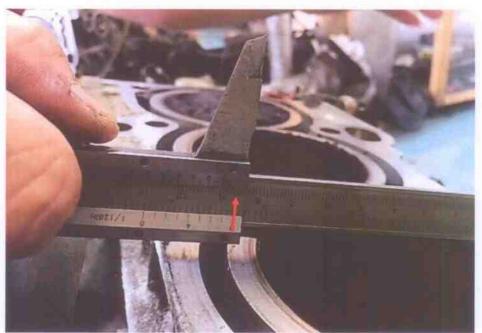
Photo 17 shows the bore measurement of cylinder 3, which was recorded to be 85.50mm.

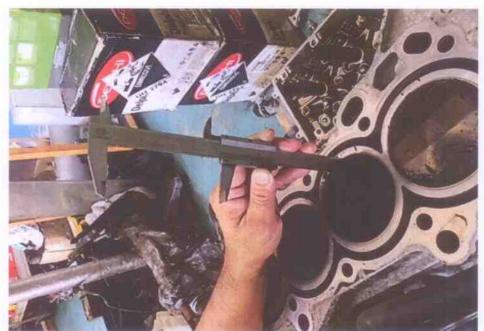
Photo 18 shows measurement of the stroke for cylinder 3 of the Honda engine that I had inspected.

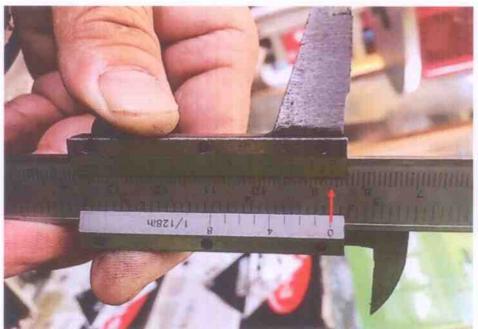
Photo 19 shows the stroke measurement of cylinder 3, which was recorded to be 86.00mm.

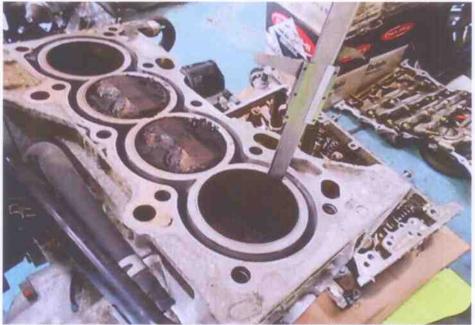
Photo 22 shows measurement being carried out to the stroke of cylinder 4 of the Honda engine. The bore and stroke measurements of the Honda engine were carried out using a Vernier Caliper.

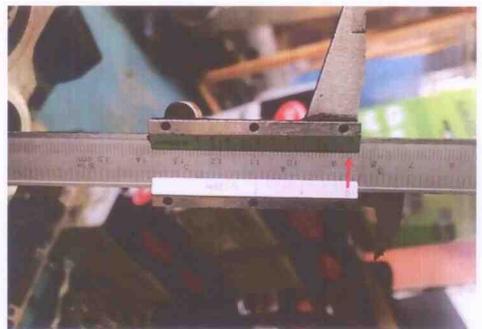
Photo 23 shows the stroke measurement of cylinder 4, which was recorded to be 85.50mm.
