To Inspect Vehicle No: SKW 4434D

1. Policy Particulars :- THIRD PARTY CLAIM (RESURVEY INSPECTION)

THIRD PARTY SURVEY
ACCIDENT OCCURED ON 05 September 2017

VEHICLE DAMAGE INSPECTION REPORT

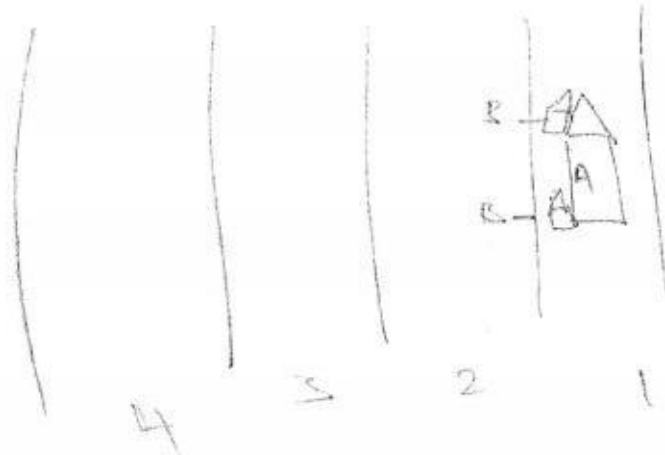
Sketch Plan

A = SKW 44340

B = FRB 9801L

On 5/9/2017 at 11.55 am, I was travelling P&E
 towards Lamine Road. In front of our vehicles
 there was an accident. My car came to a
 halt and suddenly a motorcycle hit my left
 side portion.
