LKK Auto Consultants Pte Ltd

1. Policy Particulars :- THIRD PARTY CLAIM			
Insured Veh.	YP 3087A	Veh. Inspected	YM 8767D
Policy No.		Coverage (\$)	0.00
Claim No.	16/16/16/VC00/019032	Excess (\$)	0.00
Assign From	GERALD POH	Assign Date	21/03/2018

PAPER SURVEY OF YM8767D

ADJUSTMENT ON REPAIR COST FOR VEHICLE NO. YM 8767D

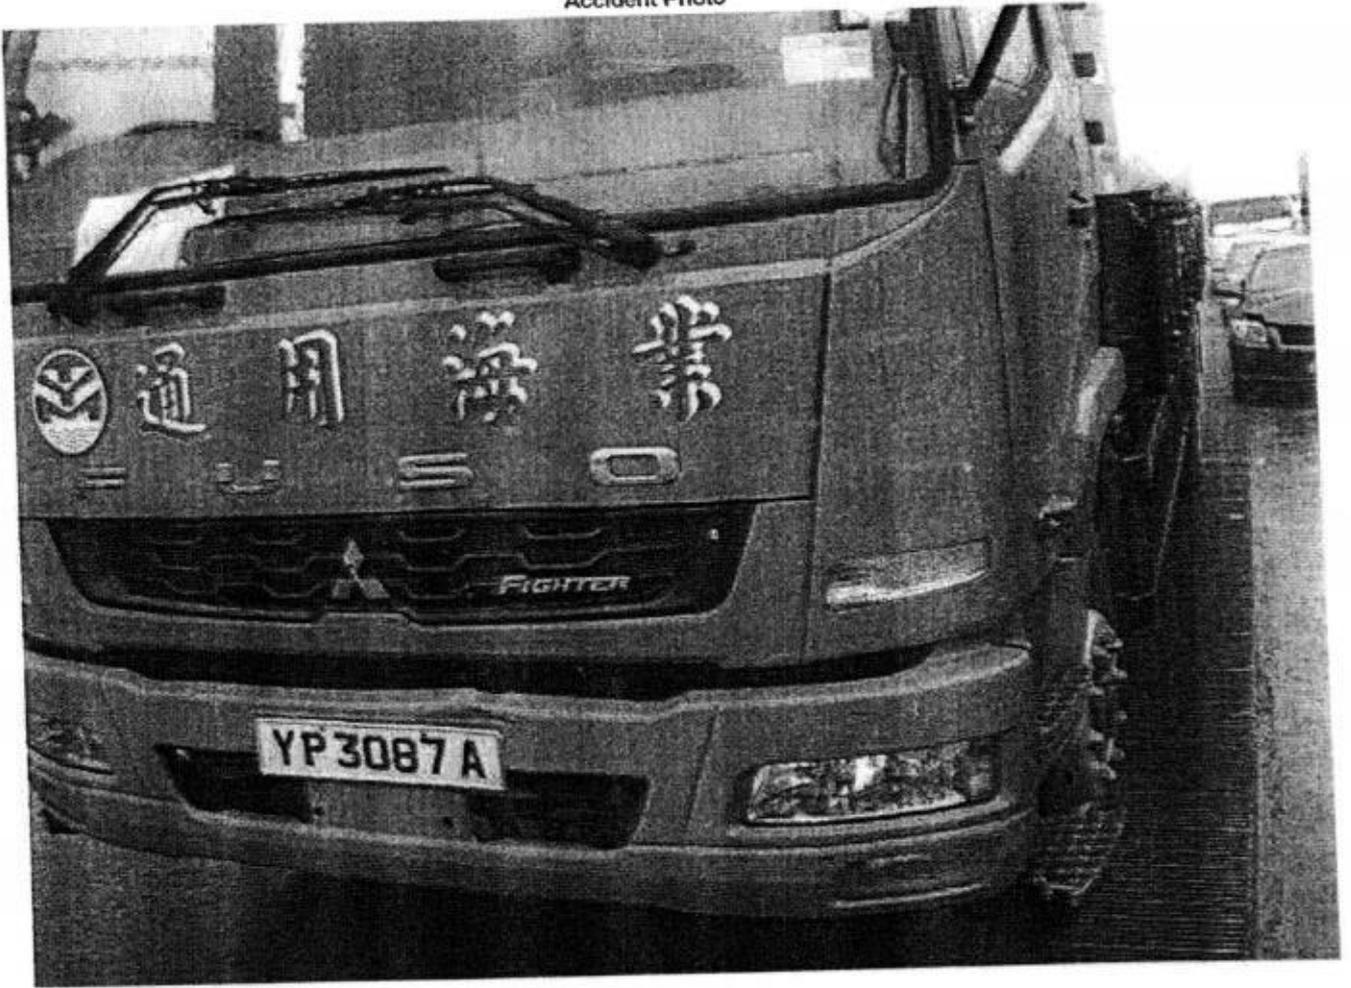
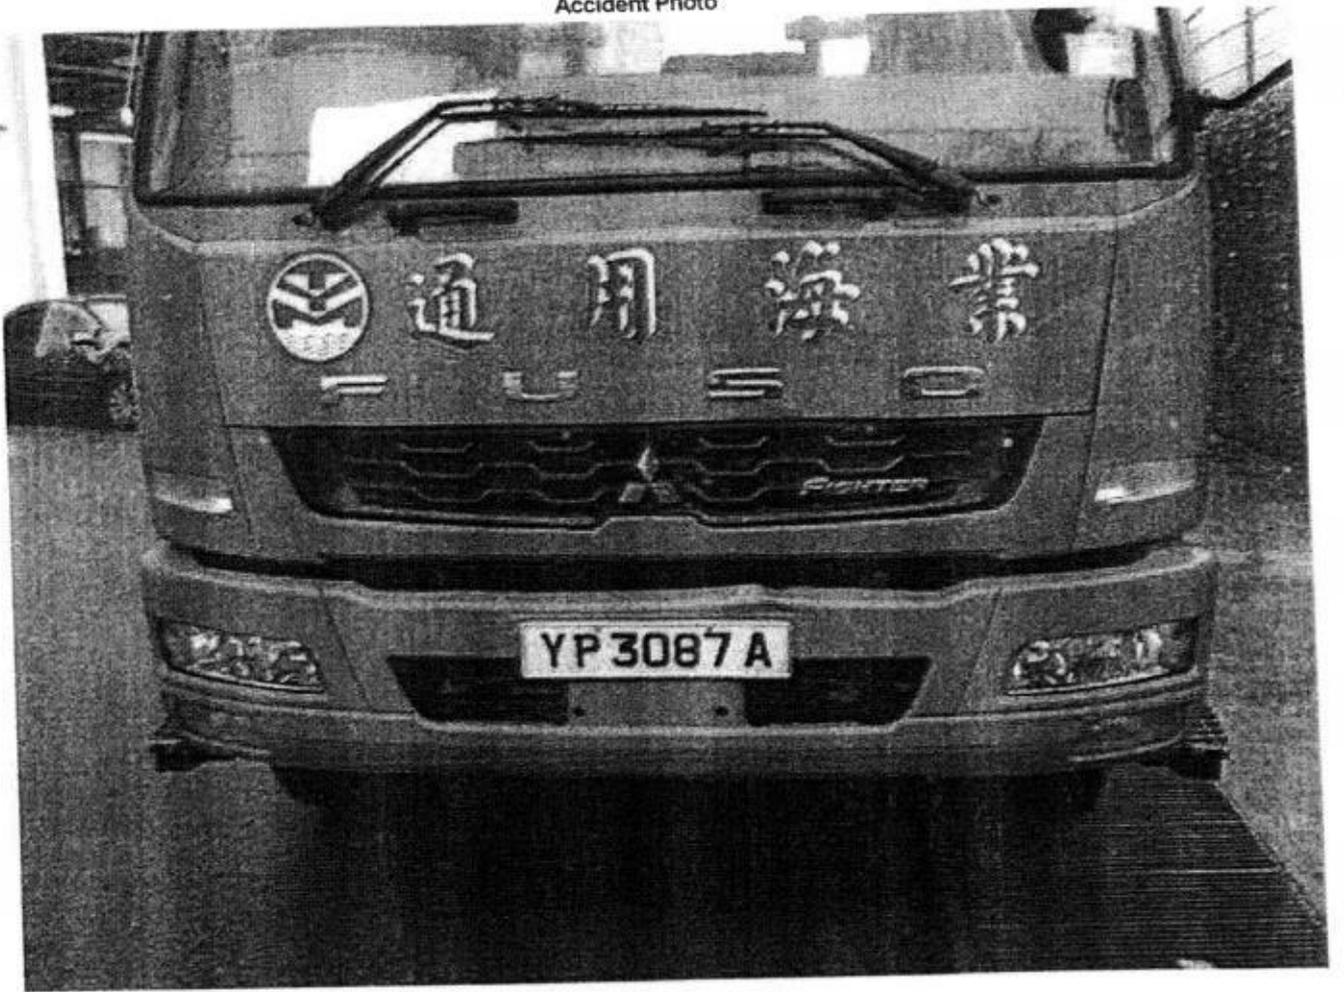
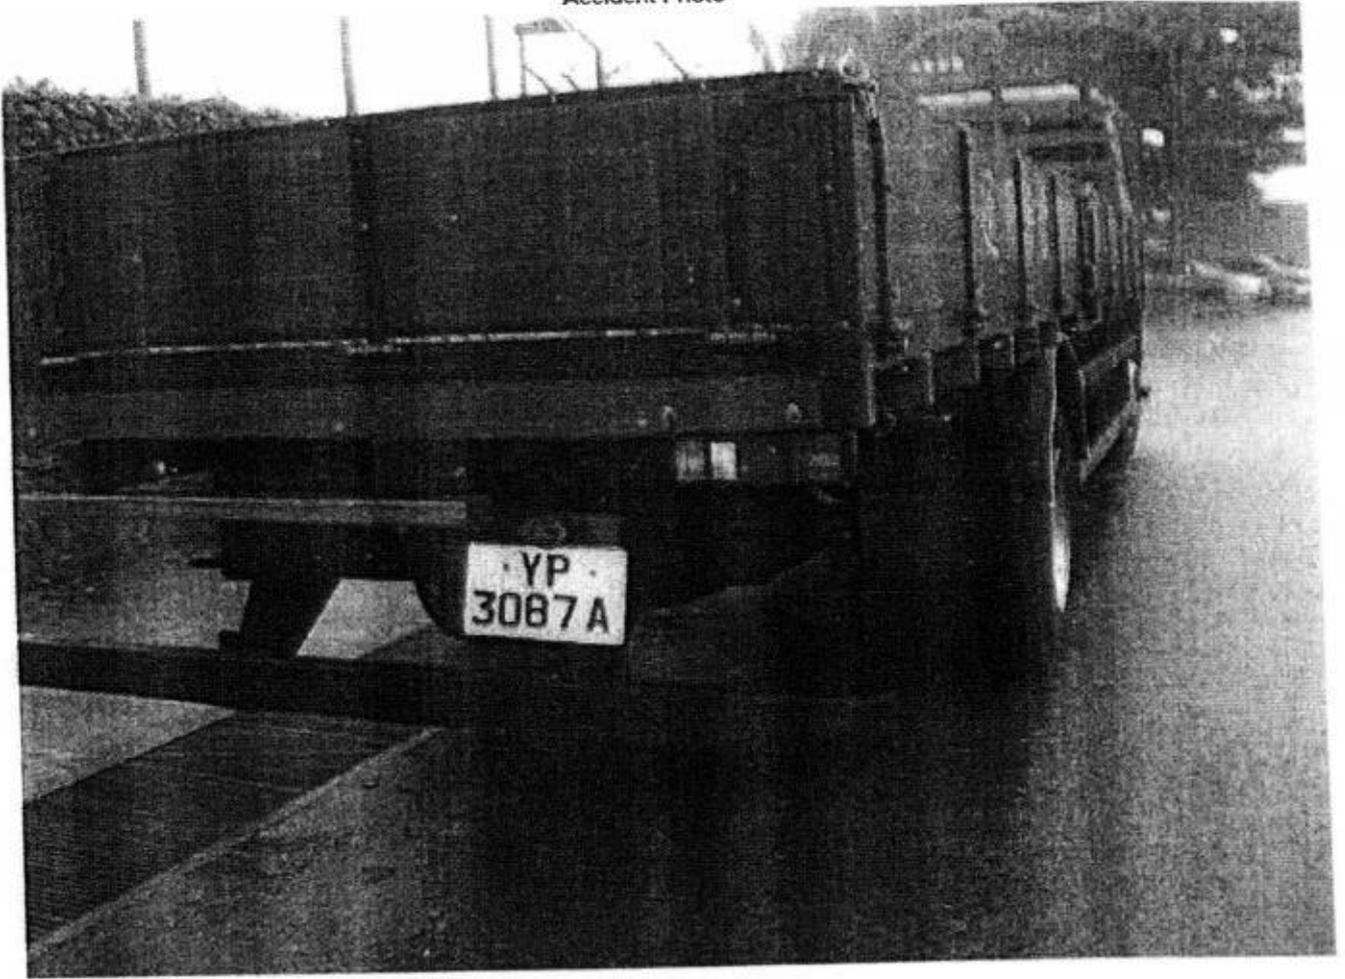
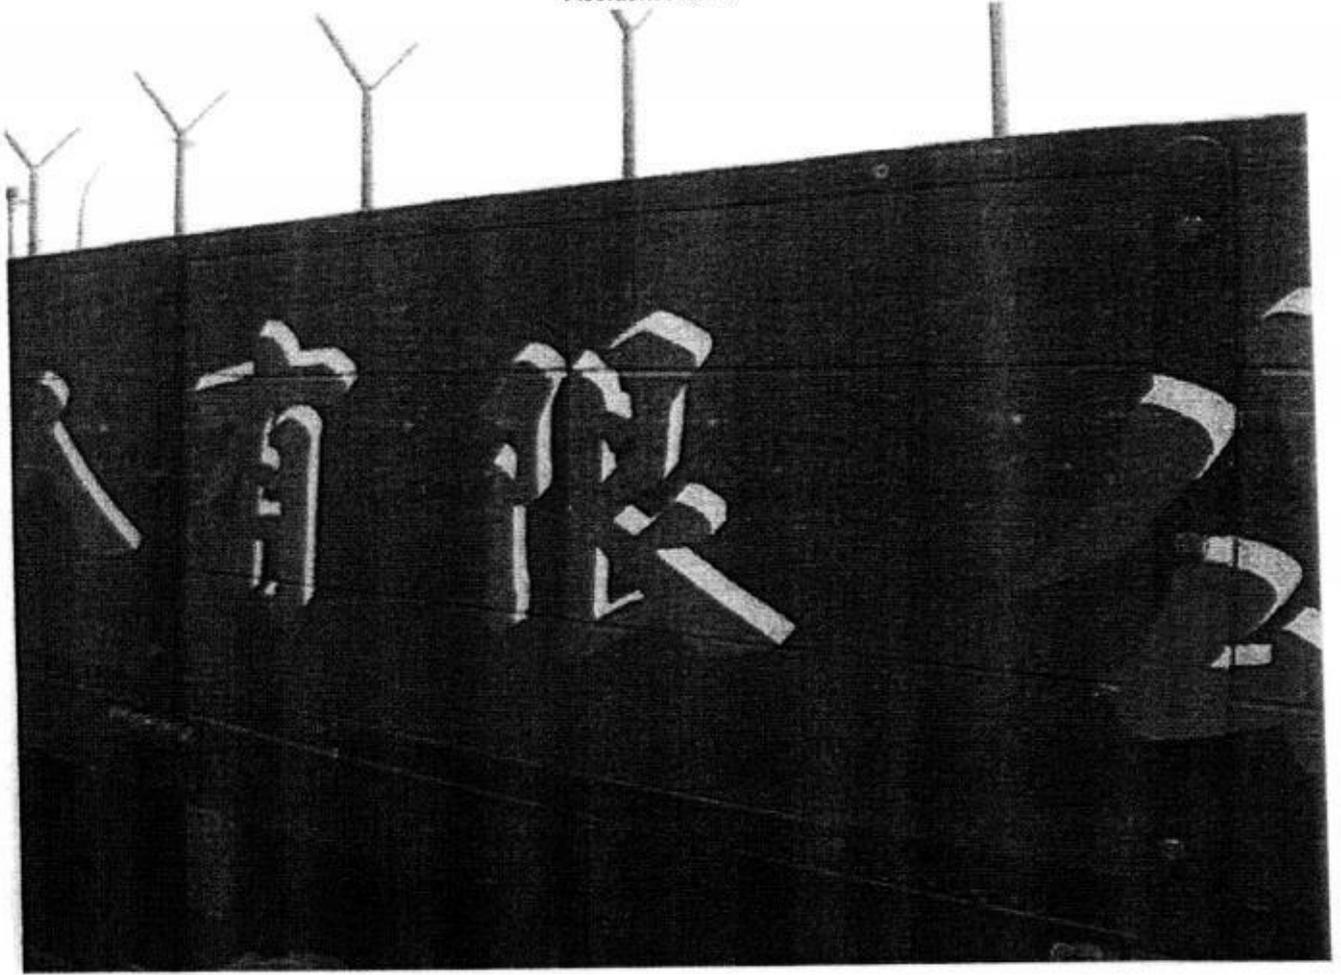
Accident Photo

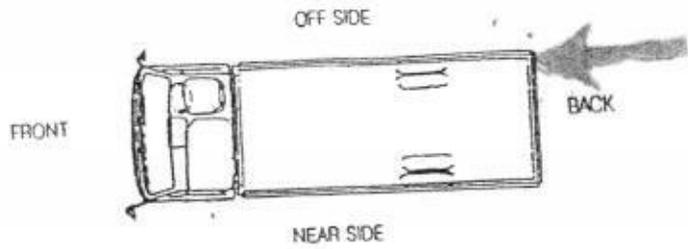
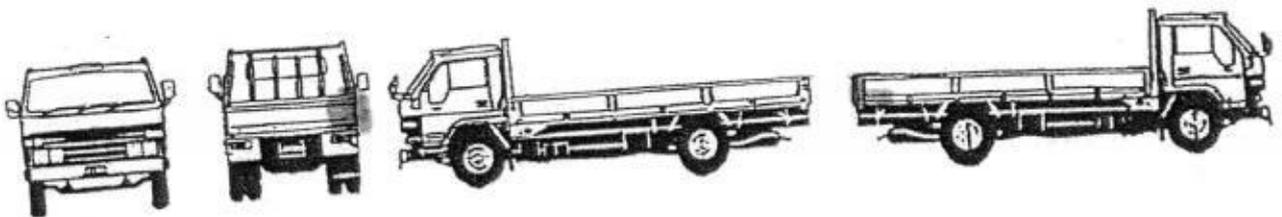
SYNOPSIS OF DAMAGES RESULTANT FROM THE ACCIDENT

Damages sustained were consistent with the subject vehicle being involved in a collision with another vehicle and the impact was delivered onto the o/s rear portion of the vehicle.

Damages sustained were the rear wooden carriage assembly- tilted, wooden tailgate iron mongery/lock & latch o/s- bent/twisted, wooden dropside iron mongery/hinge/latch o/s- twisted etc.
