Insured Veh.	SKH 8267Y	Veh. Inspected	SLT 1034Z
Policy No.	SNM18D01551C02	Coverage (\$)	0.00
Claim No.	SNM18D01551C02	Excess (\$)	0.00
Assign From	MERIMEN (IRENE TAY)	Assign Date	26/03/2018

Attn : Person In Charge
 Vehicle No : SLT 1034 Z
 Model : Audi A5
 Chassis : WAUZZZ8T6BA084948
 Year / CC : 2011 / 2.0

VEHICLE DAMAGE INSPECTION REPORT

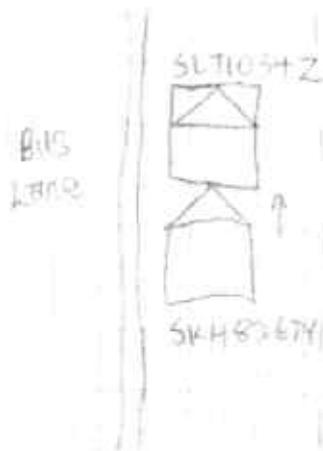
Sketch Plan #2

DESCRIBE CIRCUMSTANCES OF THE ACCIDENT

I WAS TRAVELLING ALONG THE MAIN WAY, INSIDE MAS BUILDING, AND I WAS STOPPING BY THE BACK VERANDAH SKH82674 SUDDENLY HIT ME FROM BEHIND.
