CC6/1117021132 (Anaz) 2-1

Date :22.11.2017
Vehicle no :SDU 111 E
Make/Model :AUDI A6
Accident date :01.11.2017

**ACCIDENT ON 01.11.2017 INVOLVING VEHICLE SDU 111 E & SHC 3344 C ALONG
BUKIT TIMAH ROAD**

VEHICLE DAMAGE INSPECTION REPORT

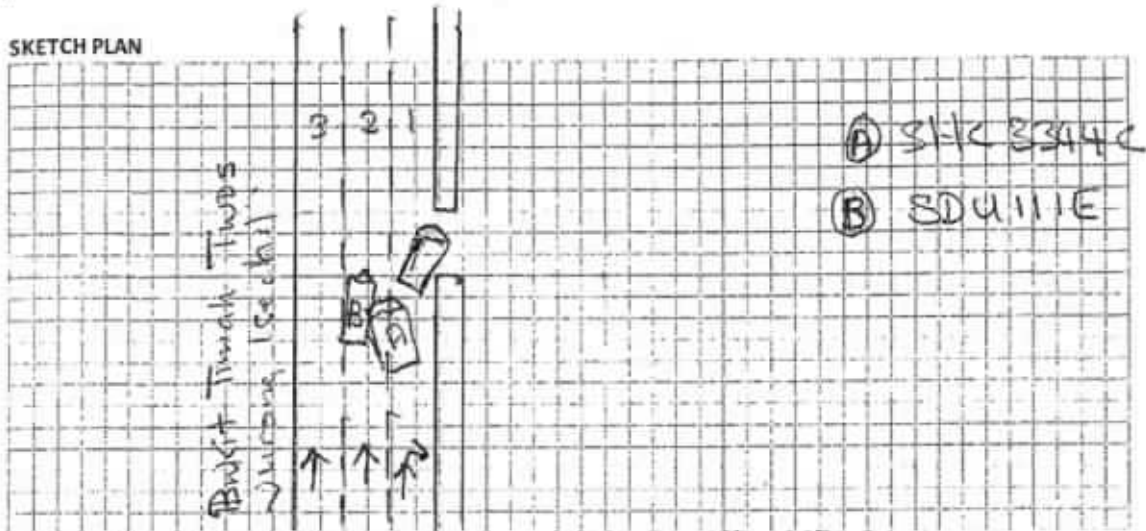
SKETCH PLAN

On 19/11/2017 at about 1945 hrs, I vehicle A was driving along Bukit Timah road toward Jurong Road on the extreme right lane. As a car in front of me is making a right turn I was follow him behind, then I try to shift to middle lane. Suddenly, vehicle B came from my left and brush against my left front portion.
