## VEHICLE DAMAGE INSPECTION REPORT

Our File No: CC3/TMI18005802/K1TBE2

Reg No: SH8000E

Make &amp; Model: HYUNDAI SONATA, 2.0 D CRDi Turbo (NF) (A)

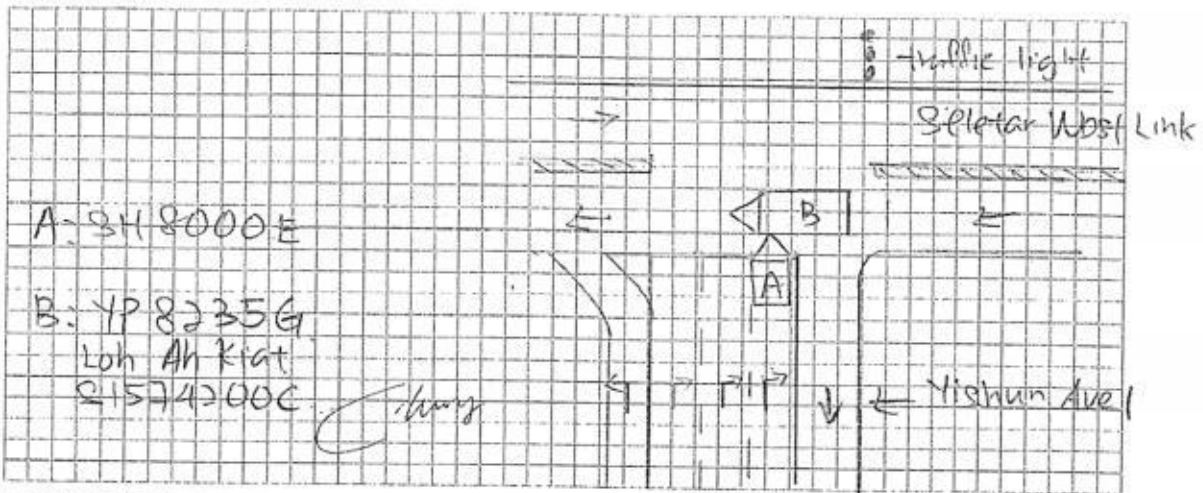
## SKETCH PLAN

On 27/3/18 at about 19:45 hrs, I was driving along Yishun Ave 1 towards the junction of Selekar West Link.

As I approached the traffic junction I noticed that traffic light is green, so I move forward turn into Selekar West Link.

In the process, a lorry YP 8235G come out from my right hand side. I immediately brake upon seeing this, however, my taxi can't manage to stop and collided onto the lorry.
