NTUC INCOME INSURANCE CO-OPERATIVE LTD Ref: NS/INC18006022/K1tb				
73 BRAS BASAH ROAD #05-01 NTUC TRADE UNION HOUSESINGAPORE 189556			Date: 02-04-2018	 
Code: INC4

5. General Information				
Accident Date	30/03/2018	Inspection Date	02/04/2018	
Survey held at	COMFORTDELGRO ENGINEERING PTE LTD 59 LOYANG DRIVE SINGAPORE 508969			
5a. Remarks				
A)THE INSPECTION WAS CONDUCTED ON A"WITHOUT PREJUDICE" BASIS. B)IN ACCORDANCE TO YOUR INSTRUCTIONS, WE HAVE NOT AUTHORISED REPAIRS.

THE VEHICLE SUSTAINED DAMAGES AT THE N/S FRONT PORTION. DAMAGES SEE DETAILS.

ADJUSTMENT ON REPAIR COST FOR VEHICLE NO. SHC 8780T

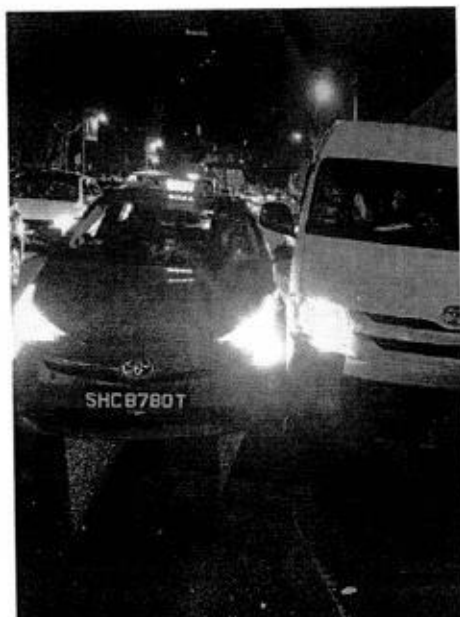
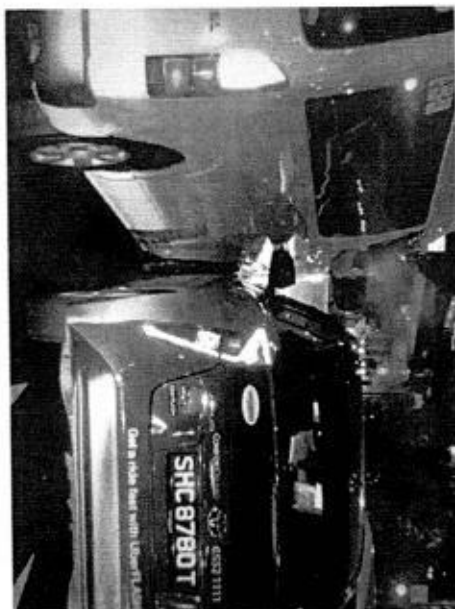
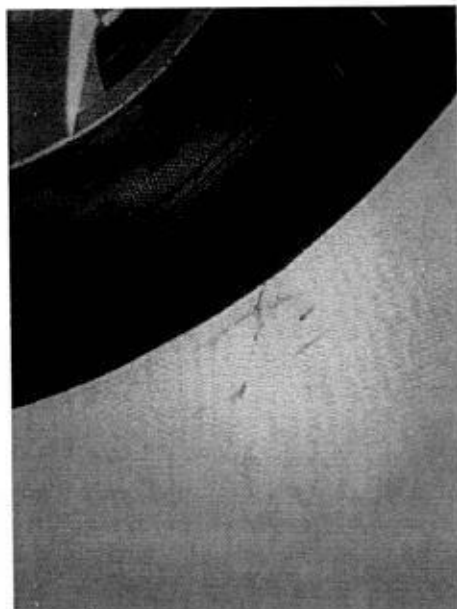
Qty	Description of Parts	Condition	Estimate By Workshop (\$)	Our Adjusted (\$)
REPLACEMENT OF PARTS				
1	FRONT WHEEL HUB CAP, LH	GRAZED	175.80	175.80
1	FRONT FENDER EMBLEM	NECESSARY	86.50	86.50
1	FRONT BUMPER (NPA)	TO REPAIR	-	-
1	FRONT LH FENDER (NPA)	TO REPAIR	-	-
	LESS 25% DISCOUNT		-65.57	-65.57
			196.73	196.73
SPECIAL NETT ITEMS				
1	FRONT FENDER ADVERTISEMENT LOGO (LH)(SN)	NOT NECESSARY	100.00	-
			100.00	-
LABOUR				
	THATCHAM STANDARD REPAIR TIME ON BODY WORKS.		370.00	200.00
	THATCHAM TTS STANDARD SPRAY PAINTING COST AND LABOUR.		500.00	400.00
			870.00	600.00
GRAND TOTAL			1,166.73	796.73
RECOMMENDED COST OF REPAIRS (CONFIRMED)				796.73

ESTIMATED NORMAL PERIOD FOR REPAIR:	2 Working Days
-------------------------------------	----------------
