## 1. Policy Particulars :- THIRD PARTY CLAIM

THE VEHICLE SUSTAINED DAMAGES AT THE REAR PORTION. DAMAGES SEE DETAILS.
--

## ADJUSTMENT ON REPAIR COST FOR VEHICLE NO. SH 8300P

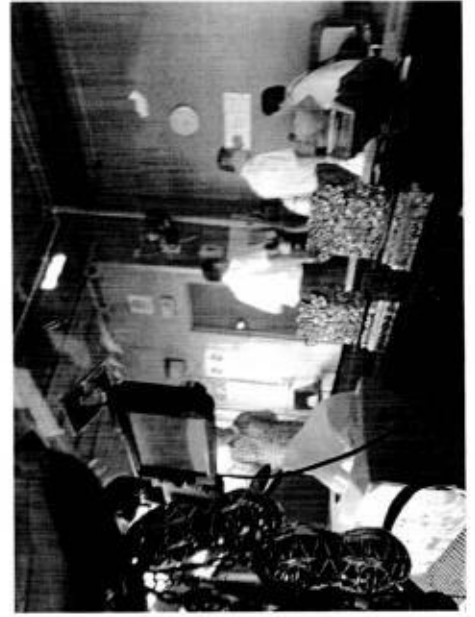
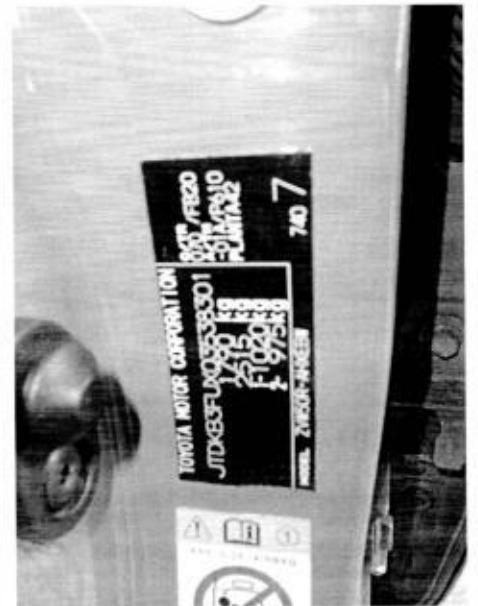
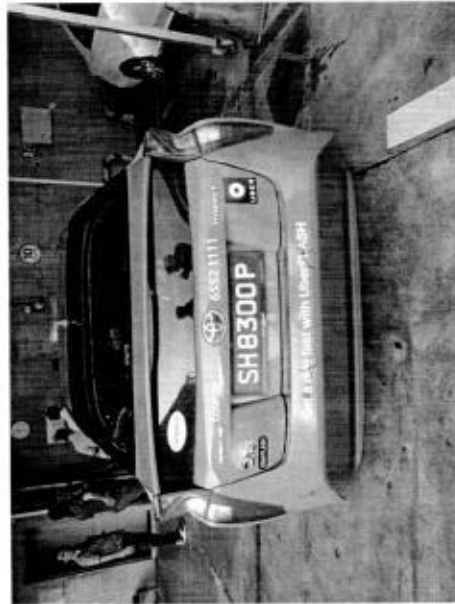
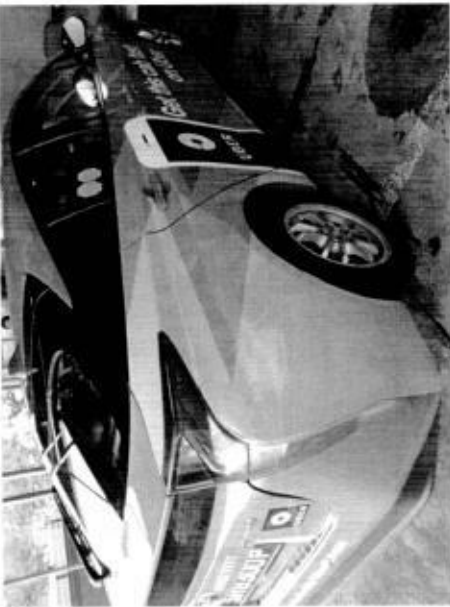
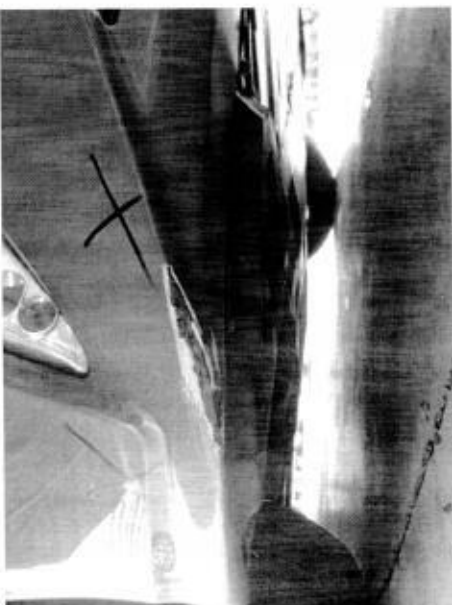
Plan  
 The U/C / Chassis frame / Body Structure affected due to collision.

Qty	Description of Parts	Condition	Estimate By Workshop (\$)	Our Adjusted (\$)
<b><u>REPLACEMENT OF PARTS</u></b>				
1	REAR BUMPER	TO REPAIR	458.60	-
1	REAR BUMPER RE-INFORCEMENT	SERVICEABLE	318.80	-
1	REAR BUMPER UNDER COVER	SERVICEABLE	552.60	-
1	REAR BUMPER SIDE RETAINER	SERVICEABLE	112.70	-
1	REAR BUMPER SPONGE	NOT NECESSARY	143.40	-
10	REAR BUMPER CLIPS	NOT NECESSARY	22.00	-
	LESS 25% DISCOUNT		-402.02	-
			1,206.08	-
<b><u>SPECIAL NETT ITEMS</u></b>				
1	REAR BUMPER REVERSE SENSOR (SN)	SERVICEABLE	135.70	-
1	REAR BUMPER RUBBER MAT (SN)	NOT NECESSARY	50.00	-
			185.70	-
<b><u>LABOUR</u></b>				
	THATCHAM STANDARD REPAIR TIME ON BODY WORKS.		420.00	100.00
	THATCHAM TTS STANDARD SPRAY PAINTING COST AND LABOUR.		250.00	200.00
			670.00	300.00
<b>GRAND TOTAL</b>			<b>2,061.78</b>	<b>300.00</b>
<b>RECOMMENDED COST OF REPAIRS (CONFIRMED)</b>				<b>300.00</b>
