# National Assessment Centre Services

## 1. Policy Particulars :- THIRD PARTY CLAIM

## 2. Vehicle Particulars & Condition

### ADJUSTMENT ON REPAIR COST FOR VEHICLE NO. SH 8949T

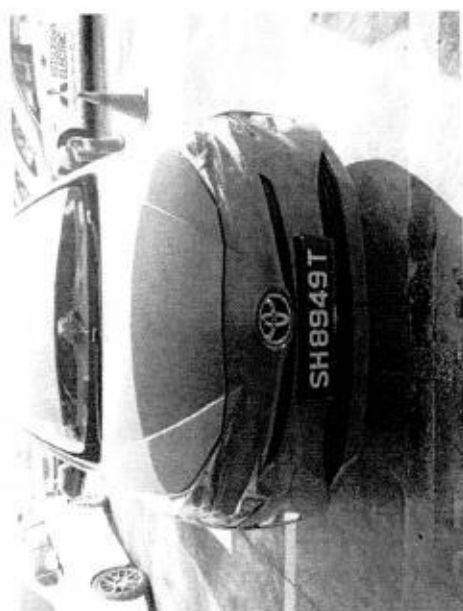
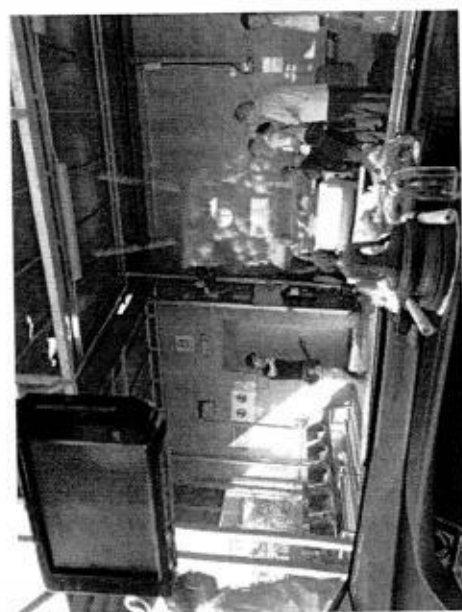
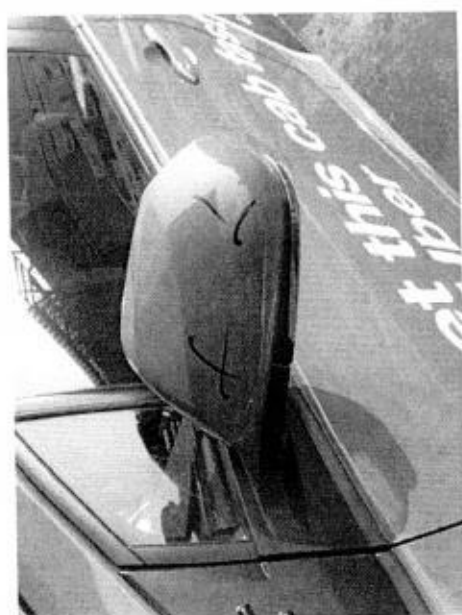
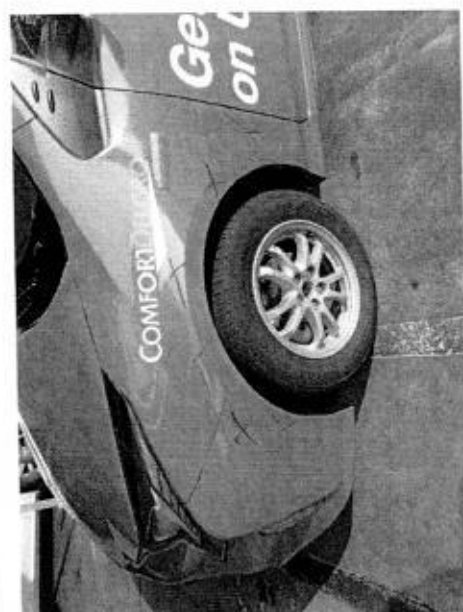
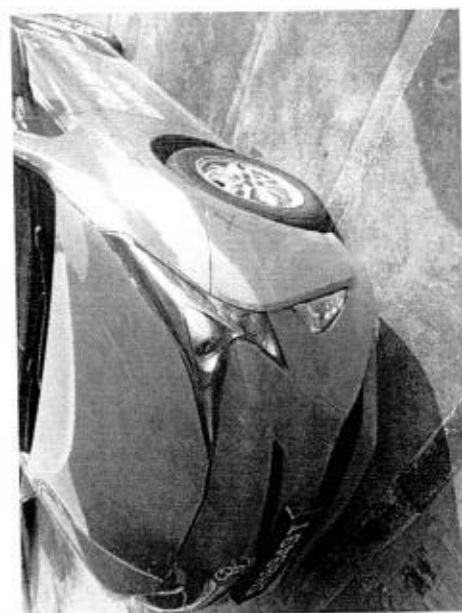
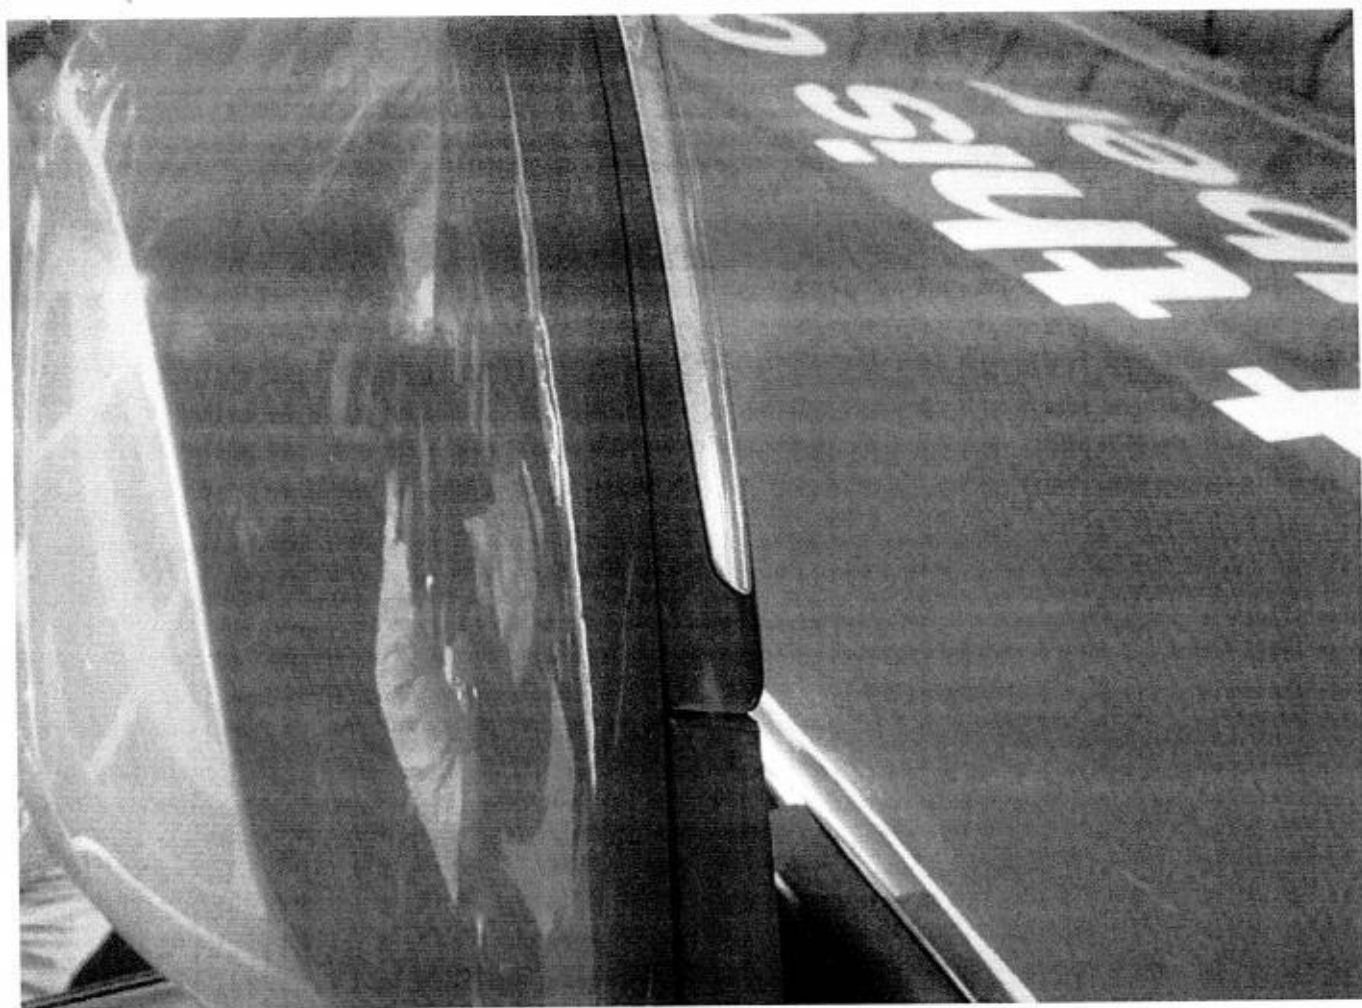
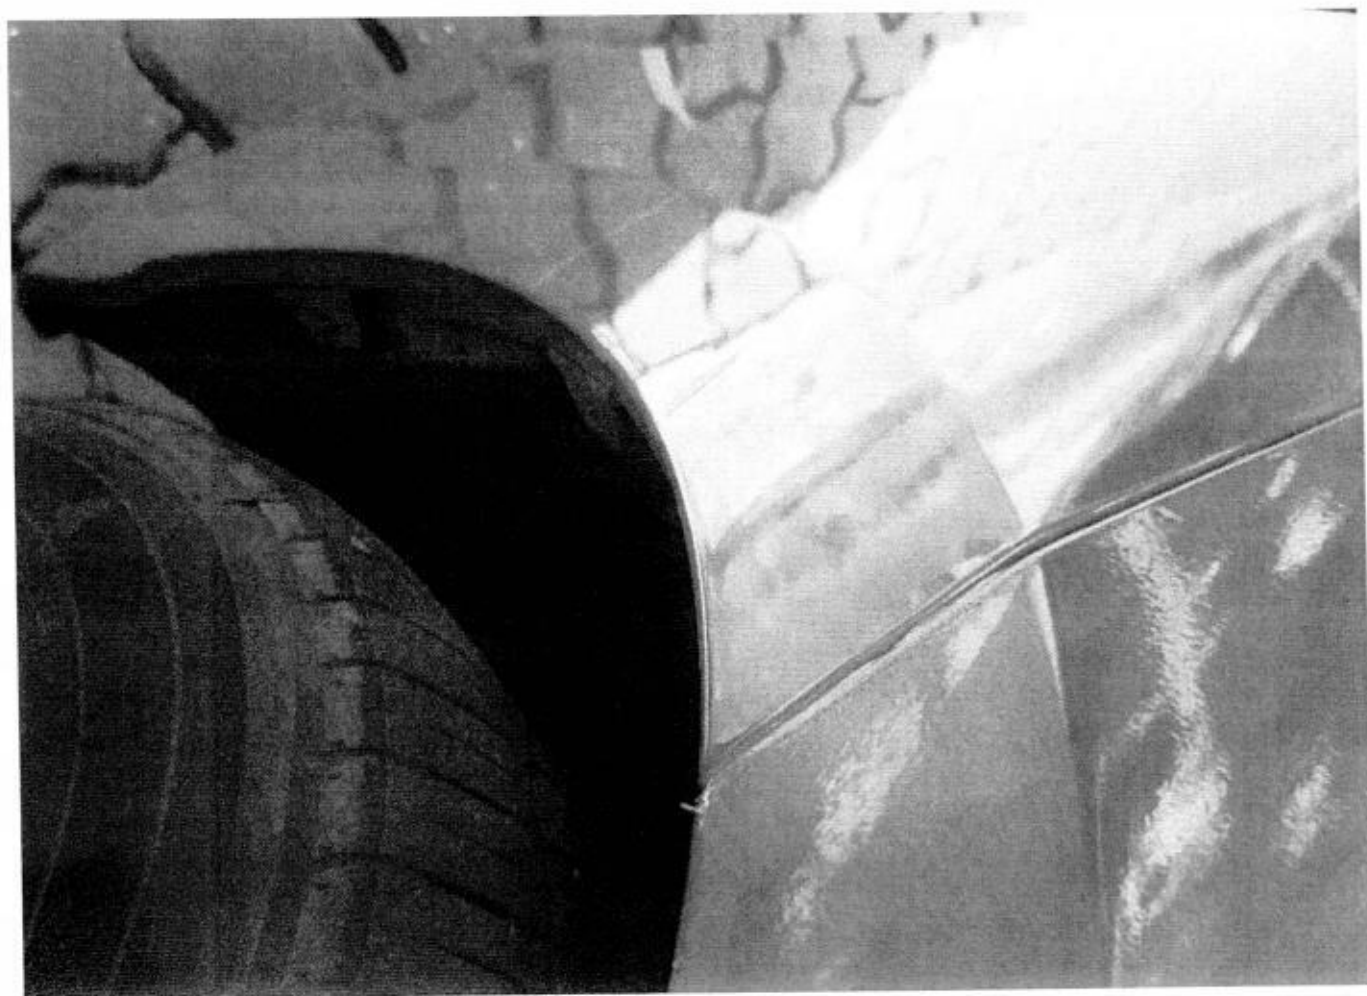
On 30/03/2018 at 1053hrs, I was driving my taxi SH8949T along Mandai Road. At that point of time the traffic is congested and moving in slow speed. As I wanted to turn into lane 1, I then signal right and slow down. However after I enter lane 1, one van PC4534U who travelling on lane 2 suddenly turned into my lane. Due to that action, I was not able to stop in time and scratched onto the said van right side mirror. This resulted in some damaged on my car front left bumper and side mirror.

THE VEHICLE SUSTAINED DAMAGES AT THE N/S BODY. DAMAGES SEE DETAILS.
--

Qty	Description of Parts	Condition	Estimate By Workshop (\$)	Our Adjusted (\$)
1	<b>REPLACEMENT OF PARTS</b>	TO REPAIR		
	PRIG4 MIRROR ASSY OUTER R		1,283.90	-
	LESS 25% DISCOUNT		-320.98	-
			962.92	-
	<b>LABOUR</b>			
	THATCHAM STANDARD REPAIR TIME ON BODY WORKS.		410.00	100.00
	THATCHAM TTS STANDARD SPRAY PAINTING COST AND LABOUR.		600.00	450.00
			1,010.00	550.00
<b>GRAND TOTAL</b>			<b>1,972.92</b>	<b>550.00</b>
<b>RECOMMENDED COST OF REPAIRS (CONFIRMED)</b>				<b>550.00</b>
