Des. of Damages: Frt / Rear / O/S / N/S / U/C / Rooftop or **N/S Rear**

Affiliated to Federation Internationale Des Experts En Automobile			
CHINA TAIPING INSURANCE (S) PTE LTD		Ref : CS/CTI18006242/R1qd3	
3 ANSON ROAD #16-00 SPRINGLEAF TOWERSINGAPORE 079909		Date : 05-04-2018

1. Policy Particulars :- THIRD PARTY CLAIM			
Insured Veh.	GBC 9838B	Veh. Inspected	SLL 9232H
Policy No.	DMCVSN3030861702 (Coverage (\$)	0.00
Claim No.	SNM18D01669C02	Excess (\$)	0.00
Assign From	MERIMEN (IRENE TAY)	Assign Date	05/04/2018

VEHICLE DAMAGE INSPECTION REPORT

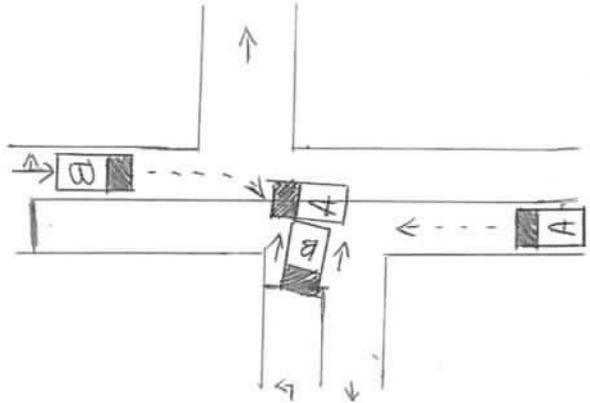
SKETCH PLAN

- (A) S1192324
- (B) QBC9838B

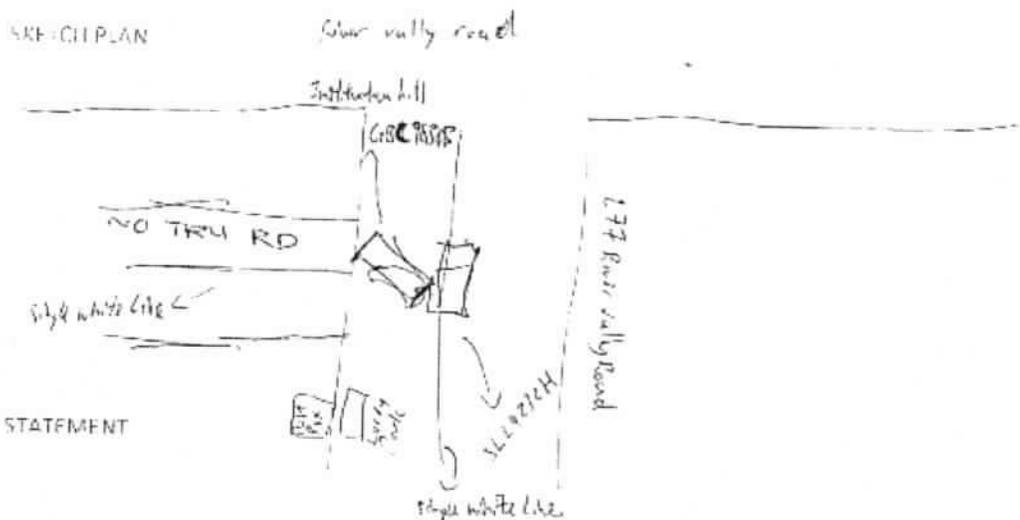
SKETCH PLAN

On 28th march 2018, at about 7.45pm, I, Zan Shi, NRIC 54177220 was travelling along
 Inhibition Hill towards river valley road at the speed of about 15-20km/h, suddenly a van
 CR08 98388 reversed out from a minor road at a fast speed I couldn't react and he ran
 onto my left side of my vehicle to the side of his car asked me to request a Ching and also
 his back right rear was dented after the incident.
