### 1. Policy Particulars :- THIRD PARTY CLAIM

Insured Veh.	SKA 3420R	Veh. Inspected	SHC 2497B
Policy No.	5087053277-01	Coverage (\$)	0.00
Claim No.	MT/0989233-002	Excess (\$)	0.00
Assign From		Assign Date	05/04/2018

### 4. Description of Damages

THE VEHICLE SUSTAINED DAMAGES AT THE REAR PORTION.  
DAMAGES SEE DETAILS.

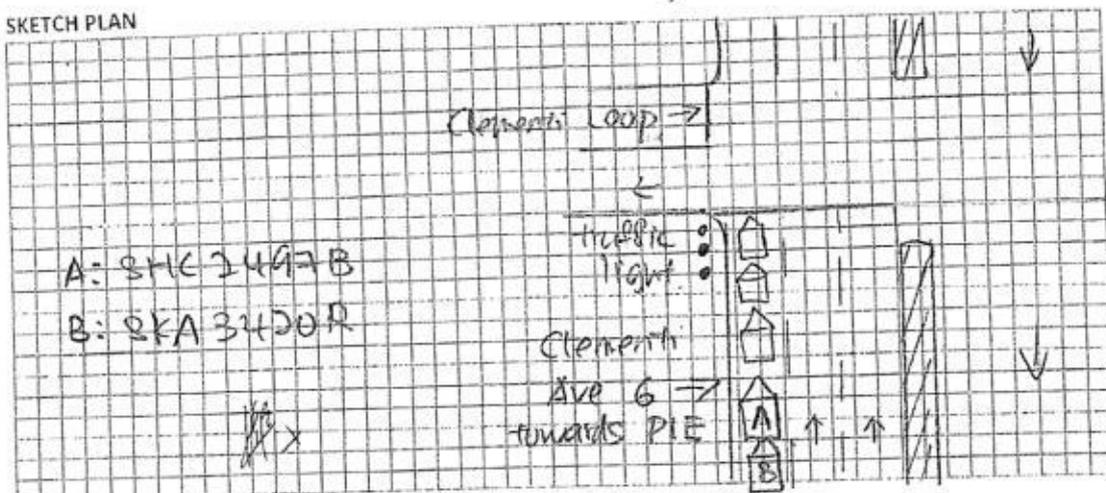
SKETCH PLAN

On 4/4/18 at about 14:45 hrs, my taxi stopped at the extreme left lane along Clementi Ave 6 before the junction of Clementi Loop waiting for traffic light turn to green.

Shortly after a few seconds, I felt an impact from my taxi behind. There is a car SKA 3420R collided onto the rear portion of my stationary taxi.

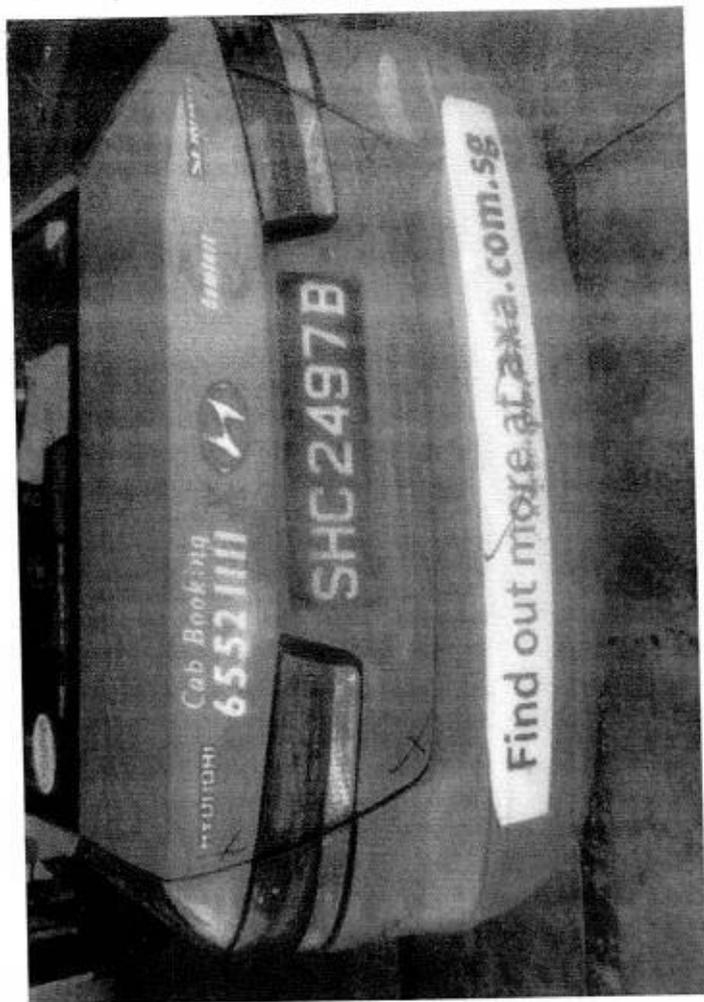
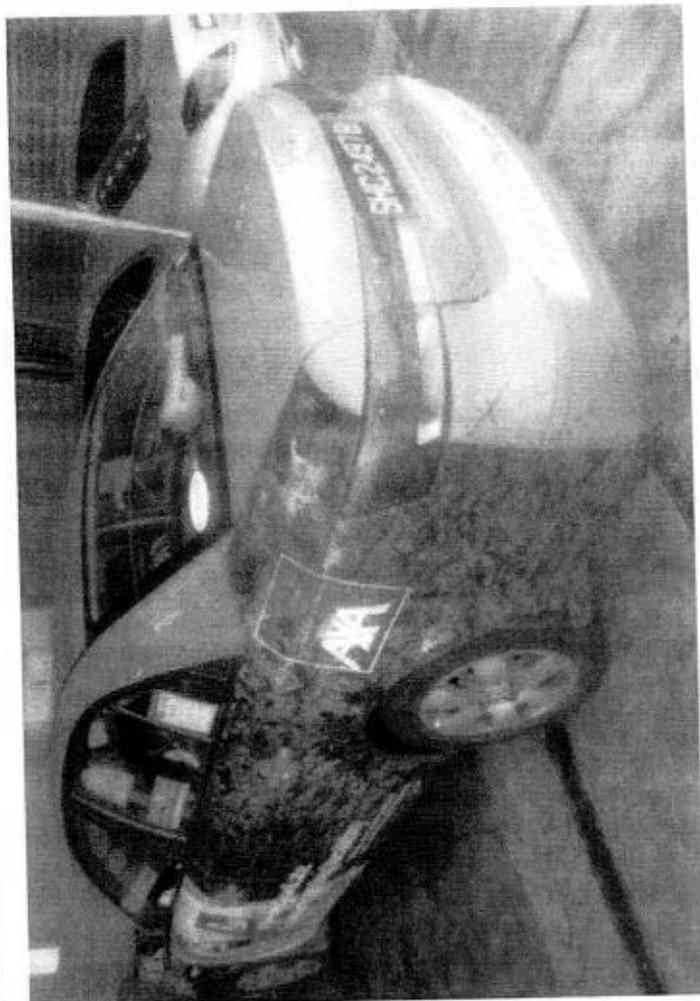
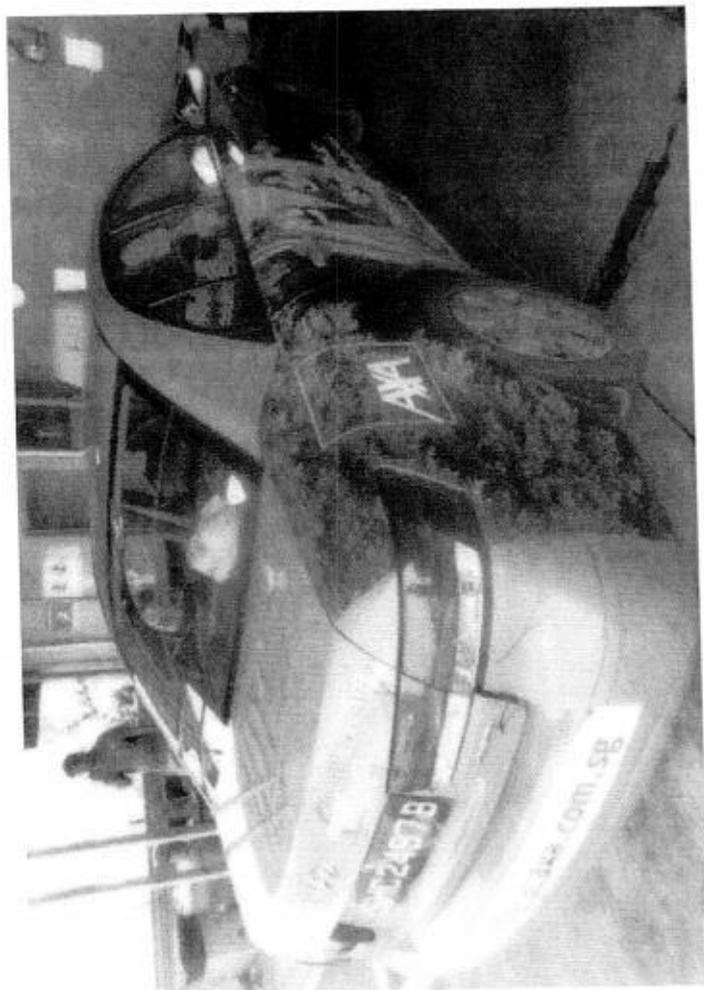
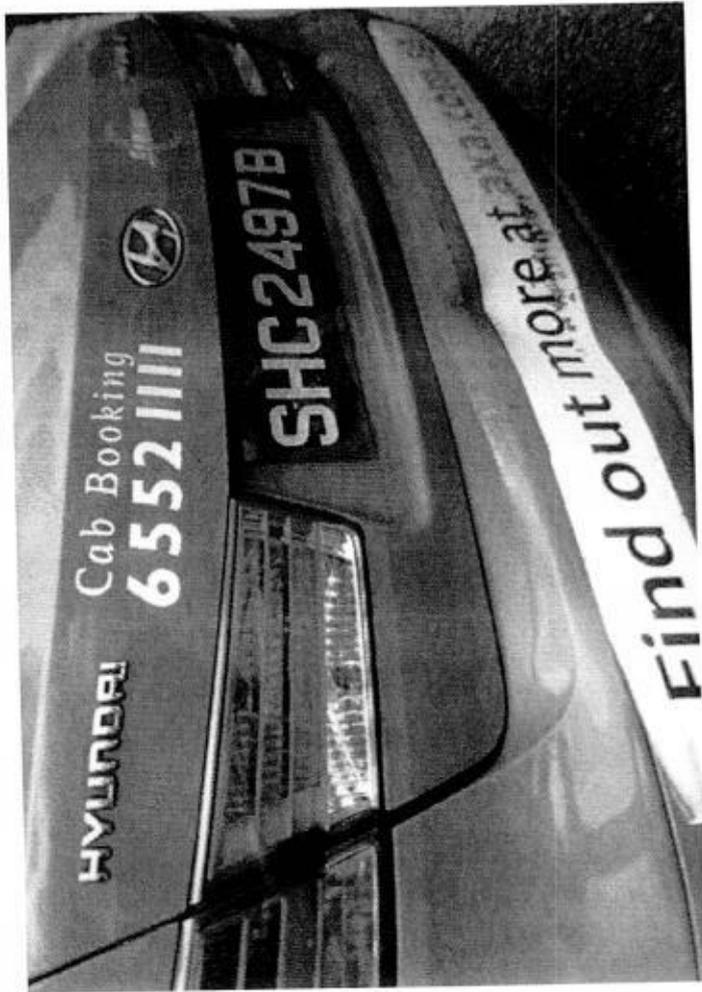
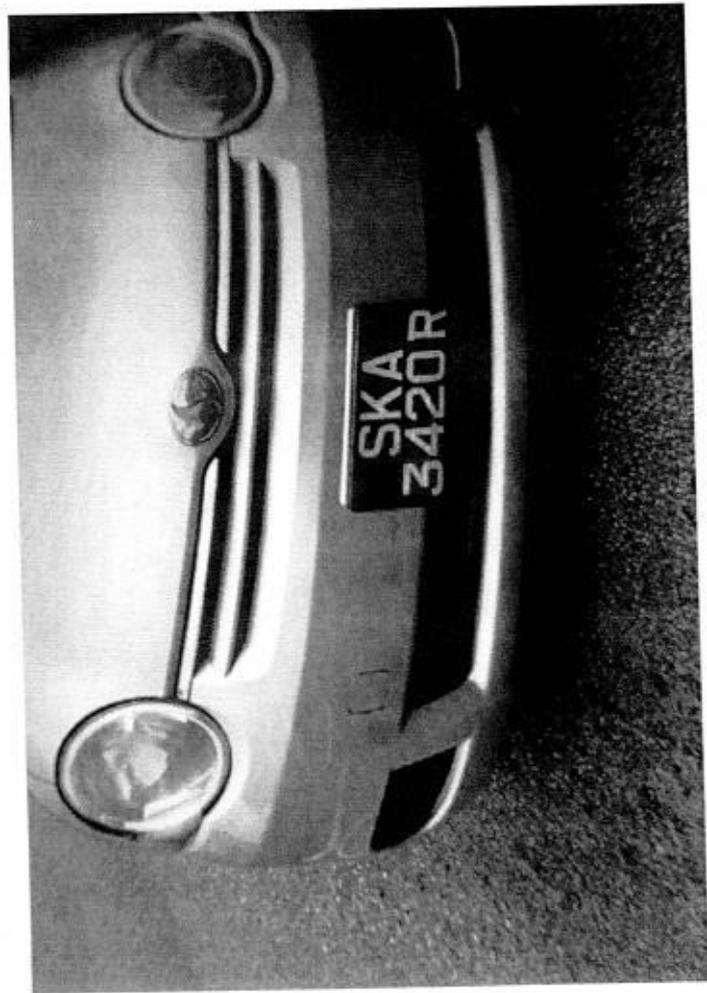
4/4/18

The U/C / Chassis frame / Body Structure affected due to collision.

Qty	Description of Parts	Condition	Estimate By Workshop (\$)	Our Adjusted (\$)
<b>REPLACEMENT OF PARTS</b>				
1	BOOT LID RUBBER	CRACKED	110.90	110.90
1	BOOT LID LOCK UPPER	NOT NECESSARY	132.10	-
1	BOOT LID LOCK LOWER	NOT NECESSARY	30.30	-
1	BOOT LID SONATA PLATE	NECESSARY	43.60	43.60
1	BOOT LID HYUNDAI PLATE	NECESSARY	24.20	24.20
1	BOOT LID "H" EMBLEM	NECESSARY	26.10	26.10
1	BOOT LID CRDI PLATE	NECESSARY	22.70	22.70
1	REAR BUMPER	DENTED	578.40	578.40
1	REAR BUMPER REINFORCEMENT	TO REPAIR	483.30	-
10	REAR BUMPER CLIP	NECESSARY	22.00	22.00
1	REAR BUMPER SPONGE	NOT NECESSARY	137.40	-
1	REAR BUMPER UNDER COVER	NO DAMAGE	185.80	-
2	REAR BUMPER PROTECTOR (LH/RH) @\$38.00	TO REPAIR	76.00	-
1	REAR PANEL	TO REPAIR	391.80	-
1	REAR PANEL GARNISH	CRACKED	95.80	95.80
	LESS 20% DISCOUNT		-472.08	-184.74
			1,888.32	738.96
<b>SPECIAL NETT ITEMS</b>				
1	BOOT LID COMFORT LOGO & TEL NO STICKER (SN)	NECESSARY	30.00	30.00
1	REAR BUMPER REVERSE SENSOR (SN)	NECESSARY	135.70	135.70

1	REAR BUMPER ADVERTISEMENT LOGO (SN)	NECESSARY	50.00	50.00
2	REAR FENDER ADVERTISEMENT LOGO (LH/RH) @\$100.00 (SN)	NECESSARY	200.00	200.00
			415.70	415.70
<b>LABOUR</b>				
	THATCHAM STANDARD REPAIR TIME ON BODY WORKS.		670.00	420.00
	THATCHAM TTS STANDARD SPRAY PAINTING COST AND LABOUR.		750.00	400.00
			1,420.00	820.00
<b>GRAND TOTAL</b>			<b>3,724.02</b>	<b>1,974.66</b>

RECOMMENDED COST OF LUMP SUM REPAIRS (TO ITS PRE-ACCIDENT CONDITION) (CONFIRMED)			1,550.00
--	--	--	----------
