OD (TP Re-inspection) / Evaluation

To Inspect Vehicle No: SKW 903T Insured: GBF 2585K

**THIRD PARTY SURVEY
ACCIDENT OCCURED ON 31 October 2017**

VEHICLE DAMAGE INSPECTION REPORT

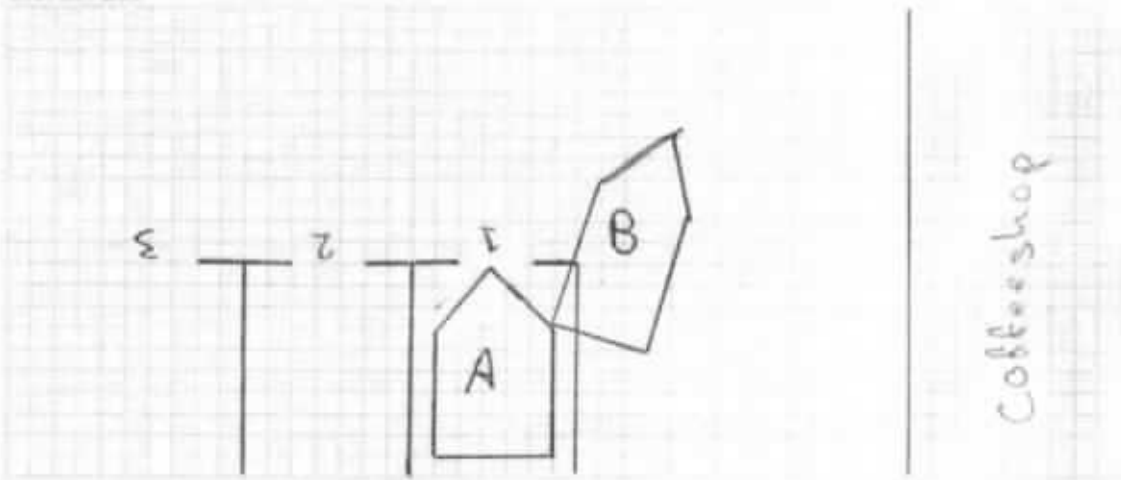
SKETCH PLAN

DESCRIBE CIRCUMSTANCES OF THE ACCIDENT

On 31/10/17, My Car was parked stationary at 21 Tuas Ave 13, inside the parking lot.

The Lorry of GBF2585K had reversed and hit my car, causing damages to my side tender, (driverside), side mirror (driver side) and driver's door.
