ASSIGNMENT

Veh No: **SHC 1324Z** Regn: **30 APR 2011**
 Type: M.Car / M.Cycle / Bus / Van / Lorry (Taxi) / Prime Mover /

Make: **HYUNDAI SONATA** DO **1991**
 Colour: **BLUE** A/C **Insured** Std / NI / NA
 Sp. Reading: **138,078** Radio **Insured** Std / NI / NA
 Eng No: _____

ADJUSTMENT ON REPAIR COST FOR VEHICLE NO. SHC 1324Z

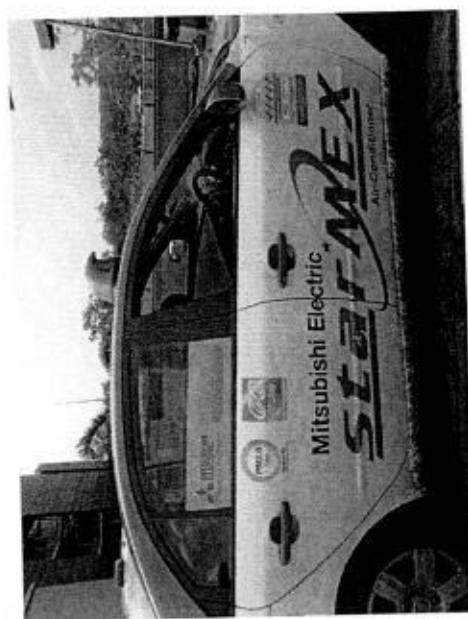
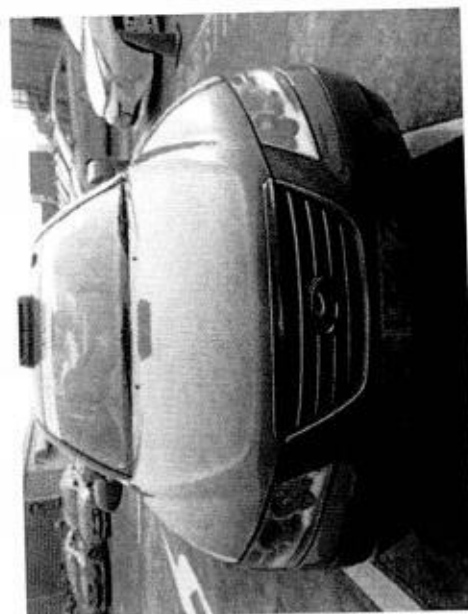
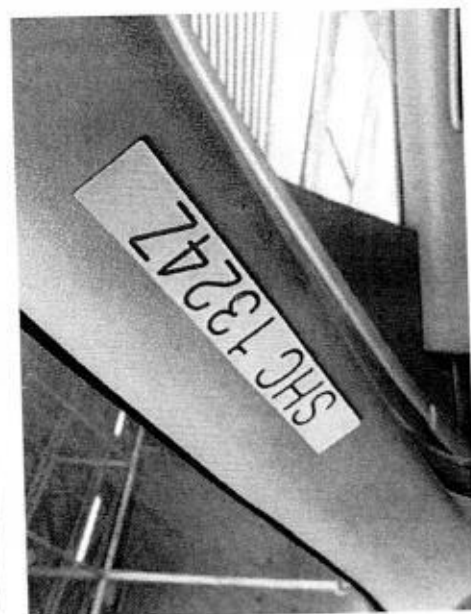
8/4/18

While I drove pass a car EL 988C, suddenly the passenger of the car open left rear door for alighting. Due to this cause, the car left rear door grazed onto the right front portion of my taxi.

THE VEHICLE SUSTAINED DAMAGES AT THE FRONT O/S PORTION. DAMAGES SEE DETAILS.

Qty	Description of Parts	Condition	Estimate By Workshop (\$)	Our Adjusted (\$)
	<u>REPLACEMENT OF PARTS</u>			
1	FRONT FENDER (RH)	DENTED	593.00	593.00
1	FRONT FENDER SHIELD (RH)	NOT NECESSARY	86.00	-
1	FRONT FENDER SIGNAL LAMP (RH)	BROKEN	45.40	45.40
1	FRONT FENDER RETAINER	NECESSARY	9.20	9.20
	LESS 20% DISCOUNT		-146.72	-129.52
			586.88	518.08
	<u>SPECIAL NETT ITEMS</u>			
1	FRONT FENDER ADVERTISEMENT LOGO (RH)(SN)	NECESSARY	100.00	100.00
			100.00	100.00
	<u>LABOUR</u>			
	THATCHAM STANDARD REPAIR TIME ON BODY WORKS.		500.00	200.00
	THATCHAM TTS STANDARD SPRAY PAINTING COST AND LABOUR.		550.00	420.00
			1,050.00	620.00
	GRAND TOTAL		1,736.88	1,238.08
	RECOMMENDED COST OF LUMP SUM REPAIRS (TO ITS PRE-ACCIDENT CONDITION) (CONFIRMED)			1,000.00
