### **National Assessment Centre Services**

TP Claims against NTUC Income: Follow-Through Survey

## THE VEHICLE SUSTAINED DAMAGES AT THE REAR O/S PORTION.

### ADJUSTMENT ON REPAIR COST FOR VEHICLE NO. SHB 4161L

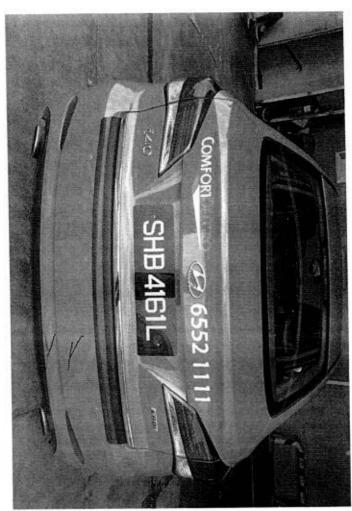
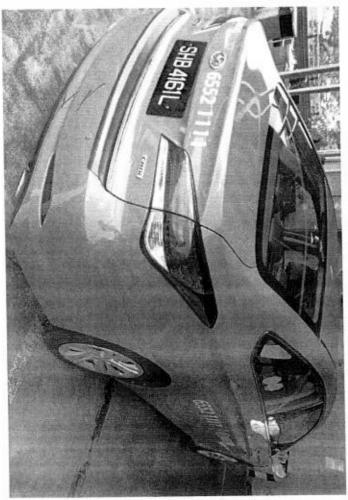
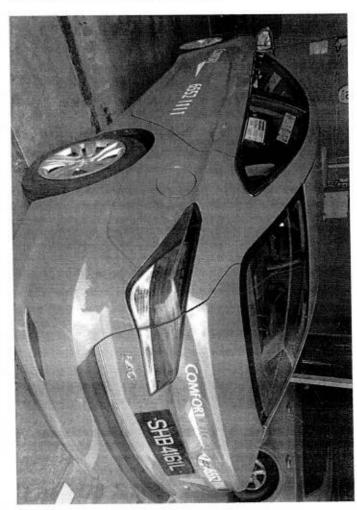
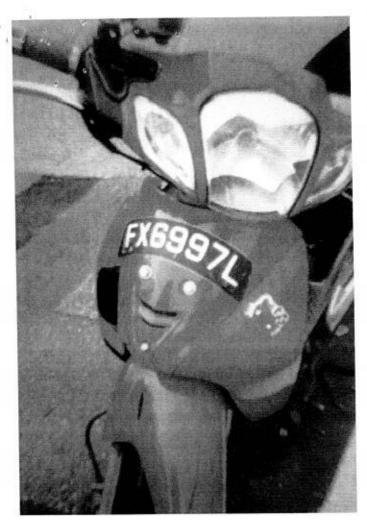
DAMAGES SEE DETAILS.

Qty	Description of Parts	Condition	Estimate By Workshop (\$)	Our Adjusted (\$)
	REPLACEMENT OF PARTS			(4)
1 10 1	REAR BUMPER REAR BUMPER SPONGE REAR BUMPER CLIPS @\$2.20 REAR BUMPER UNDER COVER LESS 20% DISCOUNT  SPECIAL NETT ITEMS	TO REPAIR SERVICEABLE NOT NECESSARY SERVICEABLE	603.60 143.40 22.00 225.00 -198.80 795.20	9
1	REAR BUMPER RUBBER MAT (SN)	NECESSARY	50.00	50.00
	ABOUR THATCHAM STANDARD REPAIR TIME ON BODY WORKS. THATCHAM TTS STANDARD SPRAY PAINTING COST AND LABOUR.		50.00	50.00
			370.00 200.00	100.00 180.00
	CDAND TOTAL		570.00	280.00
	GRAND TOTAL		1,415.20	330.00
(	RECOMMENDED COST OF LUMP SUM REPAIRS TO ITS PRE-ACCIDENT CONDITION) (CONFIRMED)			250.00
