To: MSIG Insurance (Singapore) Pte. Ltd. 4 Shenton Way #21-01 SGX Centre 2 Singapore 068807	From: LKK Auto Consultants Pte Ltd 51 Ubi Ave 1 #01-25 Paya Ubi Industrial Park Singapore 408933
Attn: Monica Chung Pei Zhen	
Date: 16 Apr 2018	
<h3><u>Preliminary Advice</u></h3>

Insured Vehicle No	: YM1798K		
TP Vehicle No	: YP6578E	Accident Date	: 29/03/2018
Make	: HINO XZU700R	Assignment Date	: 11/04/2018
Date of Inspection	: 11/04/2018	Est. Duration of Repair	: 2.00
Inspection At	: SMRT AUTOMOTIVE SERVICES PTE LTD (WOODLANDS) 60 WOODLANDS INDUSTRIAL PARK E4 SINGAPORE 757705

VEHICLE DAMAGE INSPECTION REPORT

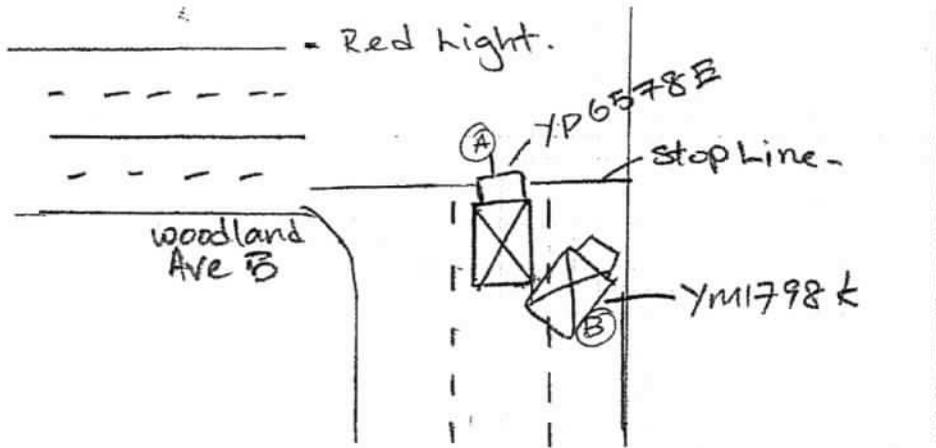
SKETCH PLAN

The driver Zhu Honglin, Licence number G6558391m of CK Seafood Pte Ltd. Drive and exit from SLR toward woodland Ave 12, stop at the middle lane of the Junction of nearest landmark (Woodland ave 5) before and stop at the red light traffic. Out of sudden, the other Party / Driver Pet Kim Chuan, S11075826 (Pink). Drivers of YM1798K - hit on our vehicle no. XP6578E white cold-truck back right rear. (with damage of. (Right Rear).

- Stainless steel handle.
- stainless steel bar.
- Scretch of cold truck Panel.
